# CITY OF ROSWELL STREAM ASSESSMENT

**2018**

Danelle Murray P.E.  
Water Resources Engineer  
City of Roswell

Austin Brown  
Scientist II  
R2T, Inc.

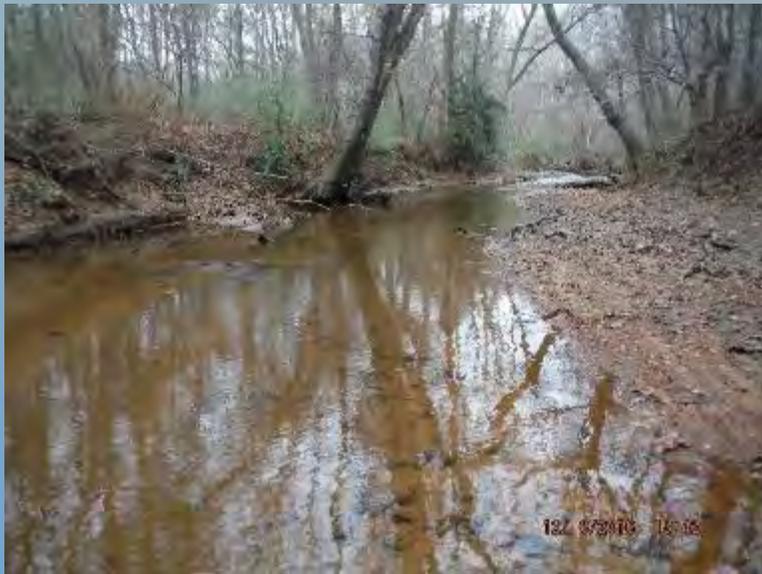
UPSTREAM

Eroded streambanks along main stem of Willeo Creek North of Roswell rd

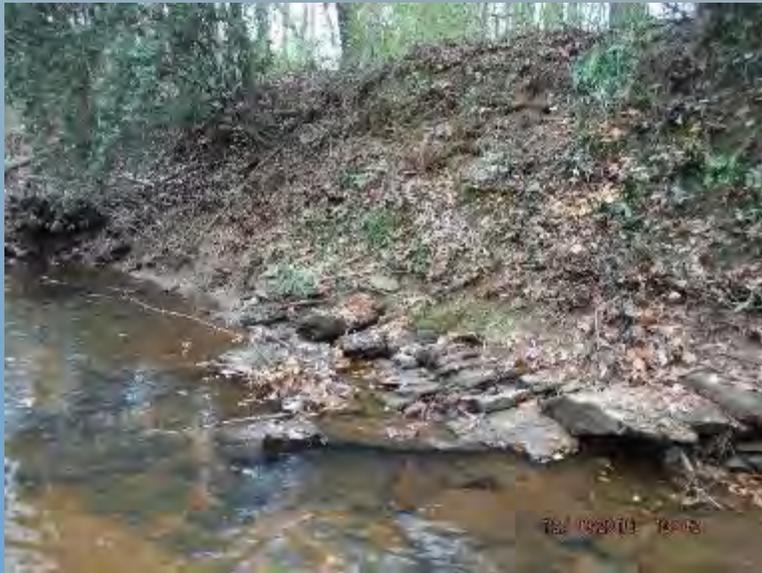
LEFT BANK

Eroded streambanks along main stem of Willeo Creek North of Roswell rd

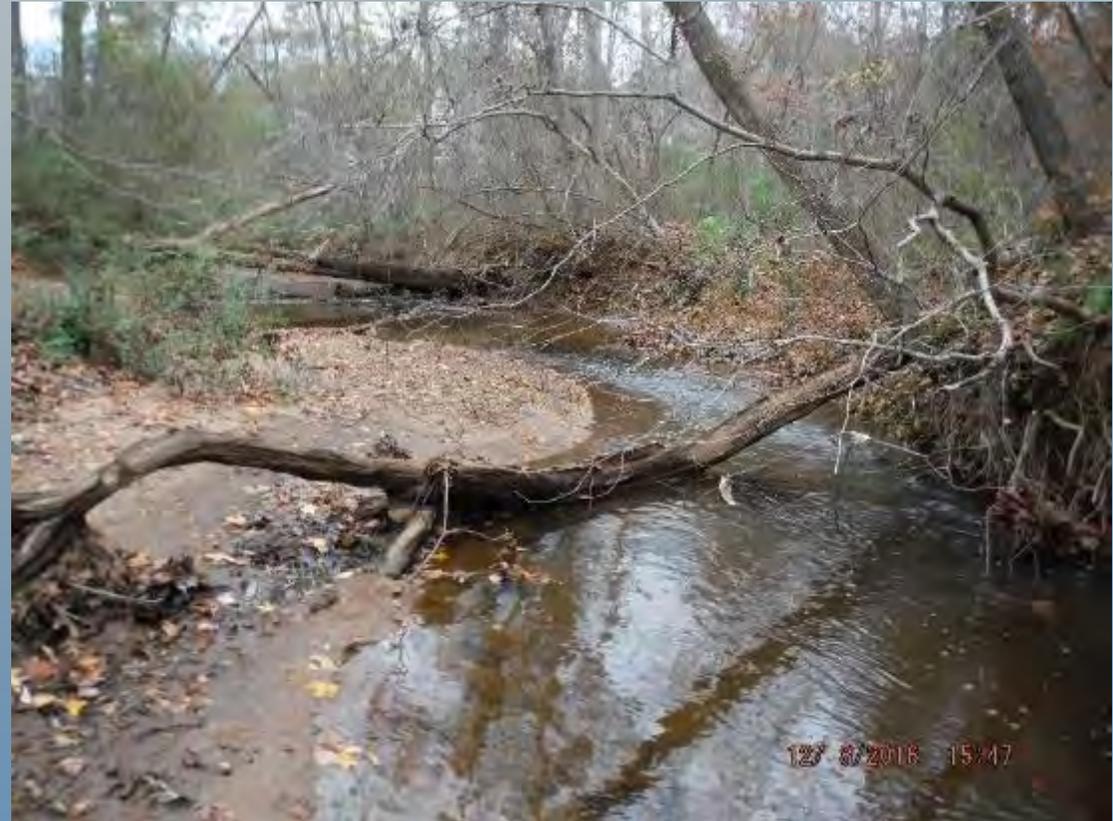
# REPRESENTATIVE REACH POINT 2 UPSTREAM

Habitat Parameters	ID (2)
1- Epifaunal Substrate/Available Cover	6
2- Pool Substrate Characterization	8
3- Pool Variability	12
4- Sediment Deposition	7
5- Channel Flow Status	6
6- Channel Alteration	12
7- Channel Sinuosity	8
Total Score:	74
Condition Categories	Marginal

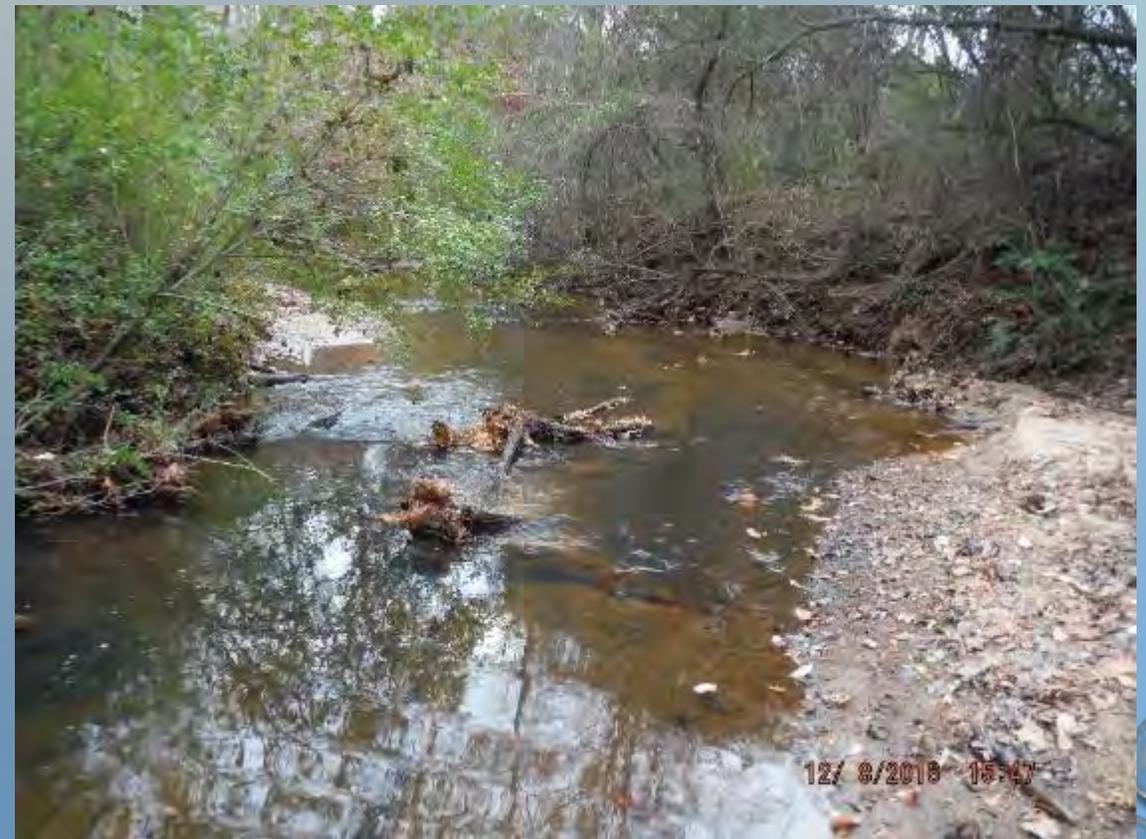
# REPRESENTATIVE REACH POINT 2 DOWNSTREAM

Habitat Parameters	ID (2)
1- Epifaunal Substrate/Available Cover	6
2- Pool Substrate Characterization	8
3- Pool Variability	12
4- Sediment Deposition	7
5- Channel Flow Status	6
6- Channel Alteration	12
7- Channel Sinuosity	8
Total Score:	74
Condition Categories	Marginal

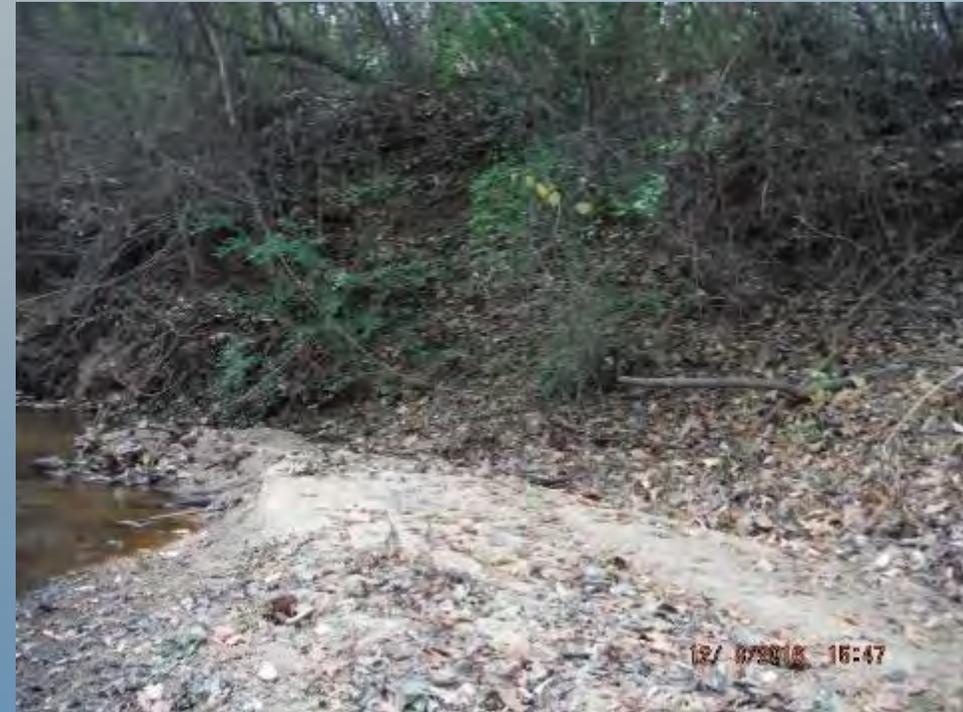
# REPRESENTATIVE REACH POINT 2 LEFT BANK

Habitat Parameters	ID (2)
8- Bank Stability Left Bank	3
8- Bank Stability Right Bank	3
9- Vegetative Protection Left Bank	2
9- Vegetative Protection Right Bank	2
10- Riparian Vegetative Zone Width LB	2
10- Riparian Vegetative Zone Width RB	3
Total Score:	74
Condition Categories	Marginal

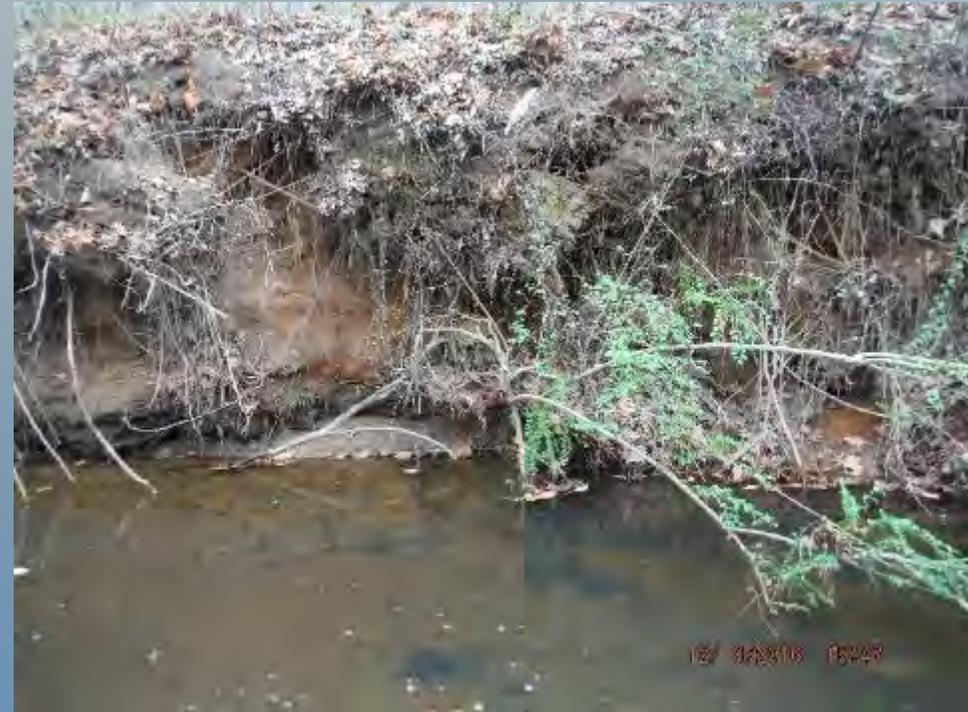
# REPRESENTATIVE REACH POINT 2 RIGHT BANK

Habitat Parameters	ID (2)
8- Bank Stability Left Bank	3
8- Bank Stability Right Bank	3
9- Vegetative Protection Left Bank	2
9- Vegetative Protection Right Bank	2
10- Riparian Vegetative Zone Width LB	2
10- Riparian Vegetative Zone Width RB	3
Total Score:	74
Condition Categories	Marginal

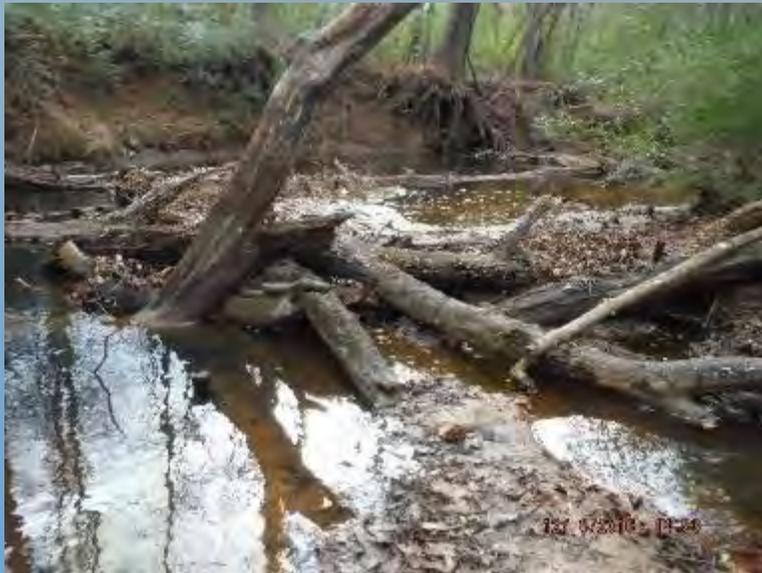
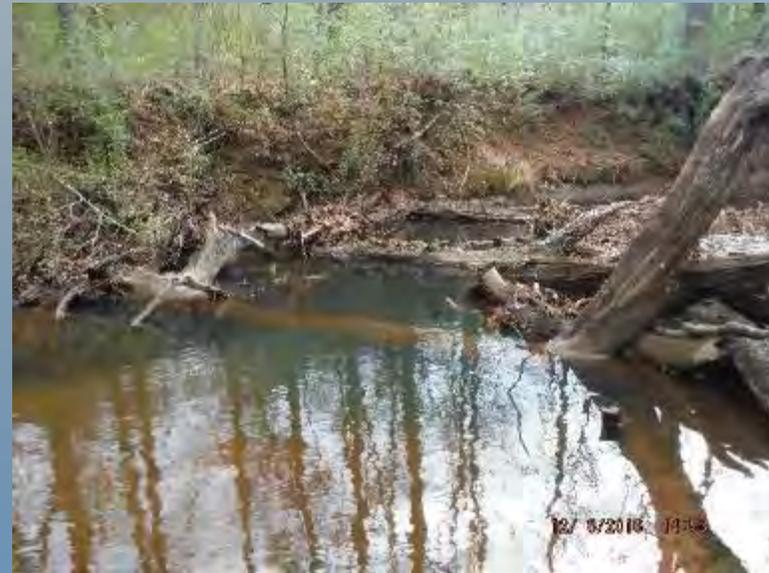
# WILLOO CREEK MAINTENANCE POINT 4504

## MEDIUM PRIORITY DEBRIS DAM

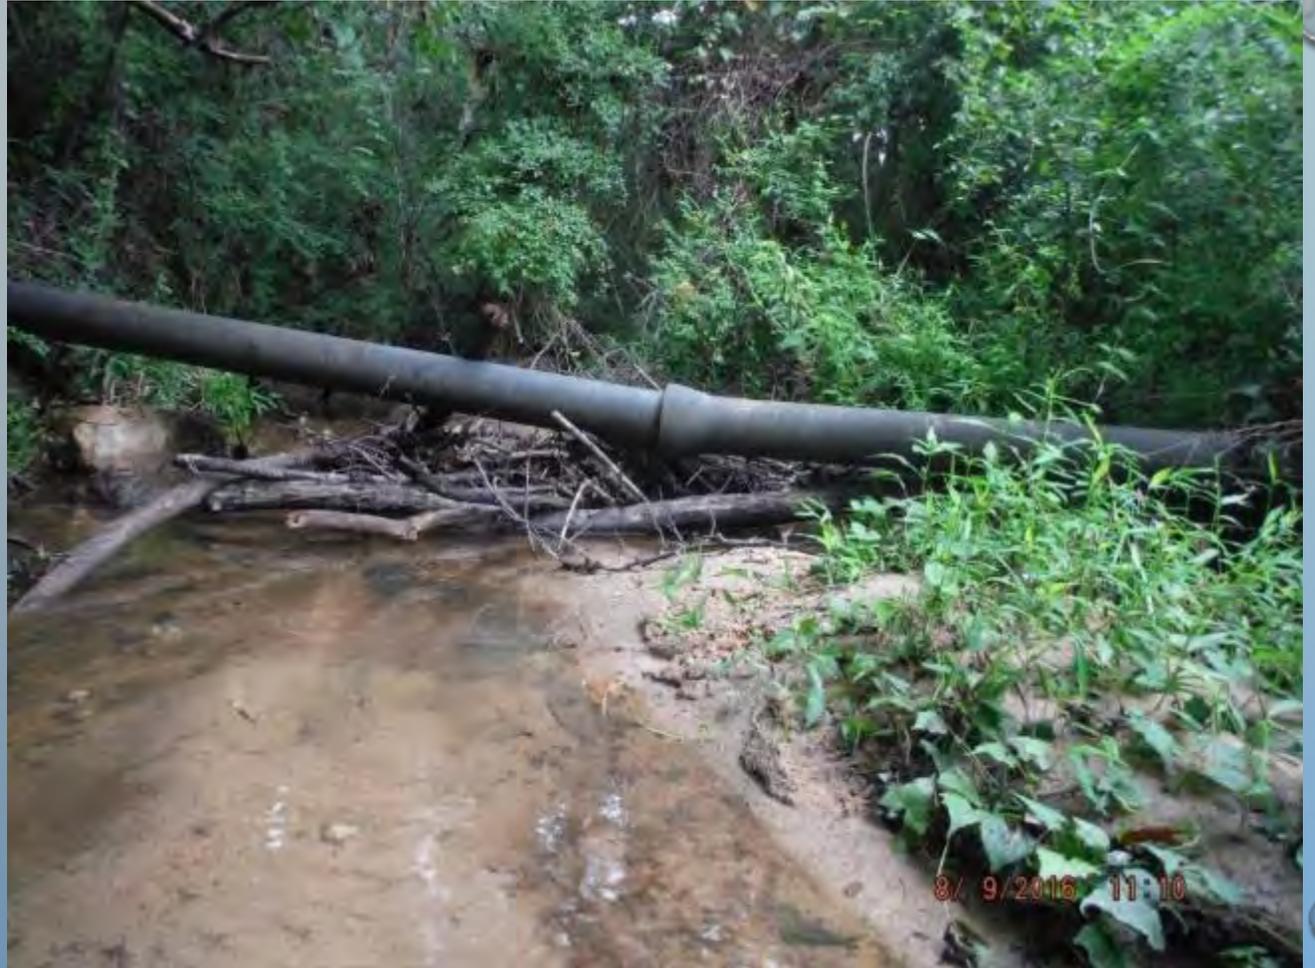
# MAINTENANCE POINT 1002

PIPE SAG, POTENTIAL FUTURE SANITARY  
SEWER SPILL

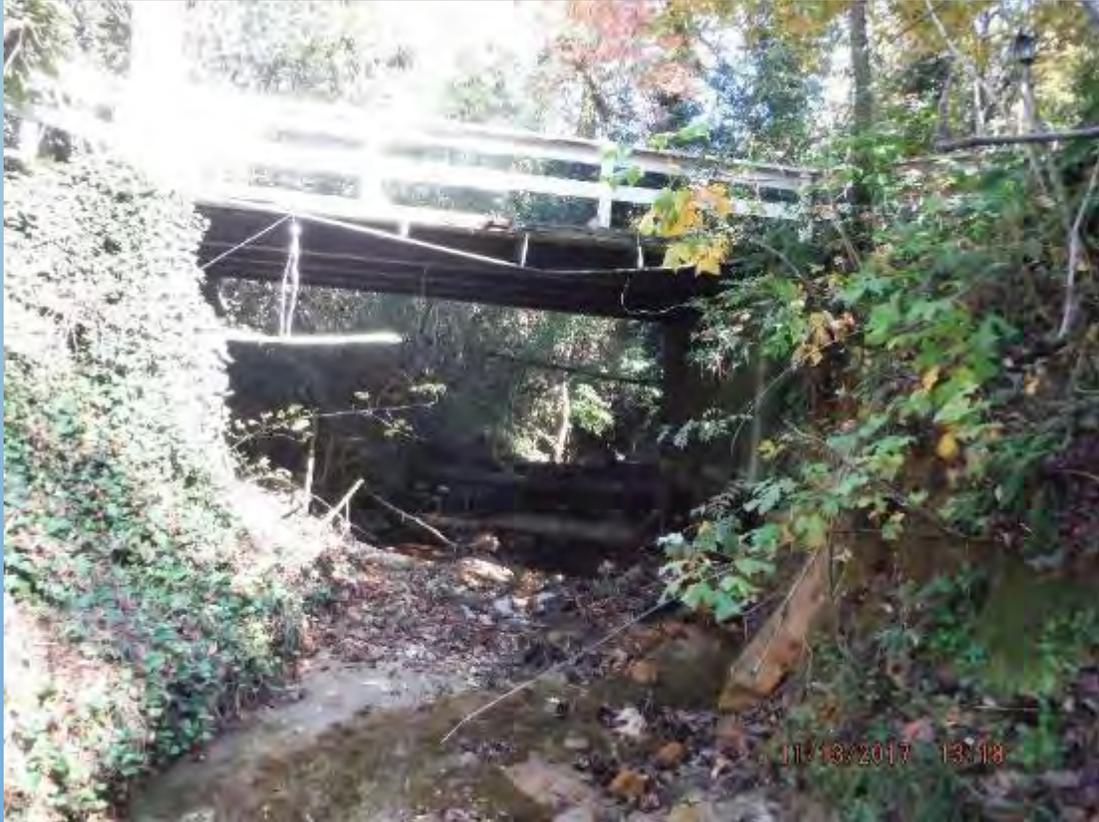
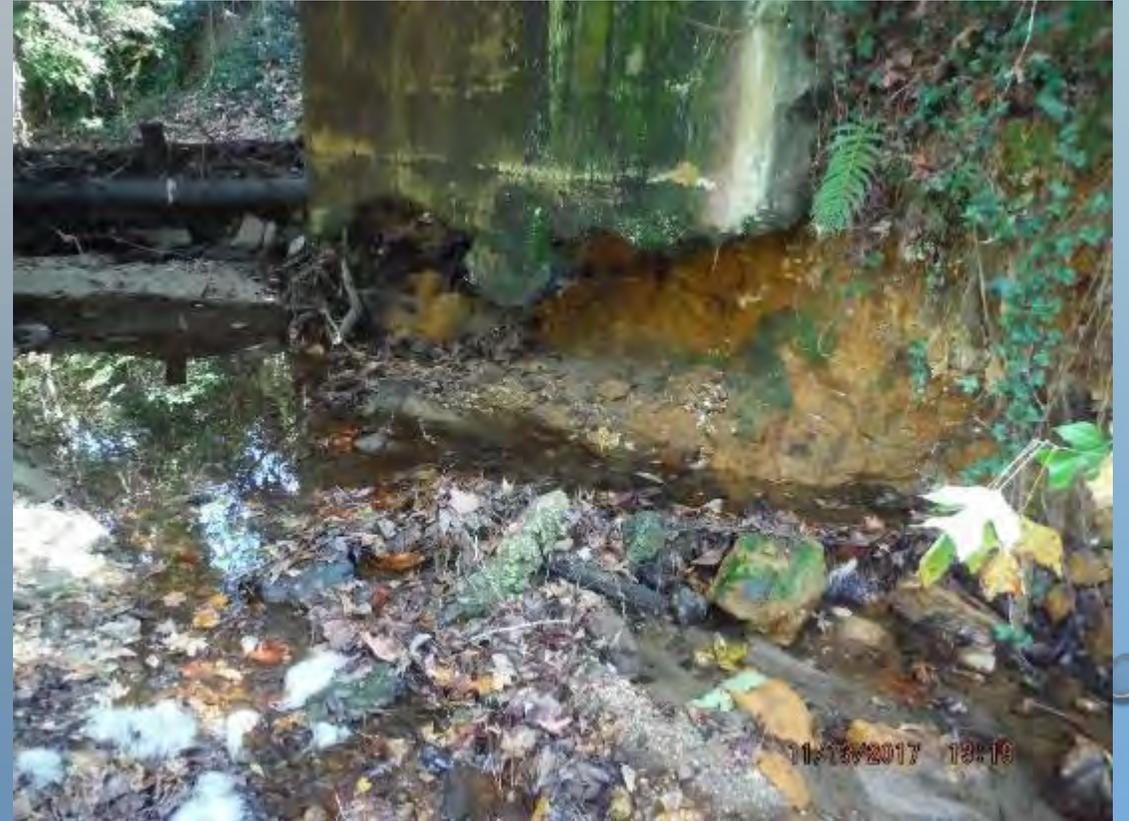
# MAINTENANCE POINT 1066

Eroded Infrastructure Support under private driveway

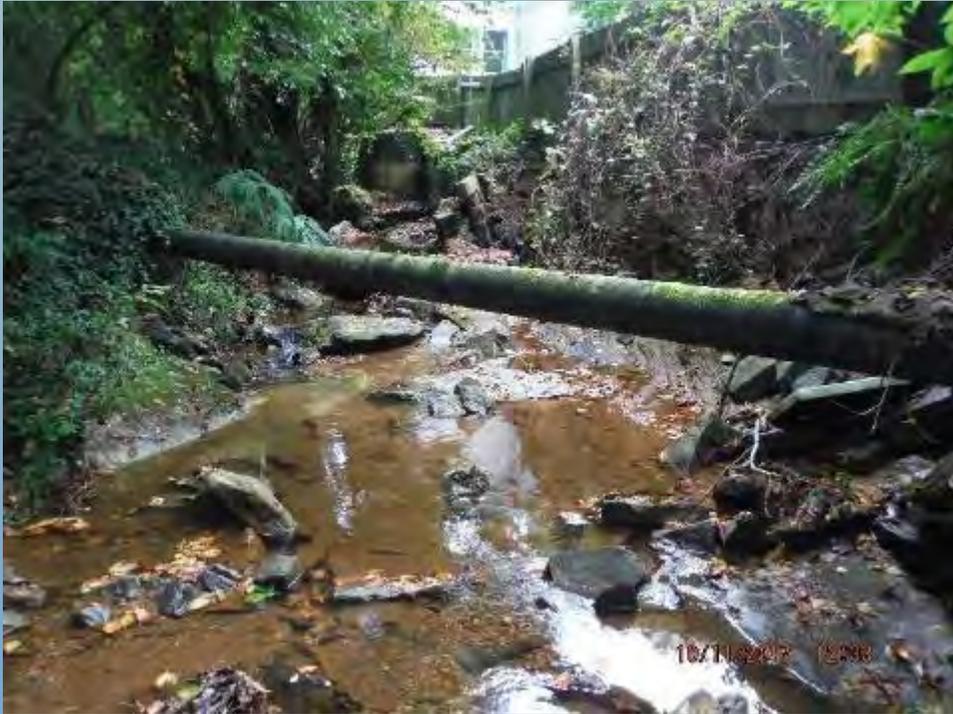
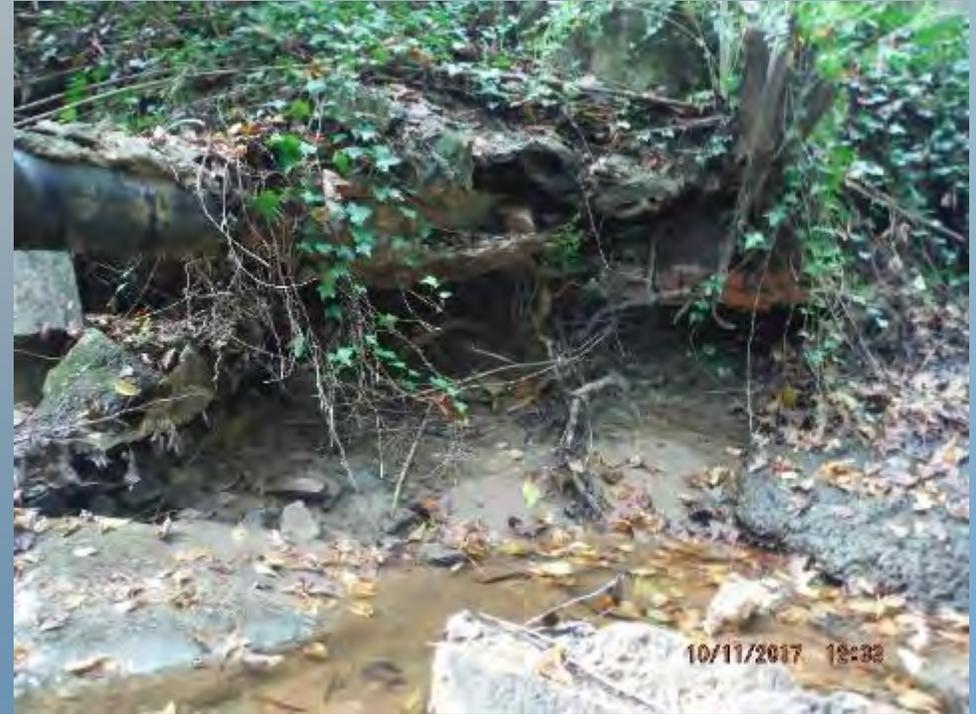
# MAINTENANCE POINT 1018

Erosion leading to emanate failure of sanitary sewer line

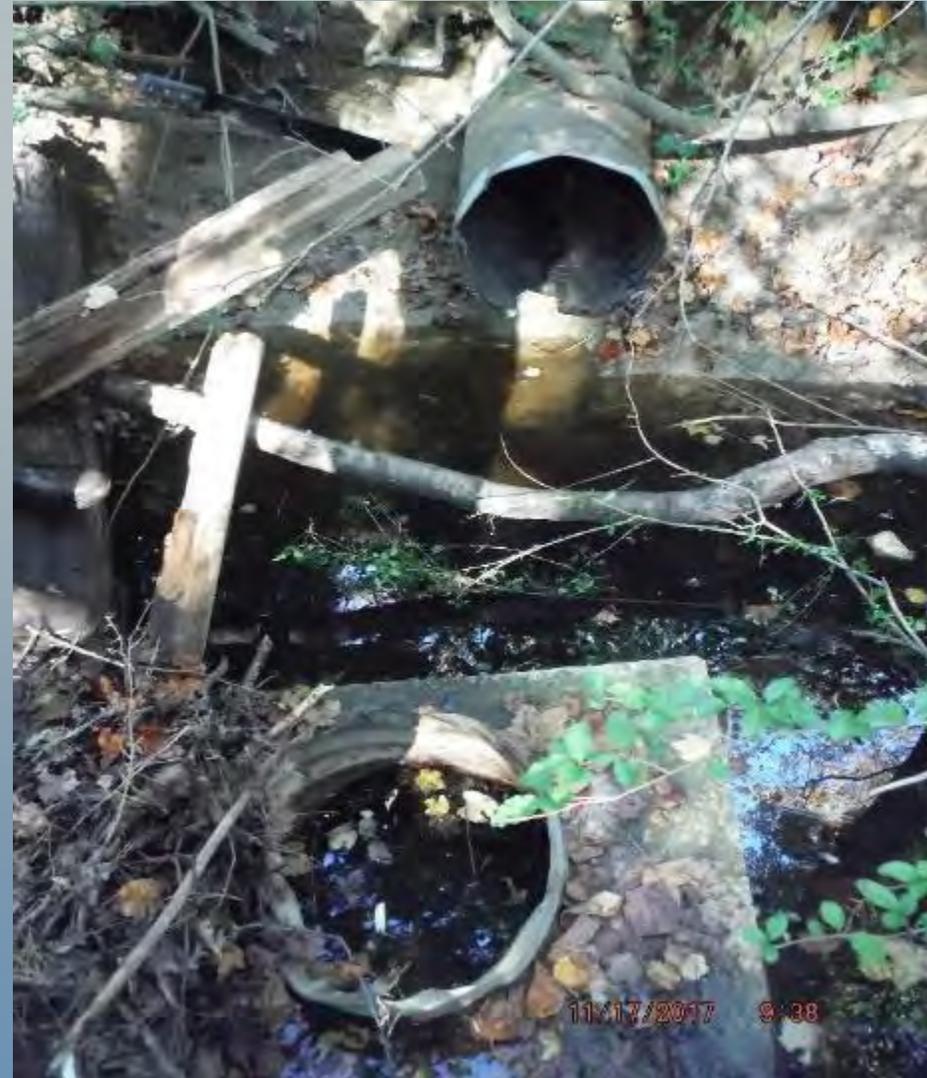
# MAINTENANCE POINT 1077

SEPARATED STORM DRAIN HEADWALL

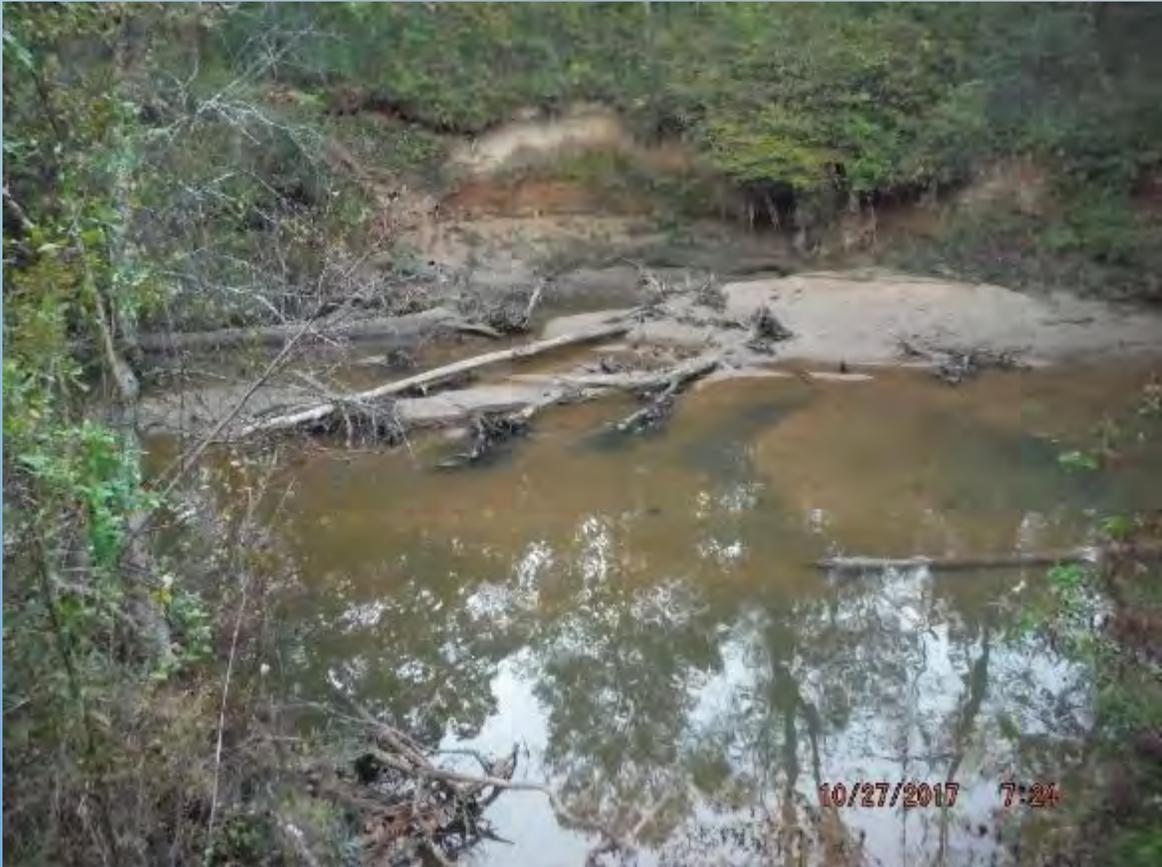
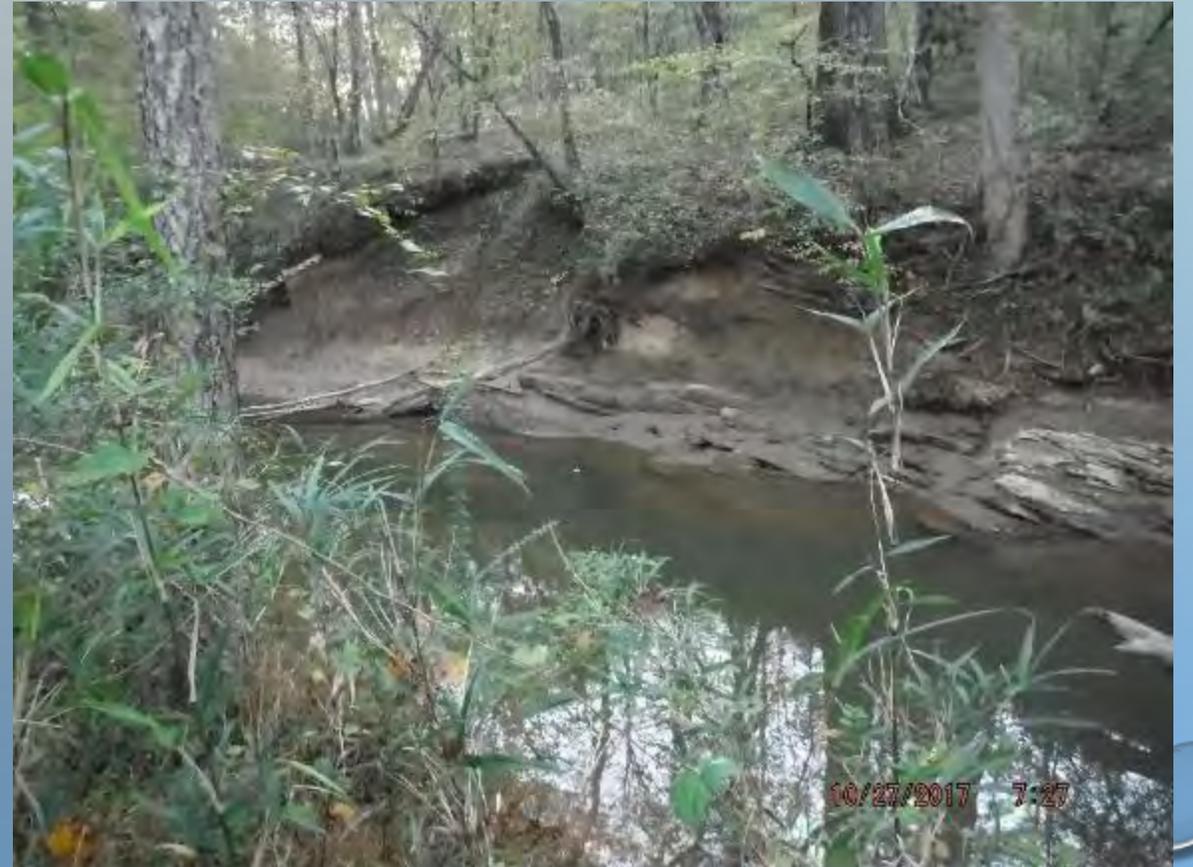
# MAINTENANCE POINT 1046

Eroded stream banks – Crooked Creek at the confluence with Chattahoochee River

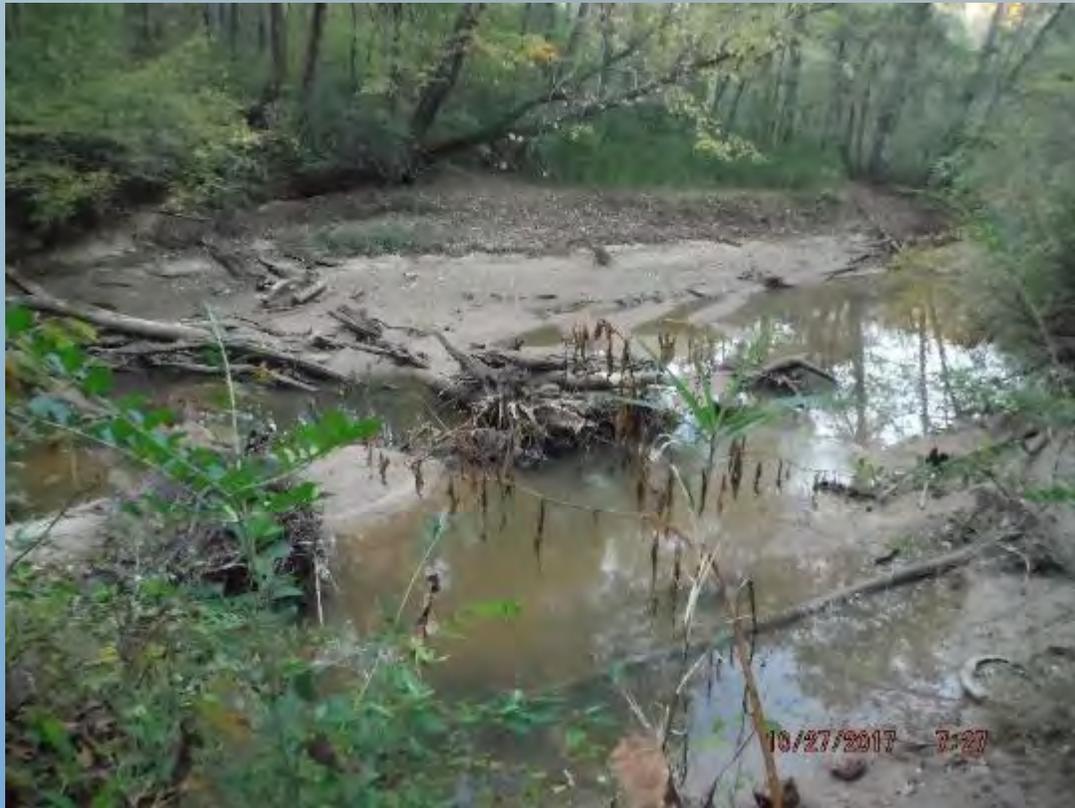
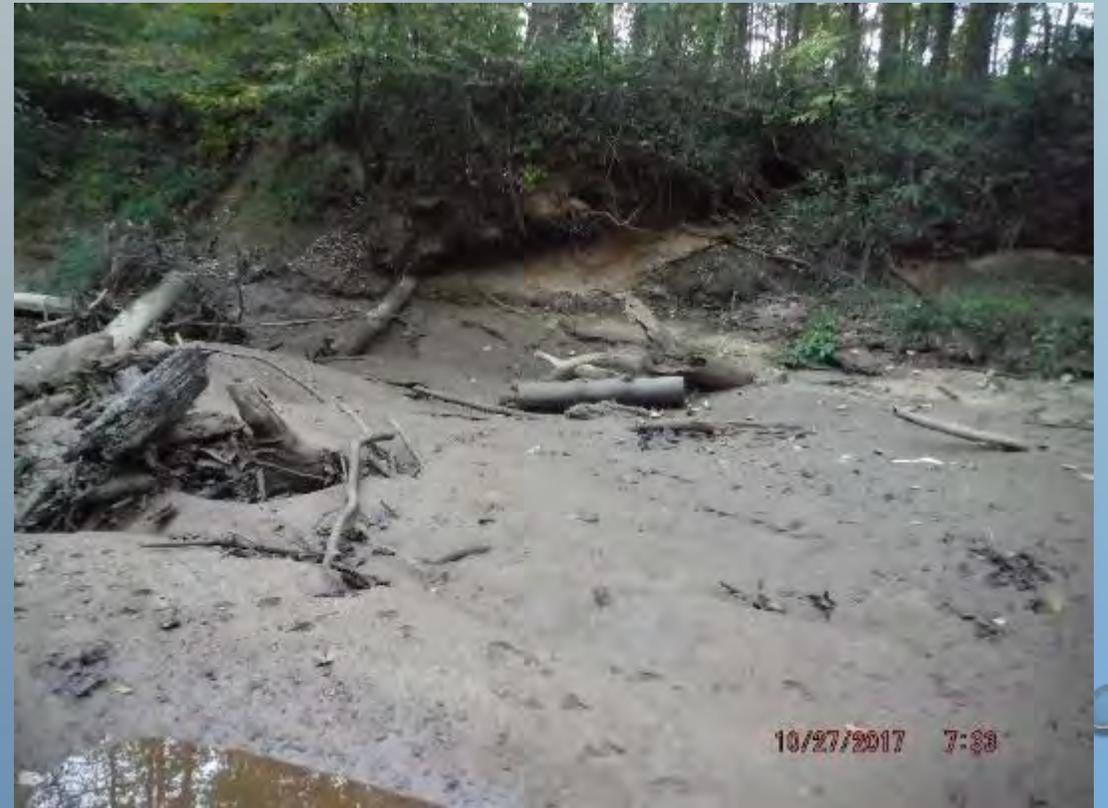
# MAINTENANCE POINT 1046

Eroded stream banks – Crooked Creek at the confluence with Chattahoochee River
