# **Maximizing the Value of Disaster Recovery Efforts: How to Turn Natural Disaster Pain into Resiliency Gain**

May 8, 2025 / 11:00 a.m. – 12:00 p.m.(Eastern)

## **HELENE'S** INFRASTRUCTURE IMPACTS ON REWA

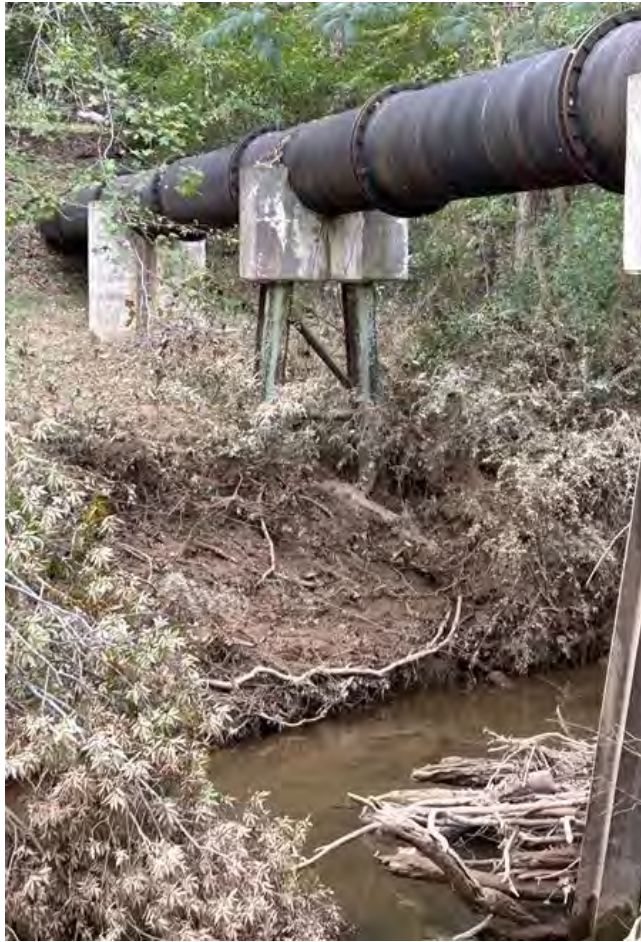
Scoured Footings on  
Support Pillar

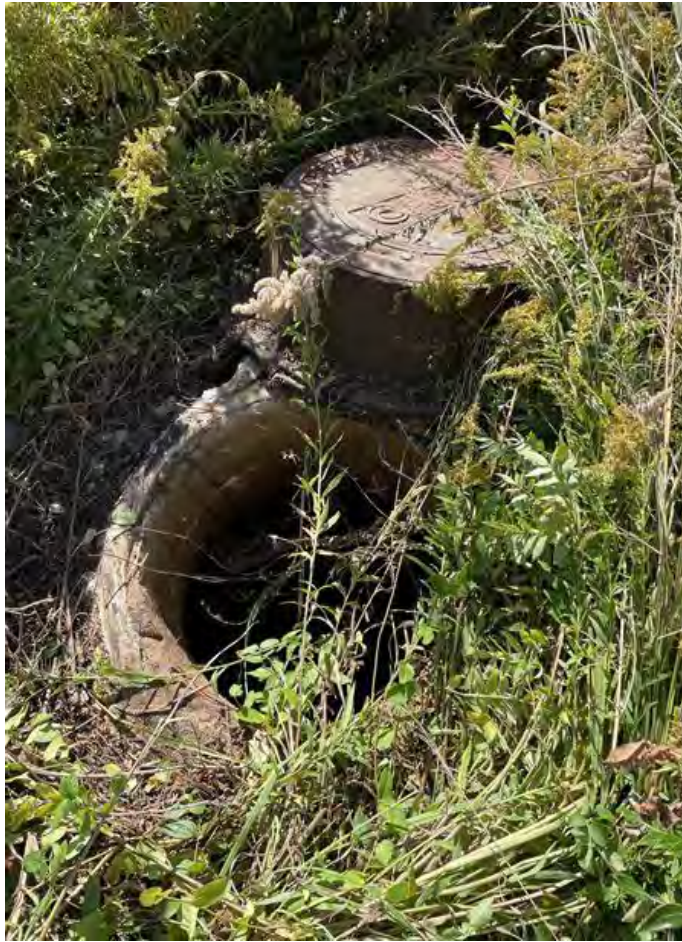
Dislodged Manhole Covers

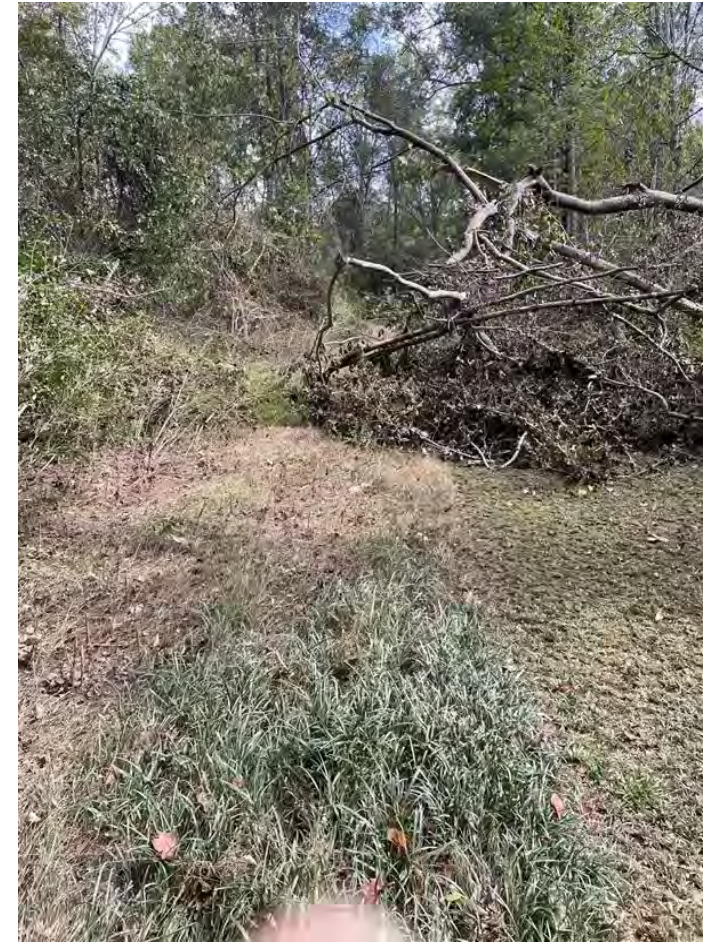
Downed Trees in ROW

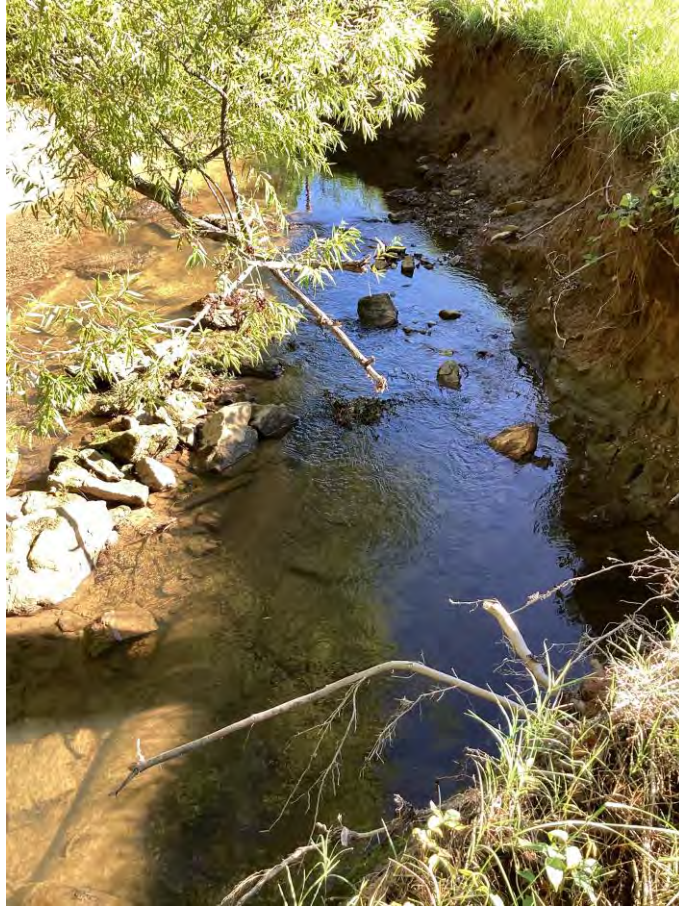
Scoured Stream Banks  
Adjacent to ROW

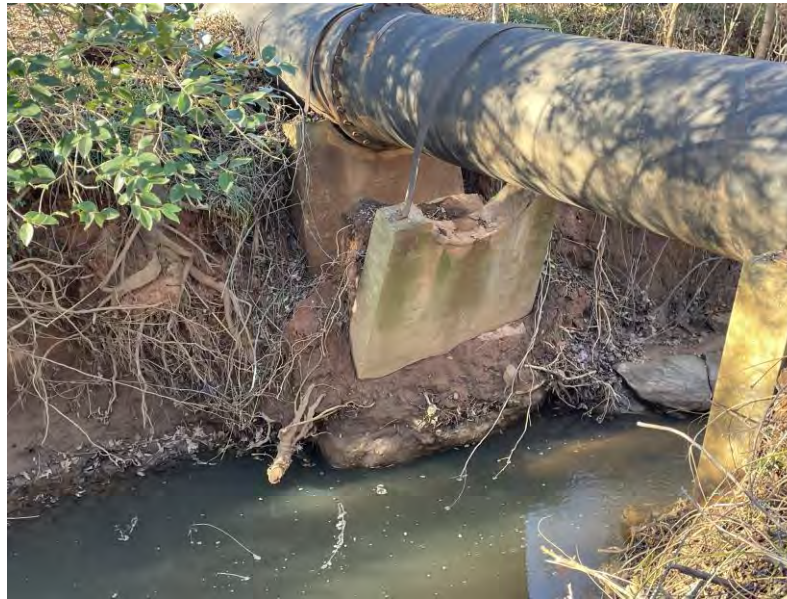
Failed Support Columns

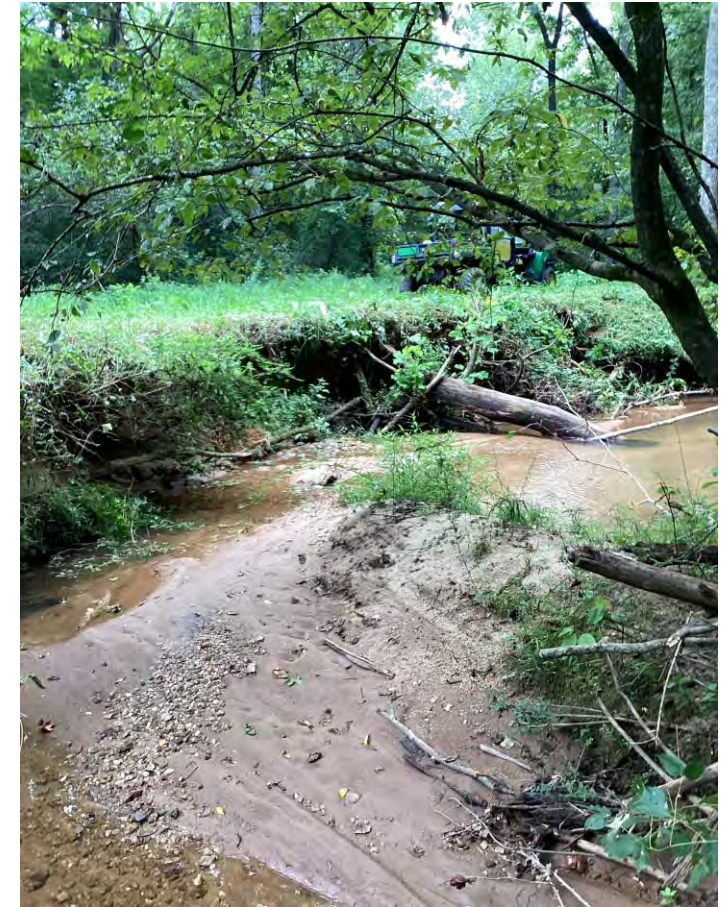
Scoured Banks and Debris  
Jams

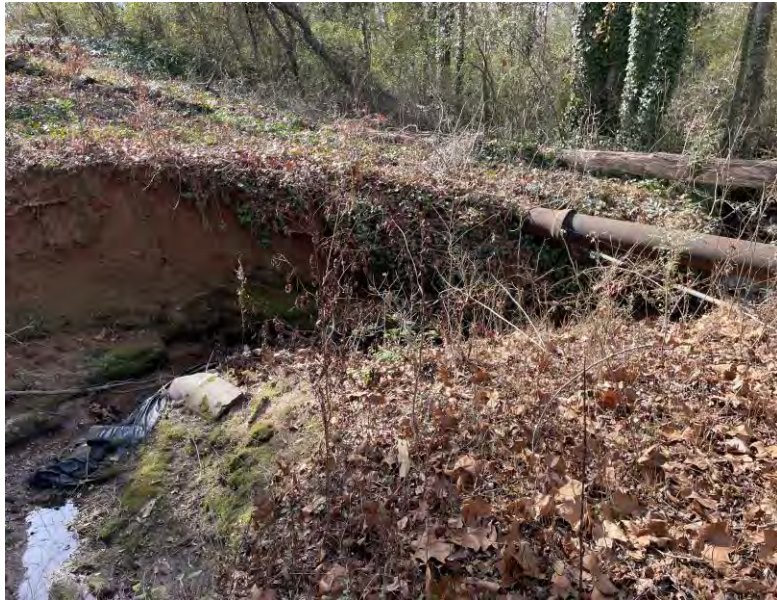
Loss of ROW due to stream migration

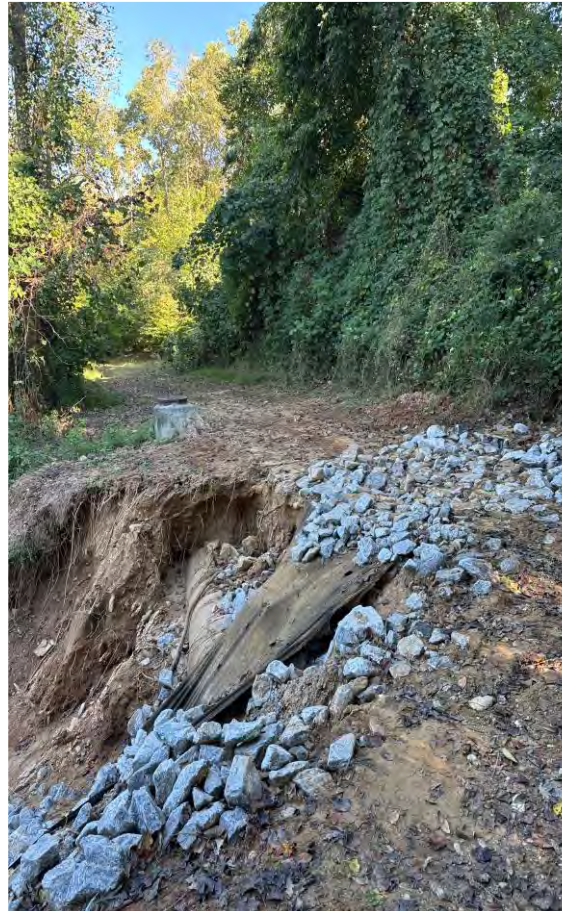
Slope Failures

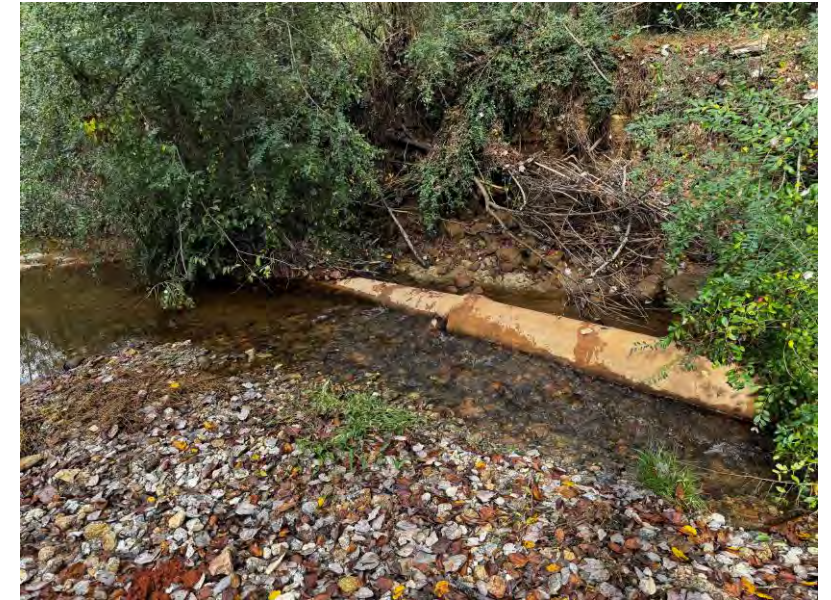
Undermining of at-grade crossings
