# Lessons Learned in the Design, Construction, and Monitoring of a Large Scale Regenerative Stormwater Conveyance (RSC)

Kyle Hall

August 25, 2016

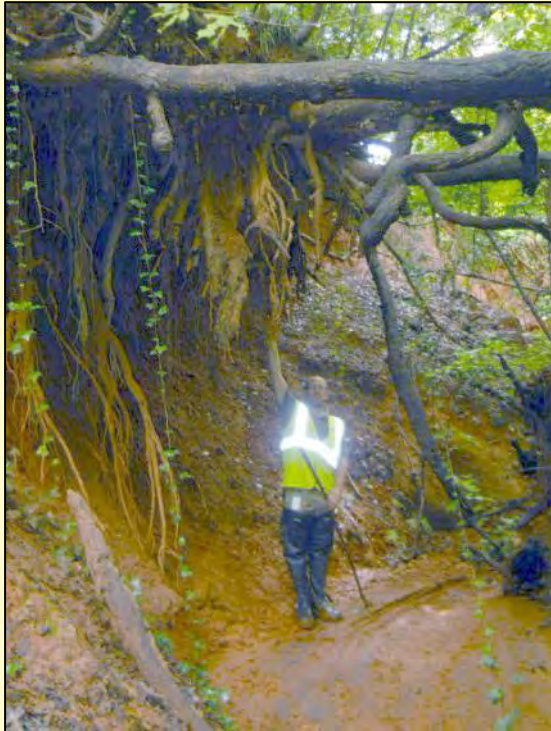
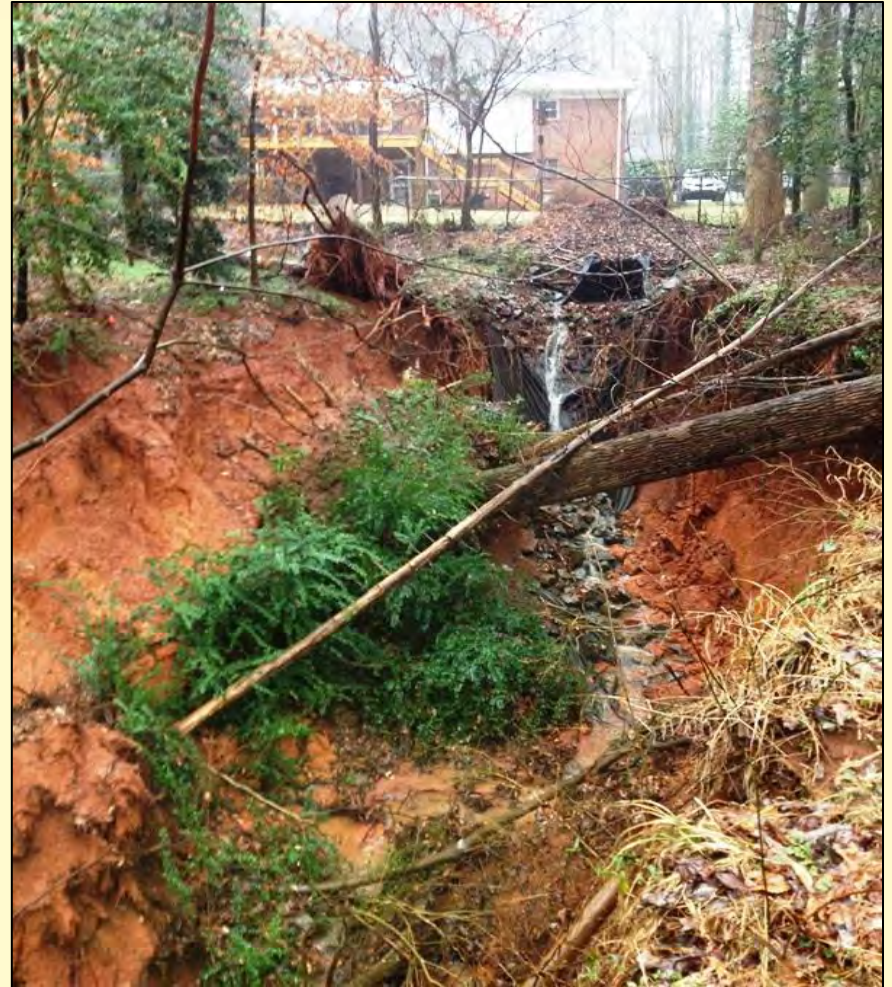
# Linda Lake Pre-Existing Site Conditions

- Severe erosion at a SW outfall
  - Tree Loss
  - Public Safety Concerns
  - Water Quality Degradation

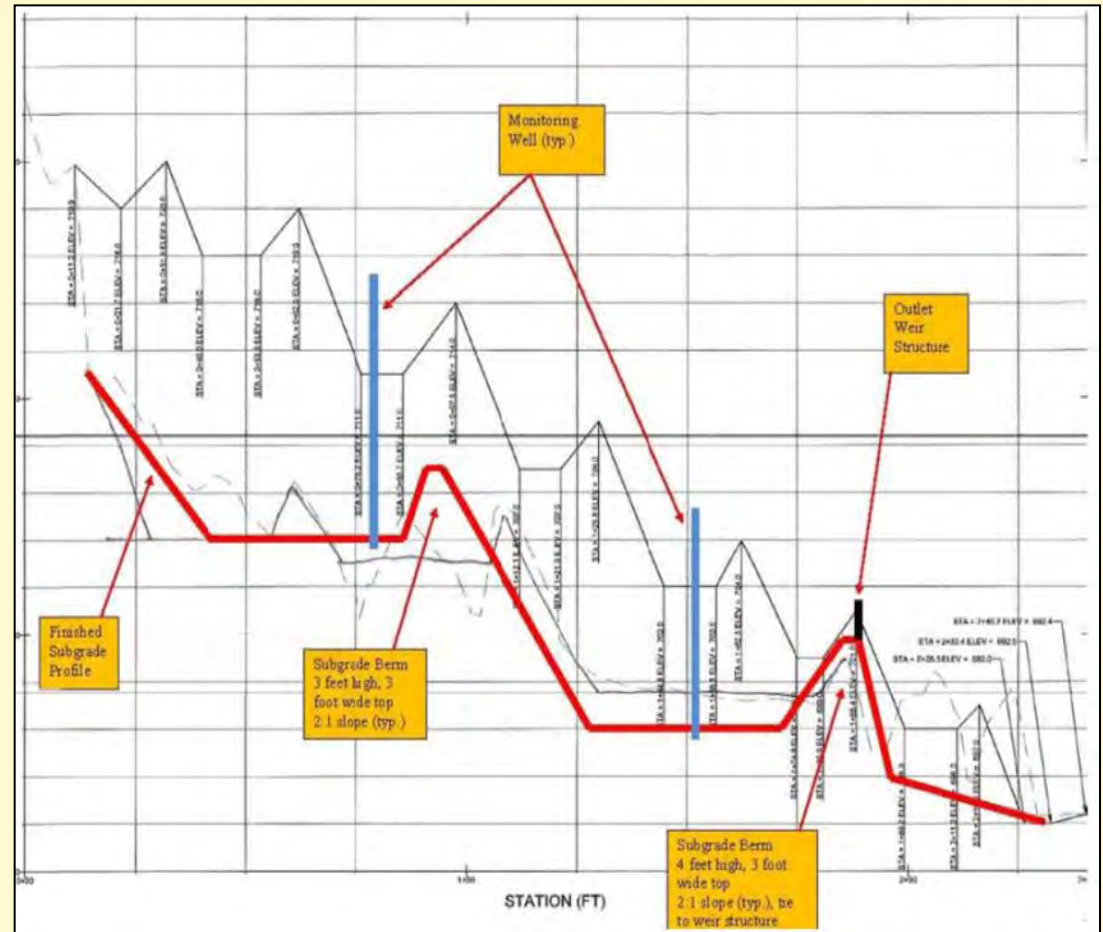
- Phase I grading to establish known dimensions (for monitorability)
- Internal berms to promote denitrification and infiltration

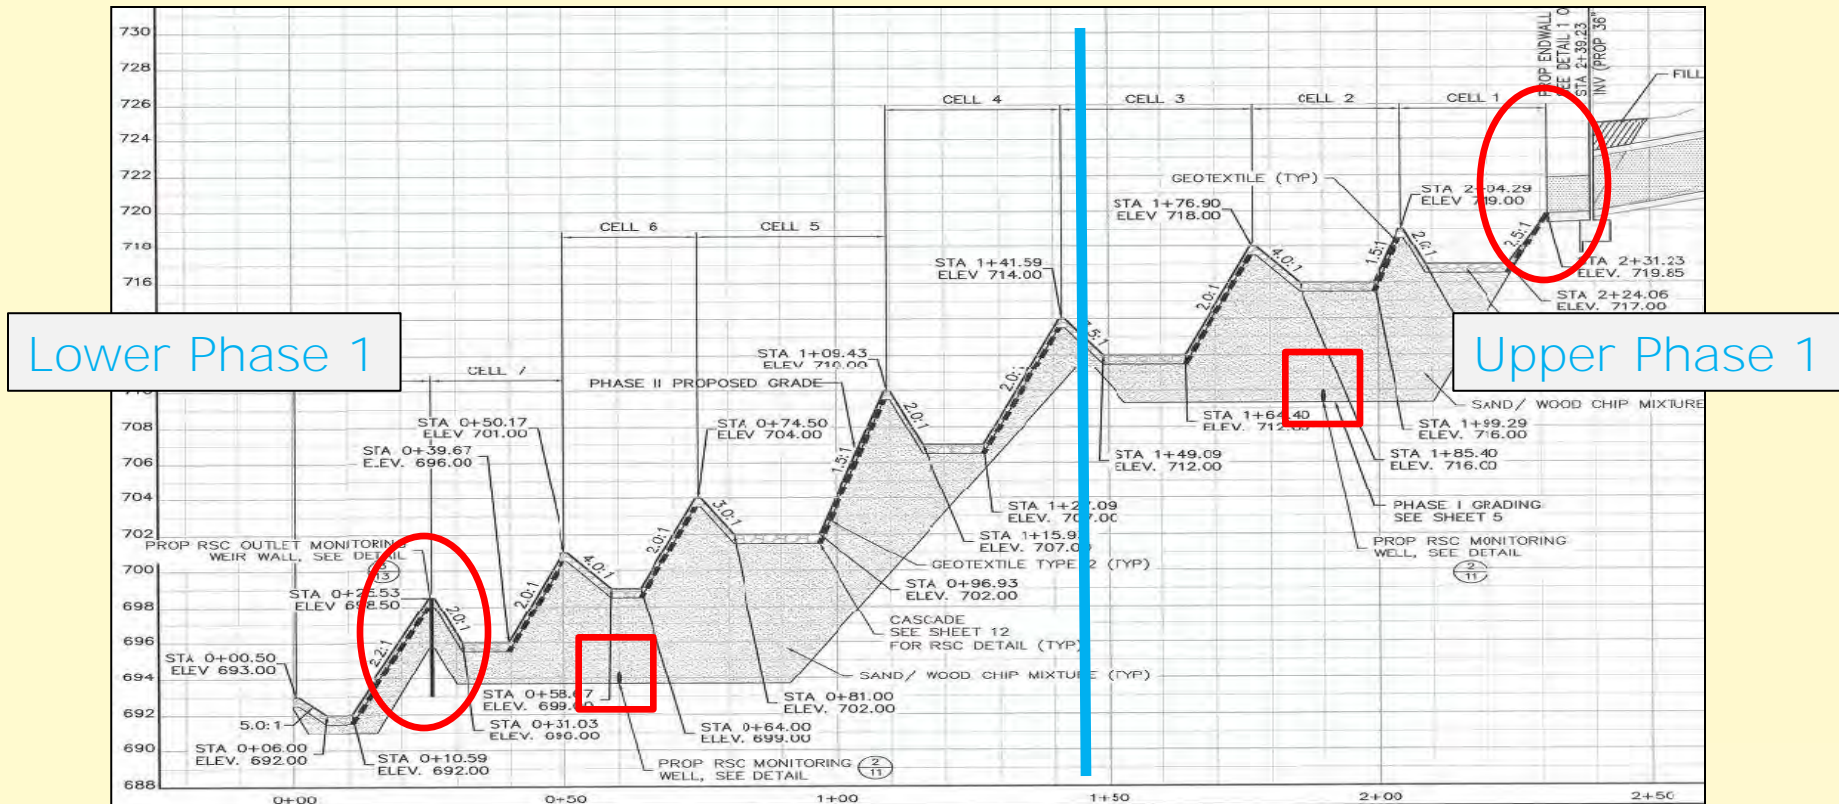
- Monitoring
  - Inlet/Outlet weirs to monitor discharge and water quality ○
  - Groundwater wells to monitor for hydrology □

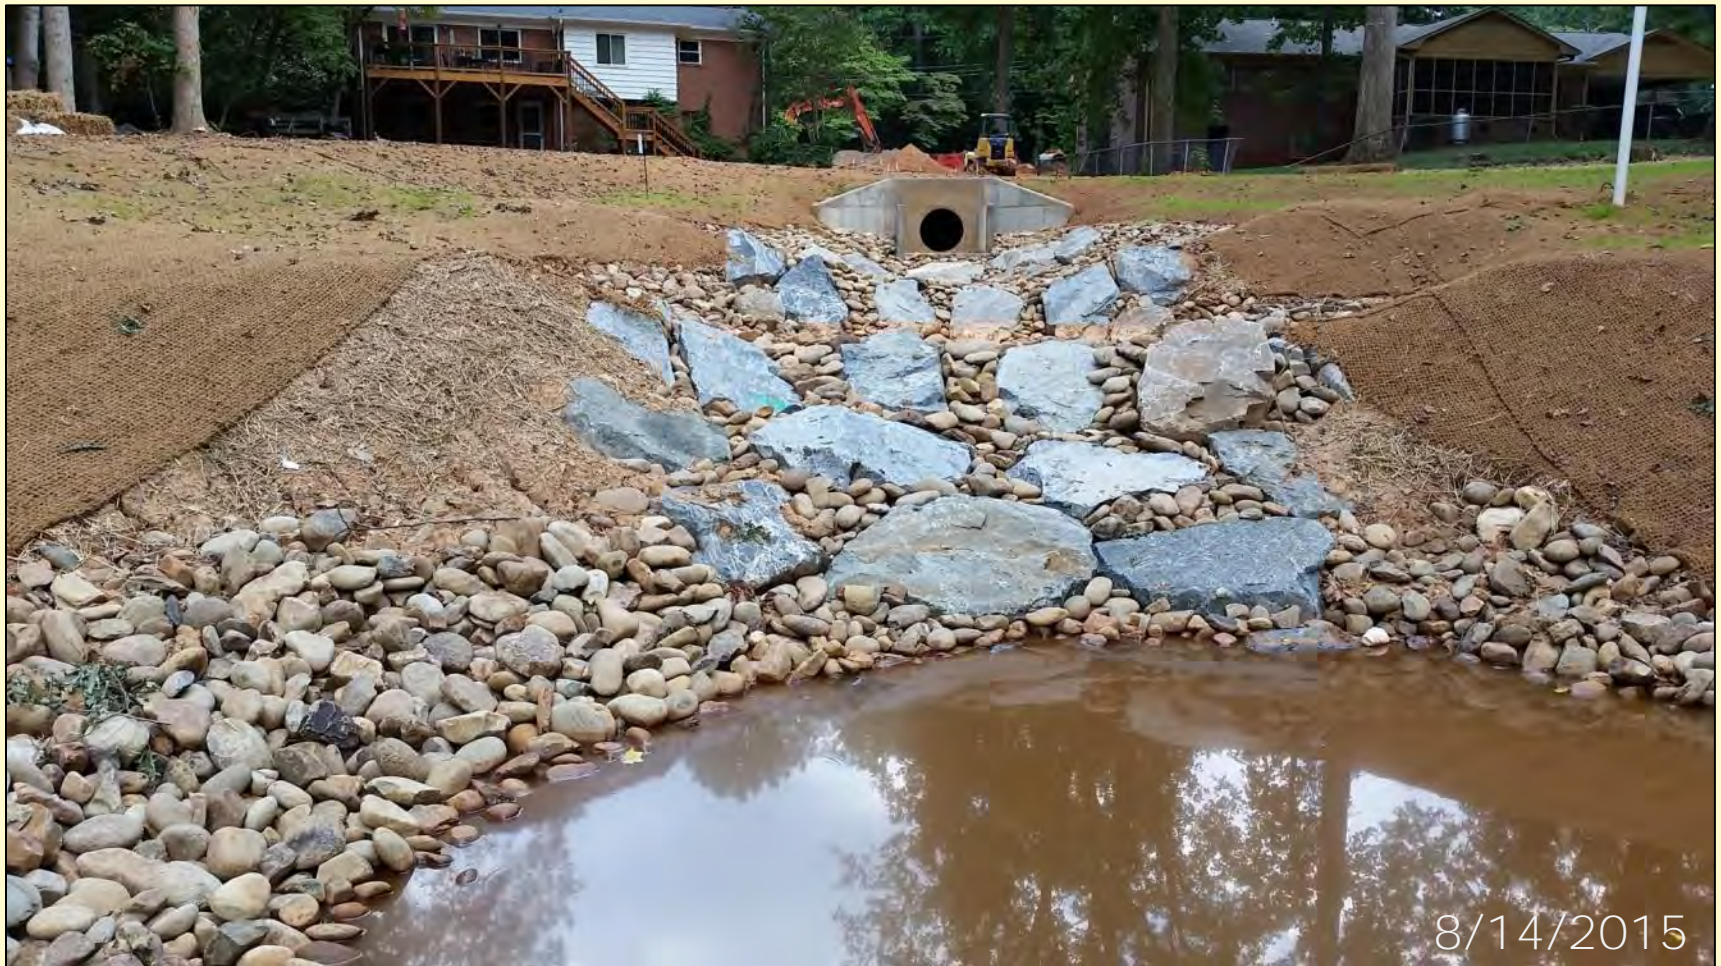
## Problem Identification (Ponding)

- Ponding in Cell 3 and concerns with mosquitos

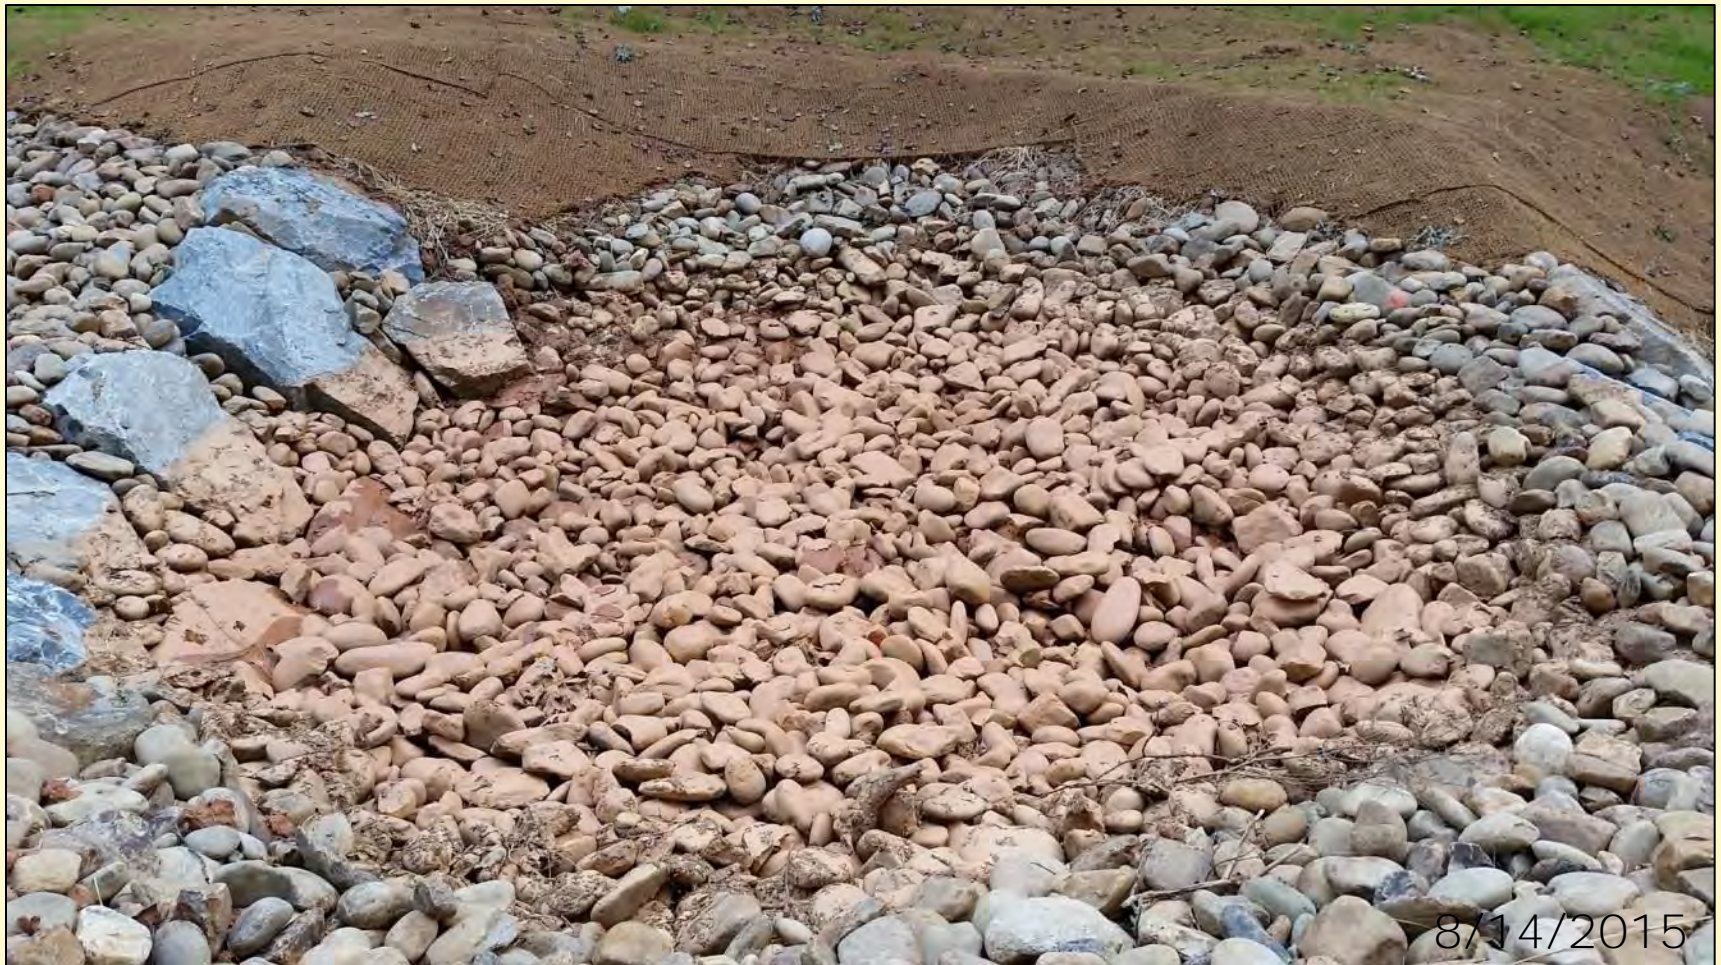
## Problem Identification (Ponding)

- Thick layer (5mm) of clay covering the cobble

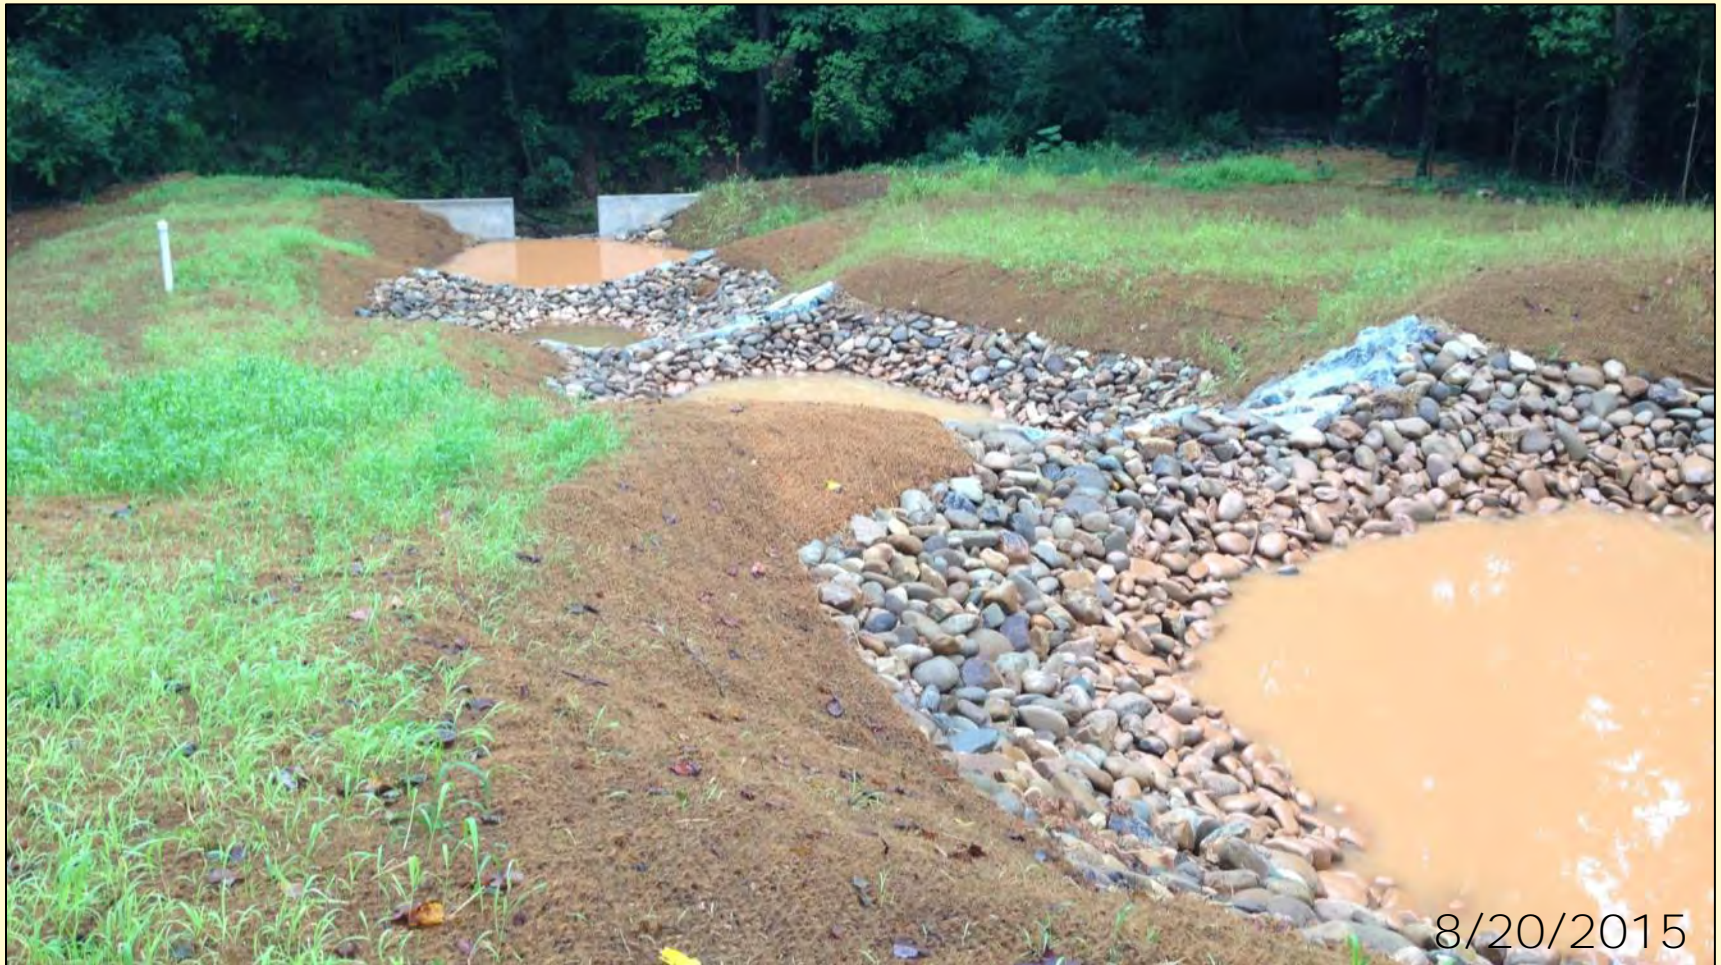
## Problem Identification (Ponding)

- Standing water in cells 4, 5, 6, and 7 by weir

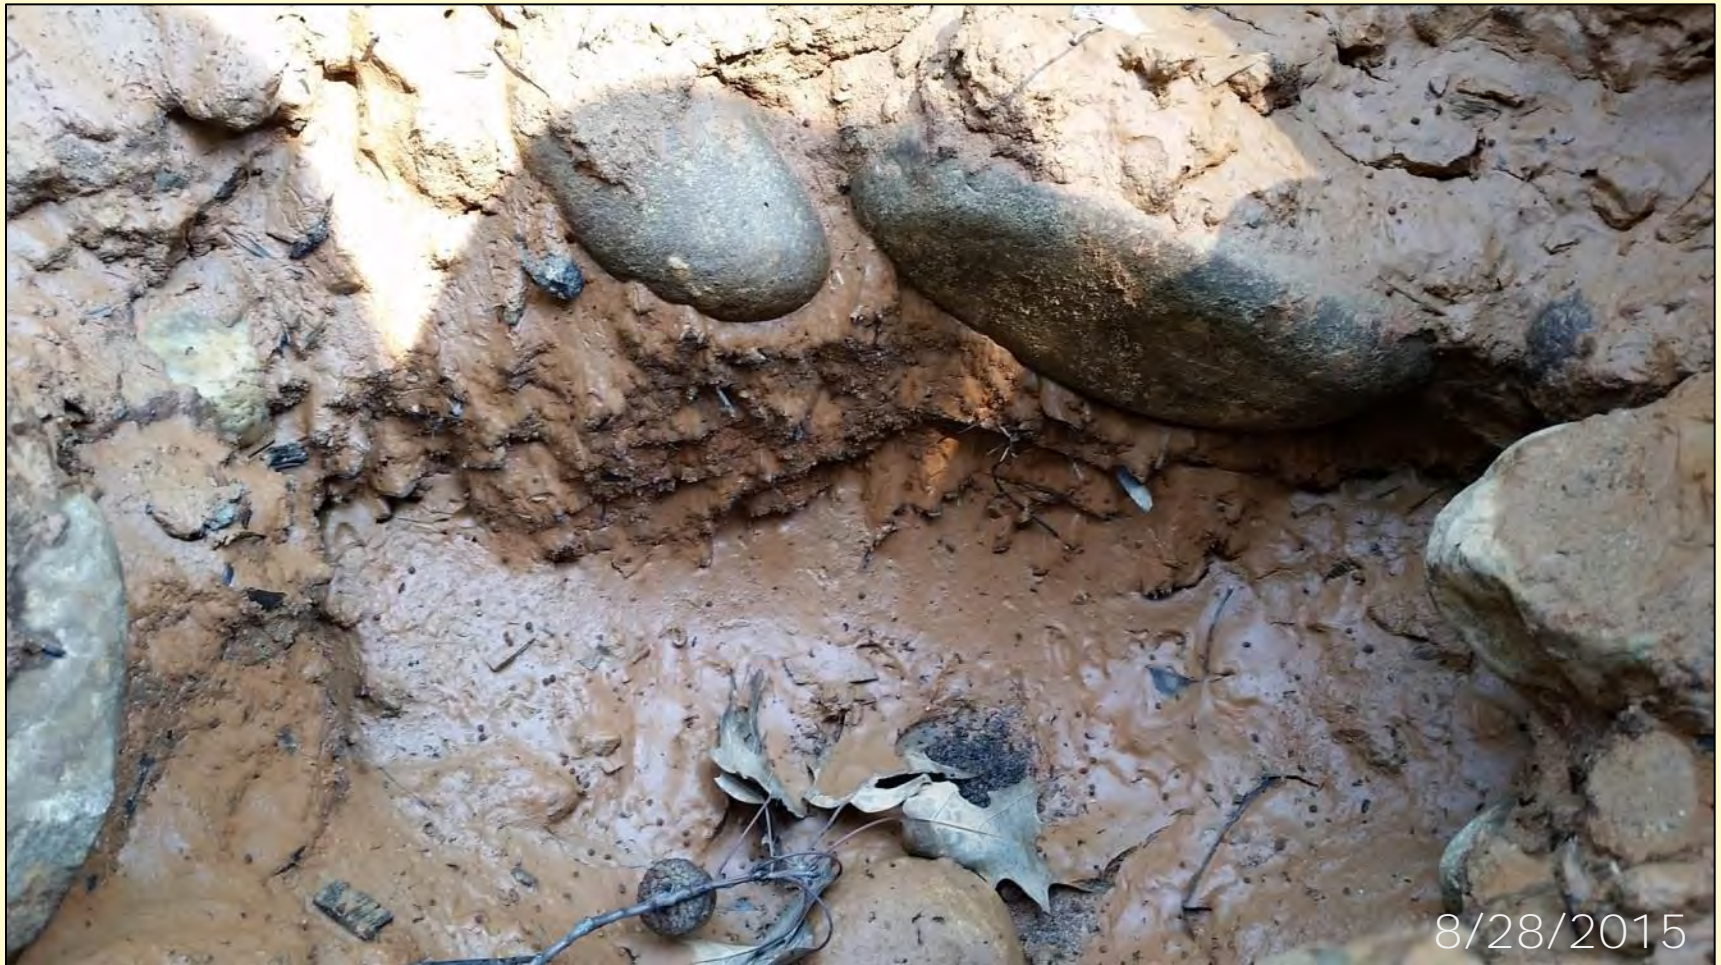
## Diagnosis (Ponding)

- Clay within the cobbles in the bottom of cells

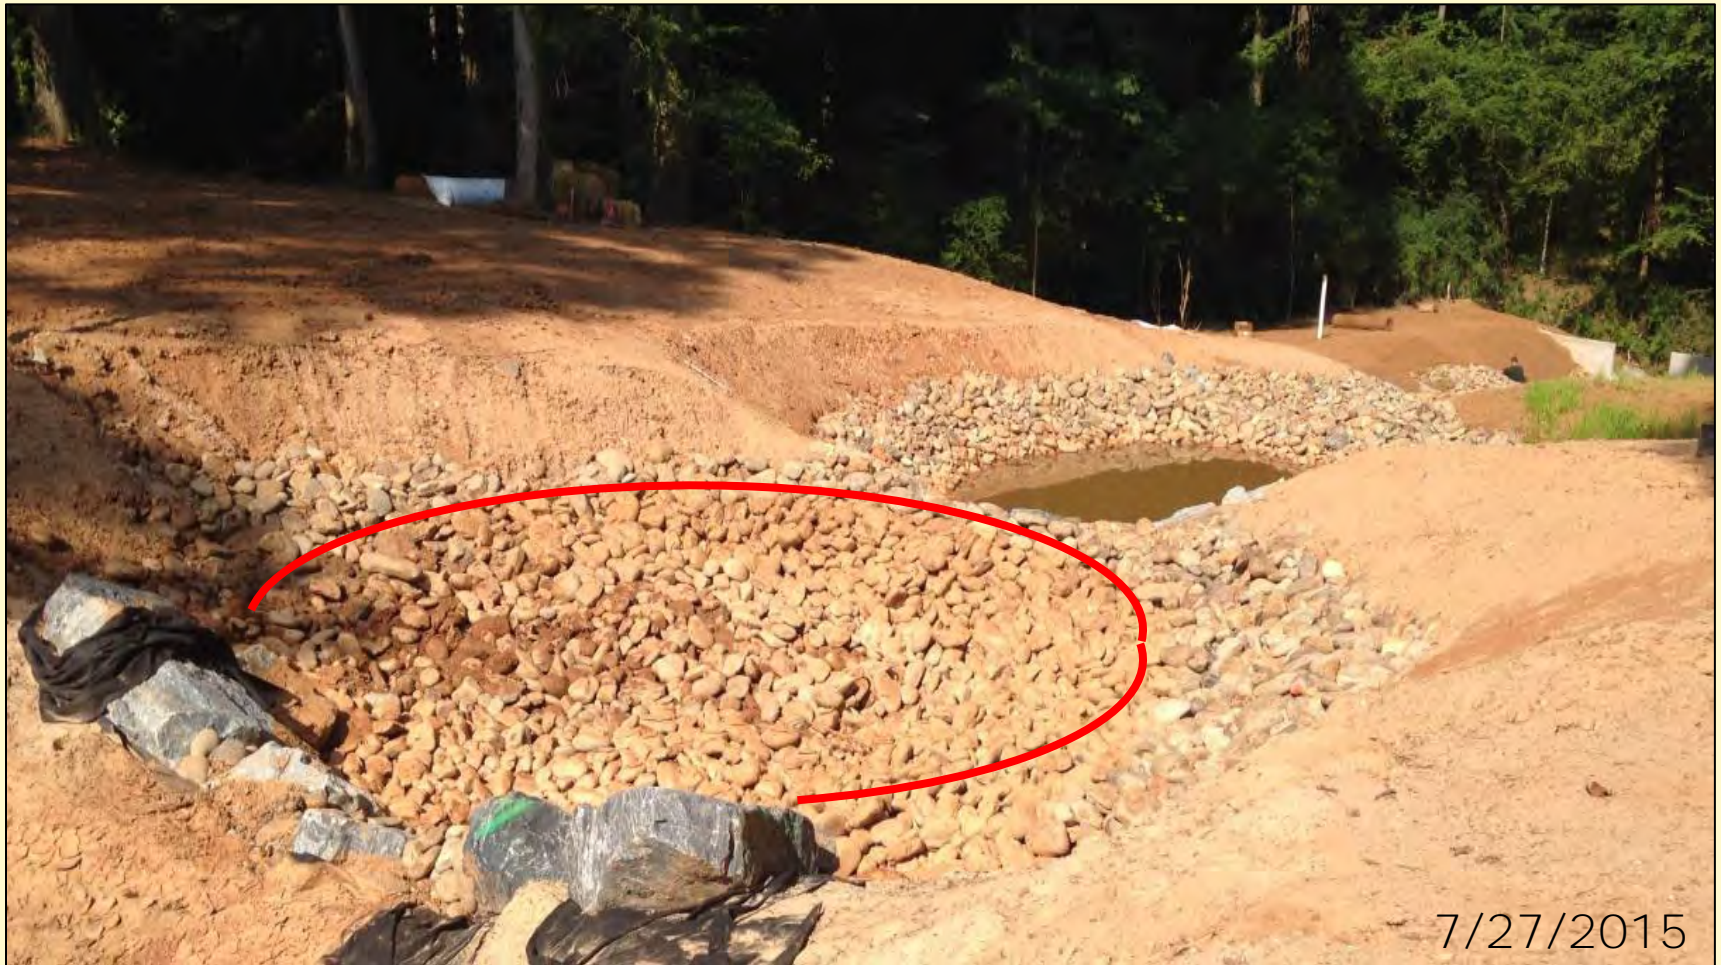
## Diagnosis (Sources of Clay)

- Ring of Clay in Cell 2

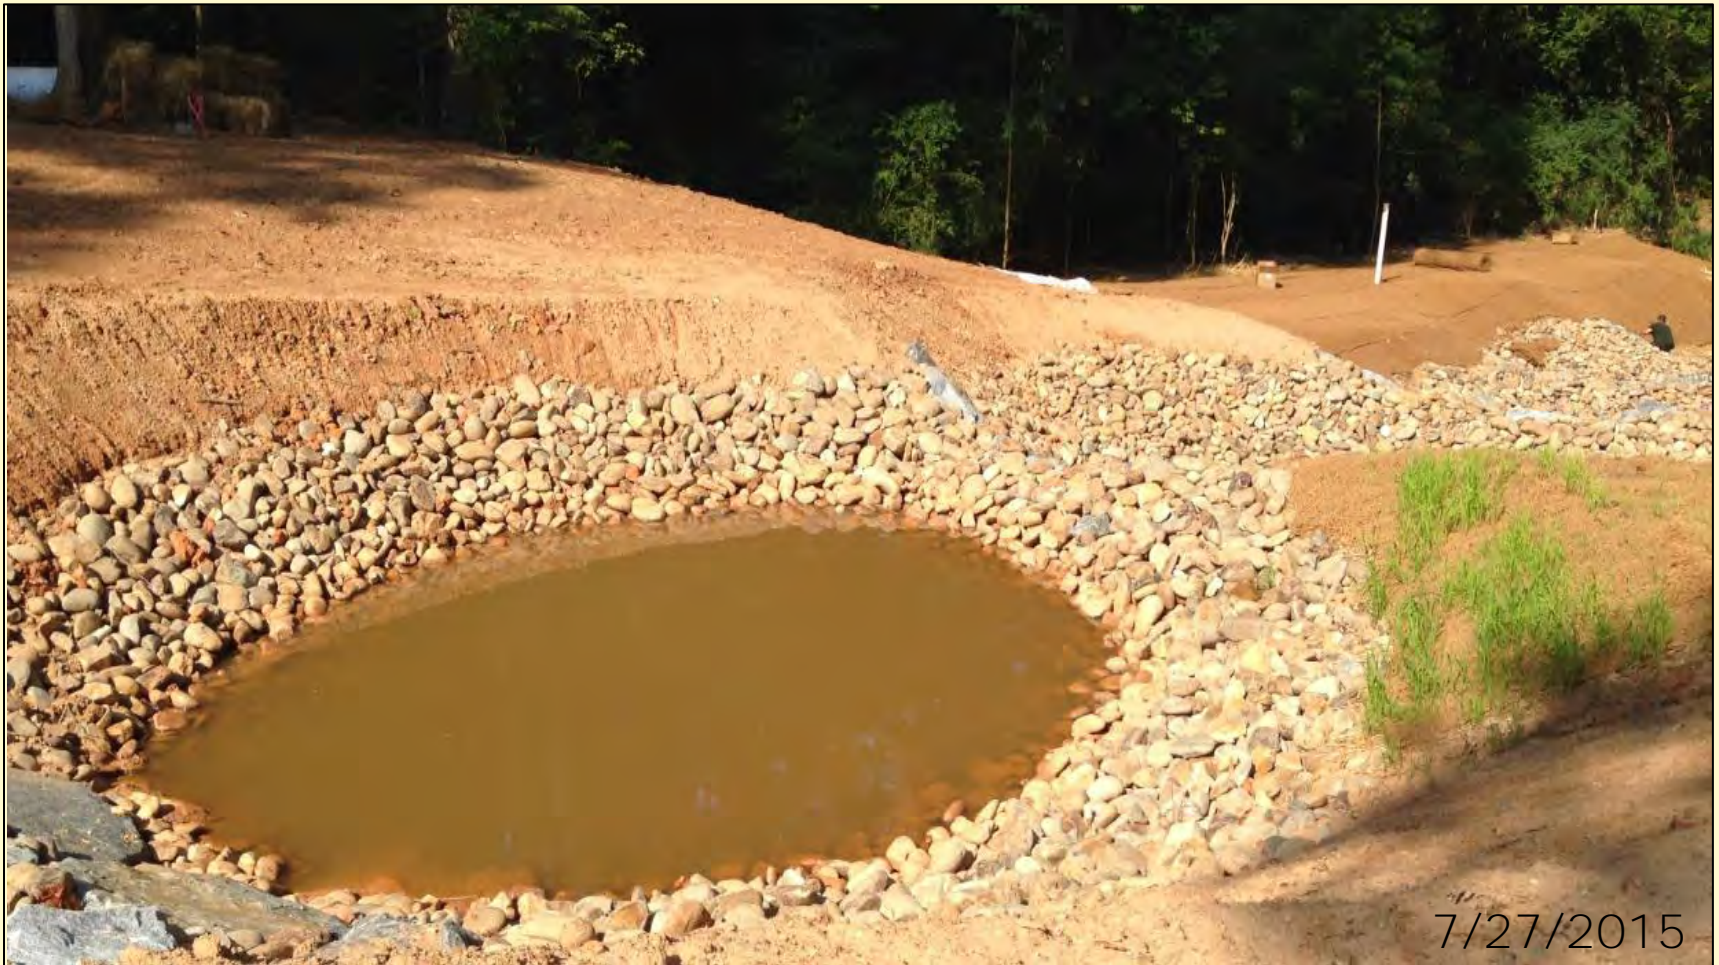
## Diagnosis (Sources of Clay)

- Rill Erosion along the inner slope of the Cells

- When placing infiltration media in a clay substrate, maintain strict EC measures and stabilize all exposed areas immediately
  - Erosion control should be tailored to the specific project and not general requirements
  - **Don't allow exposed clay within the cells, even covered by cobble.**
- As work is completed, sequence construction and EC to protect your investment
  - It may add time during initial construction but can save time by preventing retrofits.
  - **Don't** allow exposed clay to wash into infiltration media

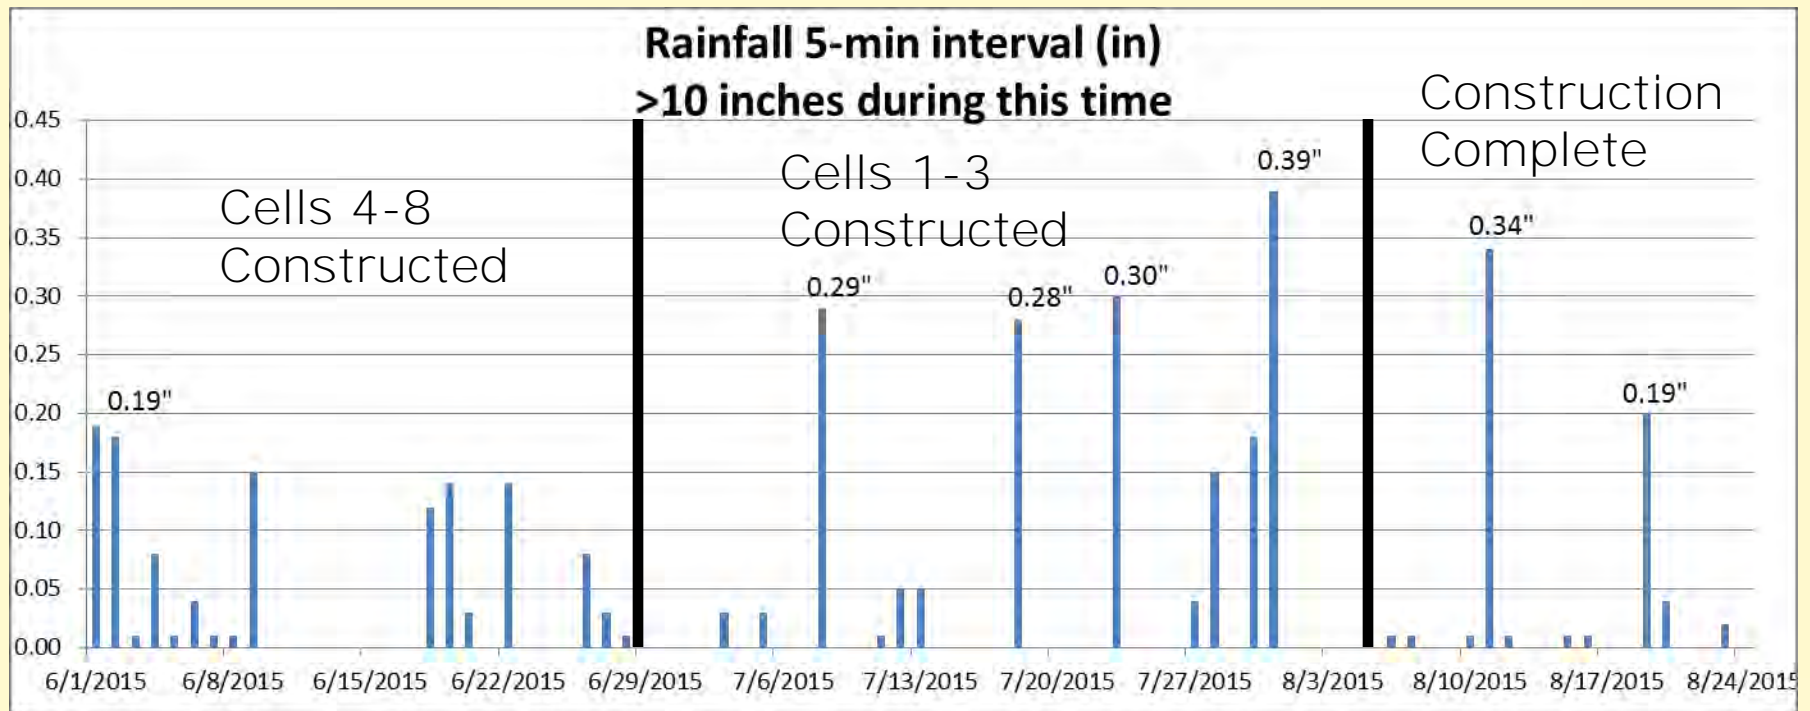
## Diagnosis (Construction Timing)

- Significant rainfall throughout the phase 2 media installation and cascade construction period

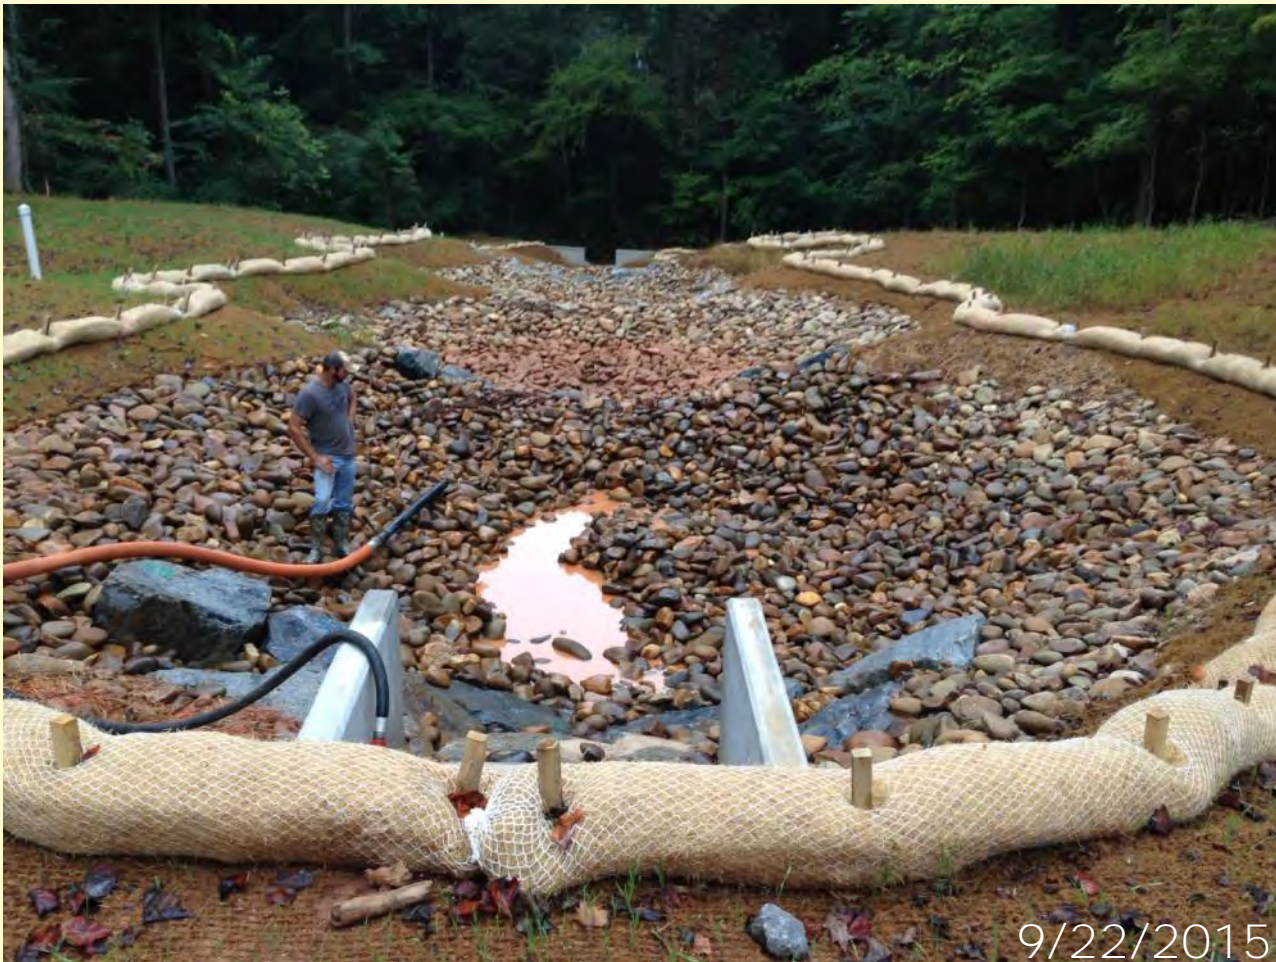
## Initial Retrofit (Clean out the clay)

- Standing water in Cell 1

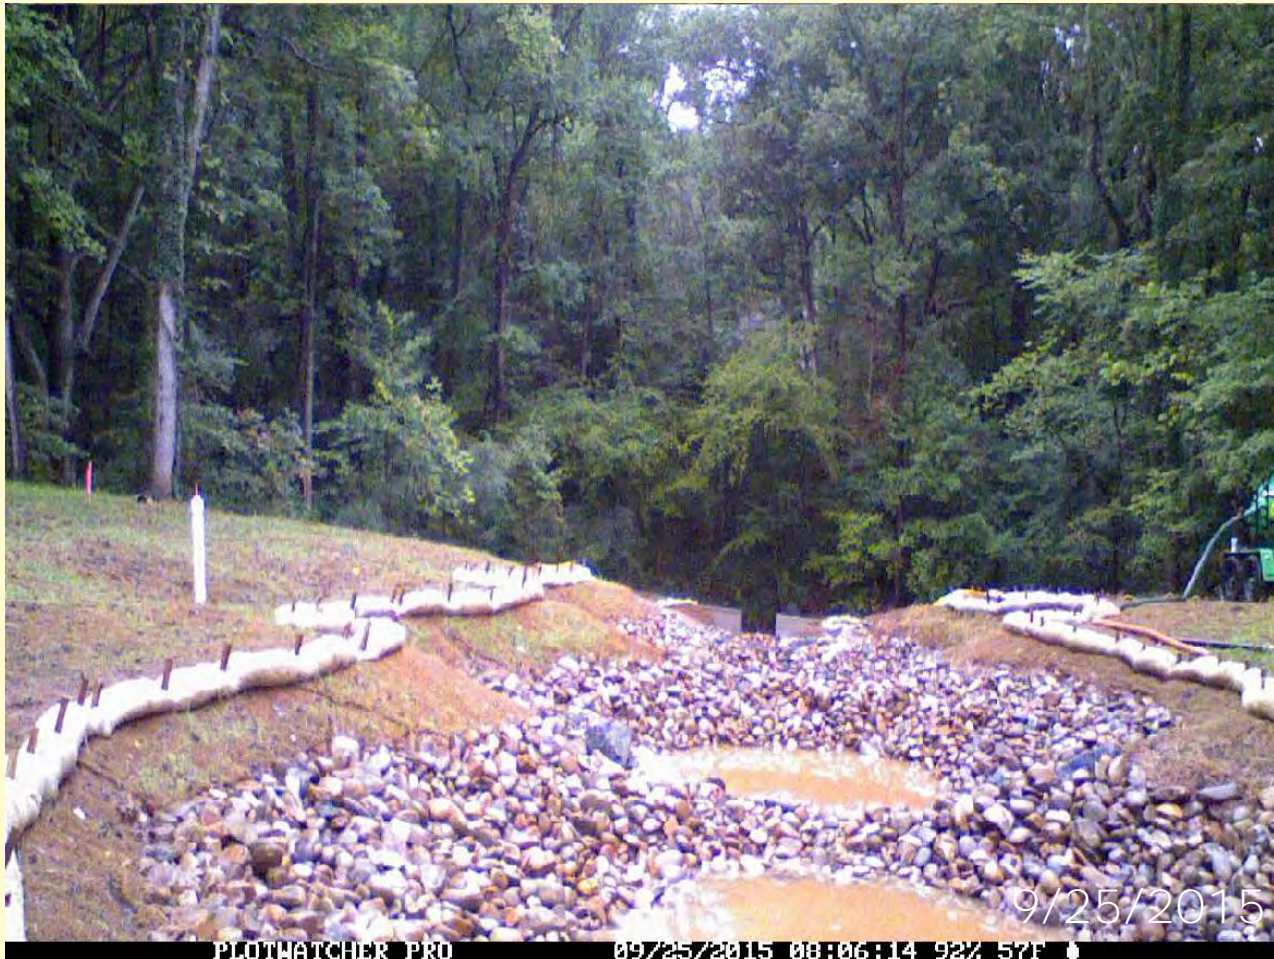
## Initial Retrofit (Clean out the clay)

- Ponding continued after cleaning

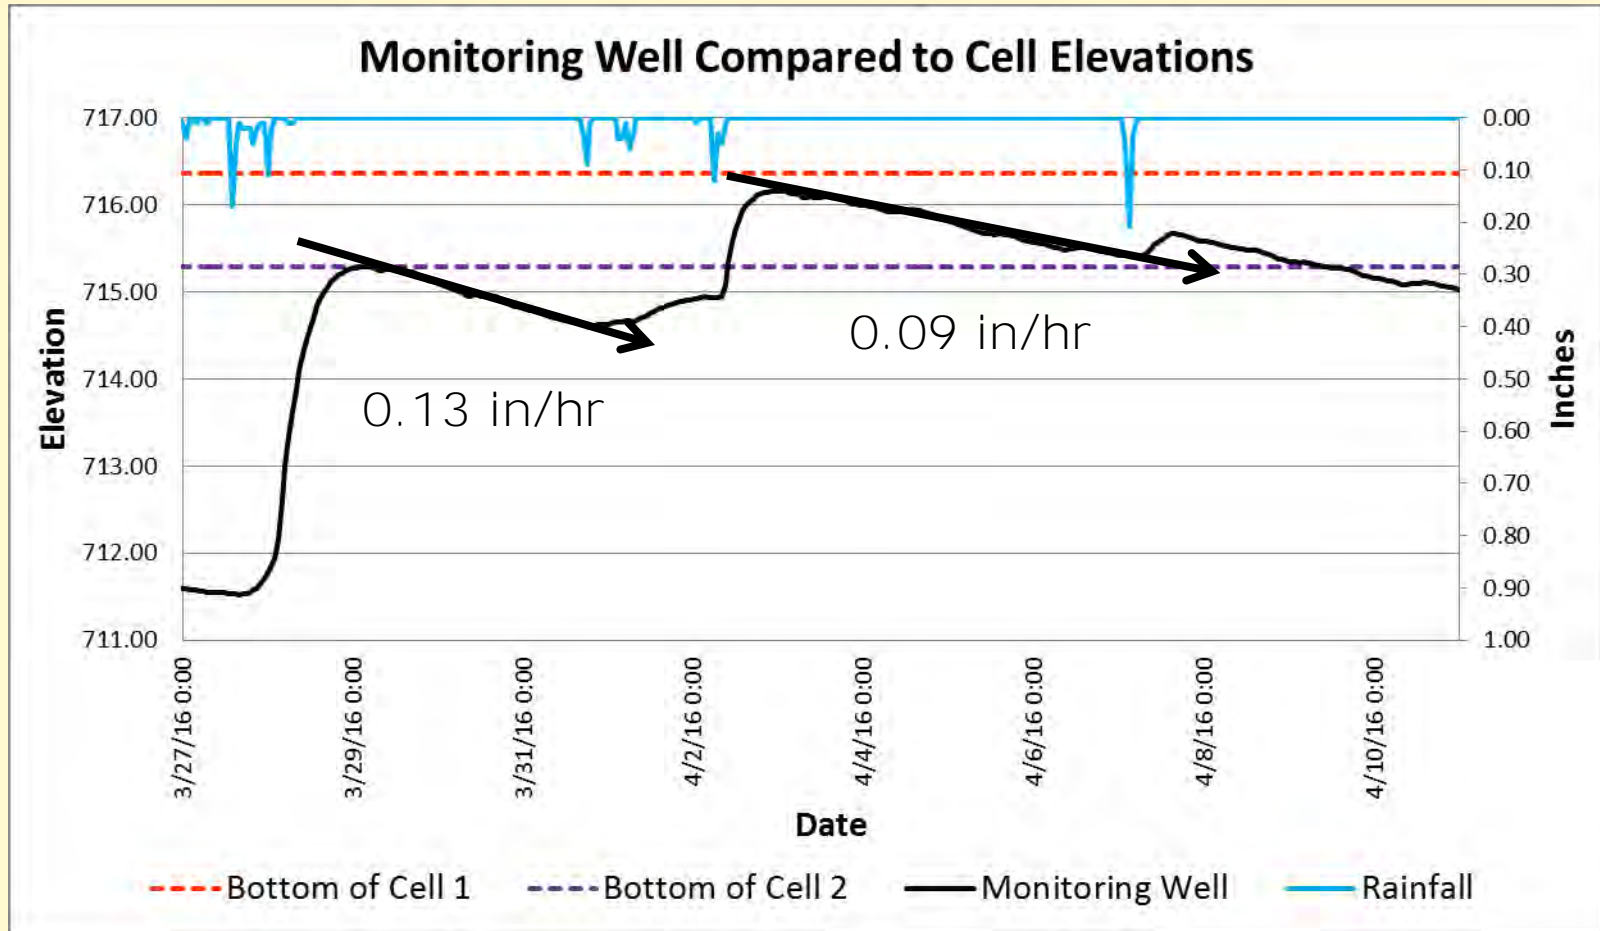
# Diagnosis (Monitoring Well Data)

- Seasonal water table influence in Cells 5-7
  - ? Reduced infiltration due to media compaction
  - ? Slow permeability of surrounding soil
