Investigation of Fecal Sources Impacting an Urban Creek

By: Mike Hardin, PhD, PE, CFM – Geosyntec Consultants, Inc.
Lisa Lotti – City of Orlando, Stormwater Compliance Manager

Annual Conference
October 6 – 8, 2021

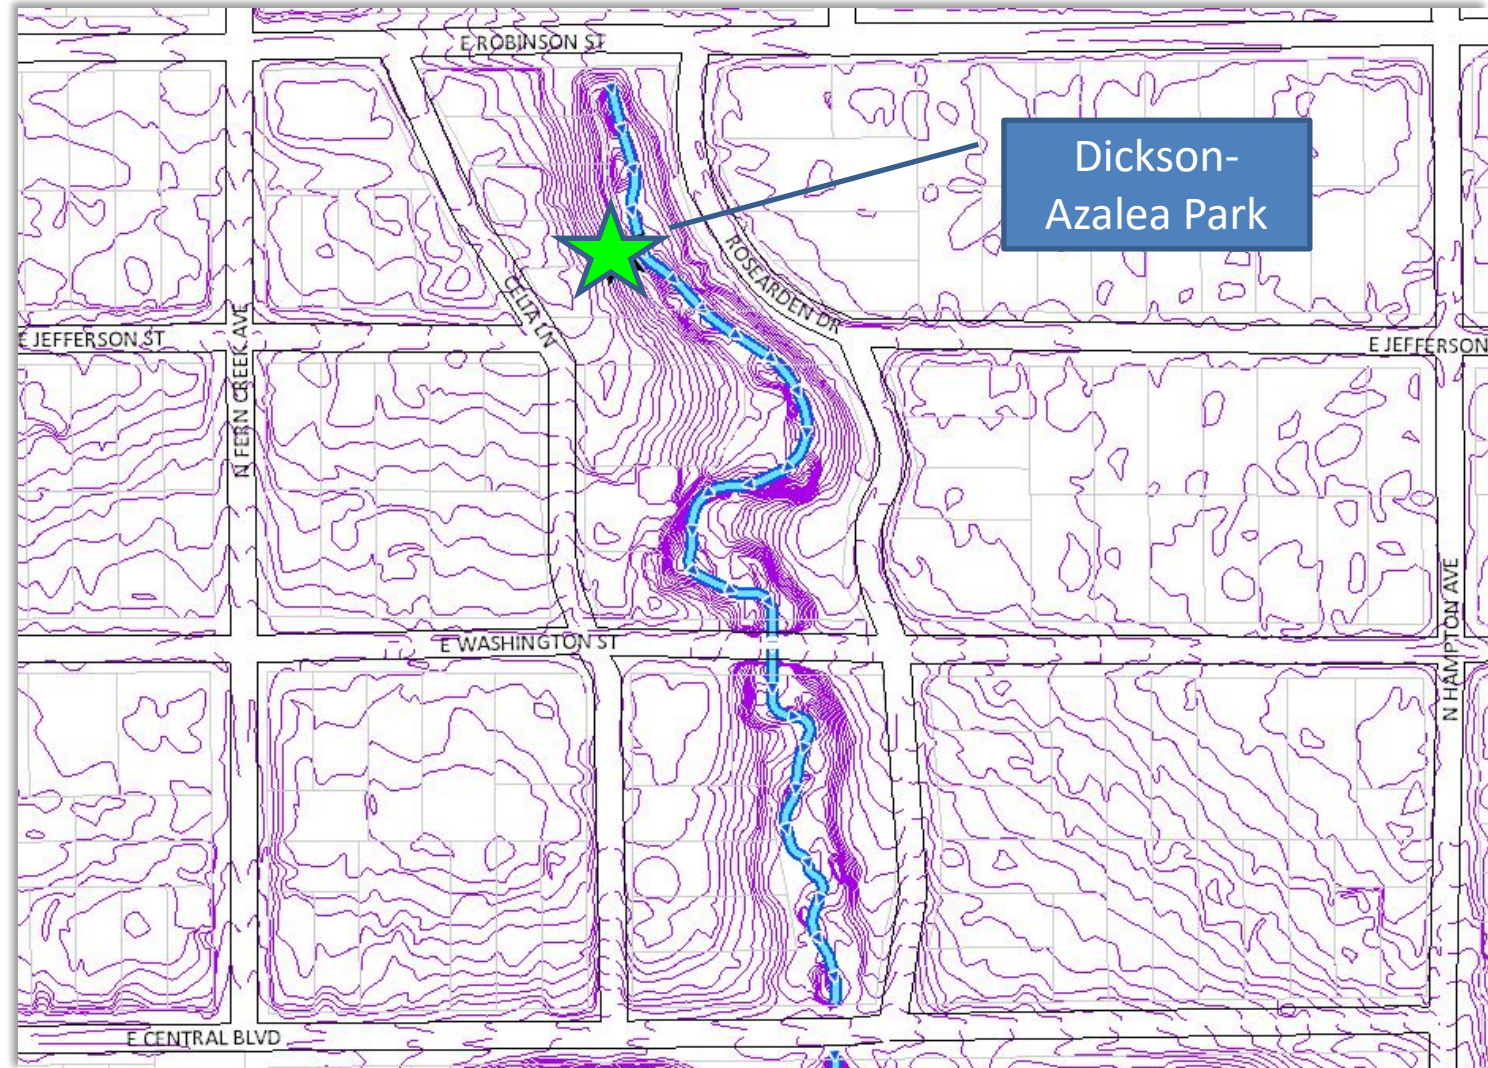
Background of Issue – Study Area

- Receiving area for this portion of Fern Creek basin = 203 acres
- 54" RCP upstream in creek
- DRMP 1996 report*:
 - Avg velocities = 4.8 fps
 - Modeled peak flow = 128 cfs
- Contours display steep banks which also meander
- Elevation changes within 1000 feet
 - Ground: 104 feet to 84 feet MSL
 - Pipe invert: 84 feet to 76 feet MSL
- Some tree roots present, but not as much vegetation to stabilize banks

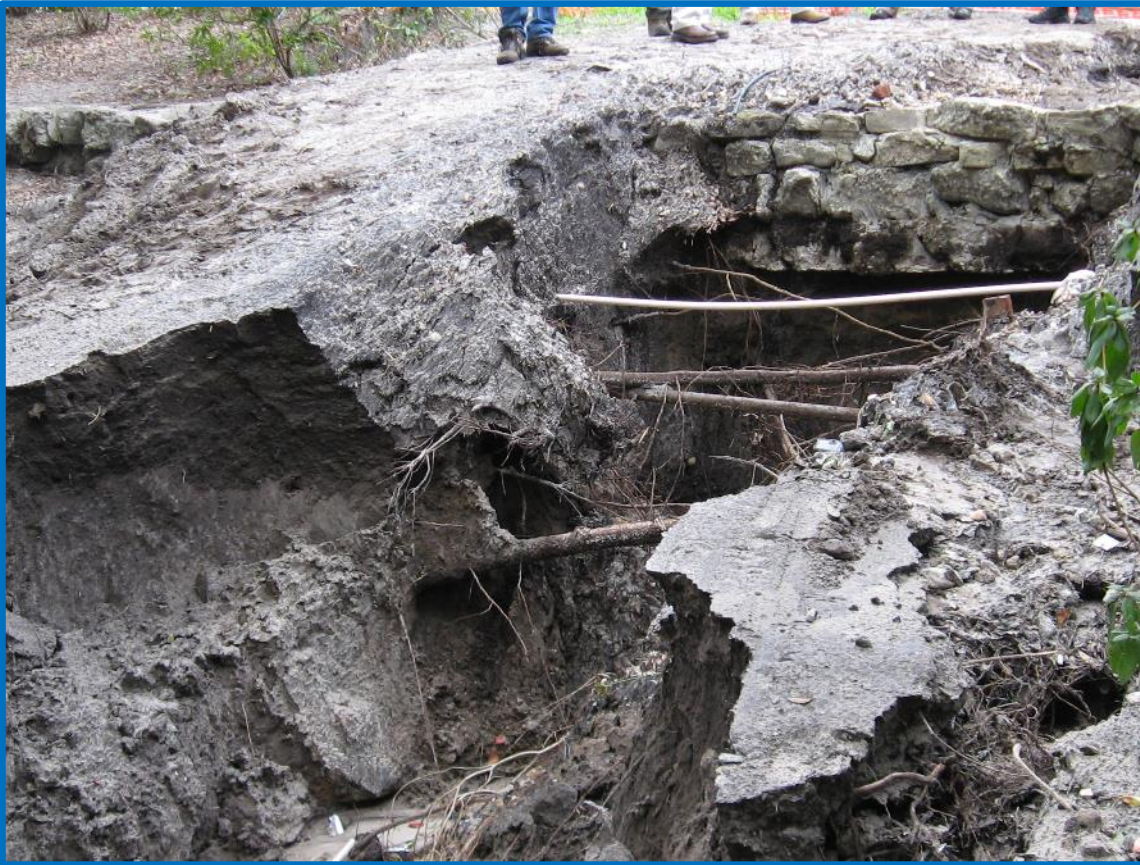
Background of Issue – Collapsed Wall

Sediment deposition into creek

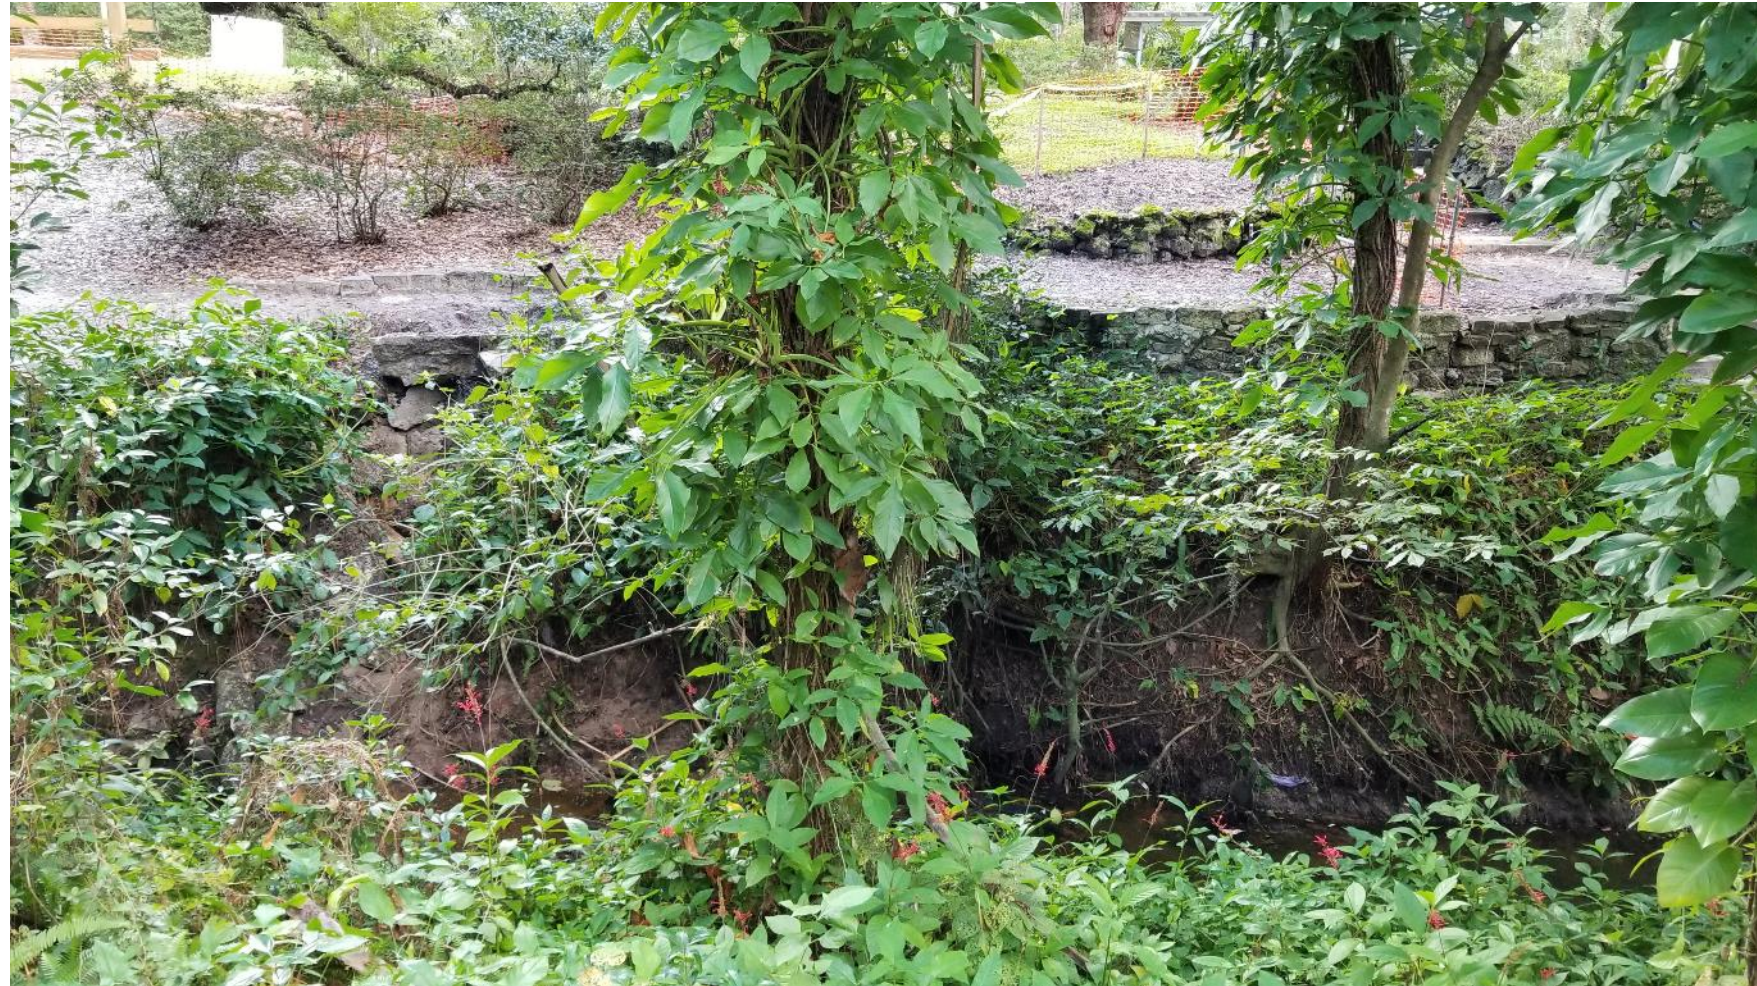
Background of Issue – Collapsed Wall Surrounding Area

- Steep terrain
- Terraced, but stabilization still an issue
- Wall present in immediate area, but overland flow caused undermining behind wall

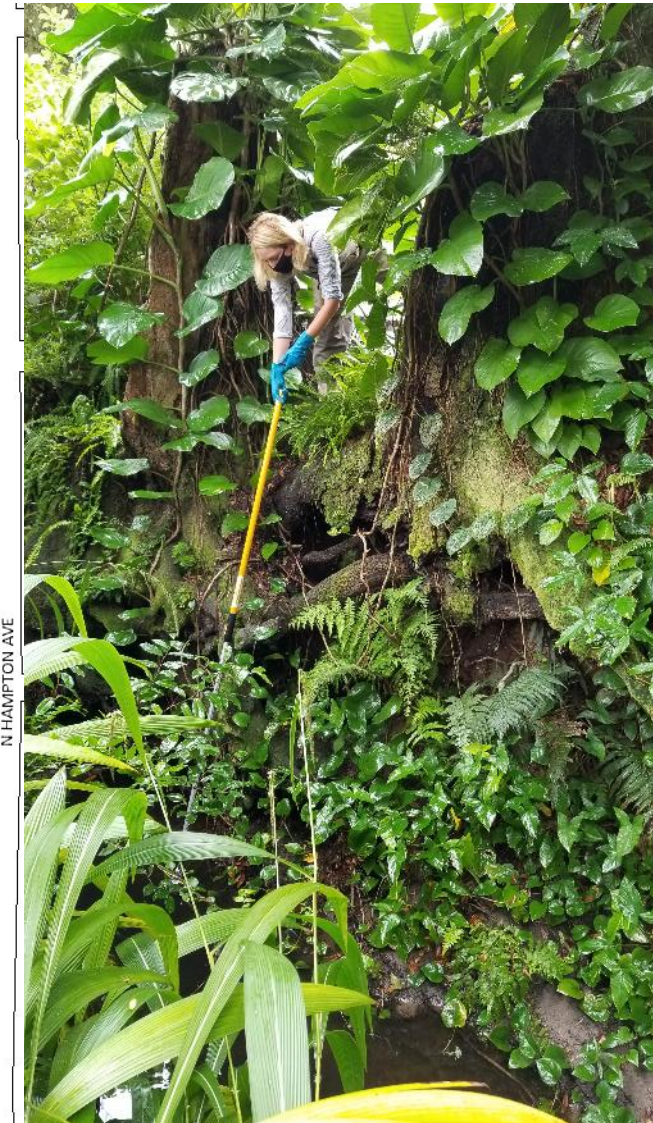
- Fecal Coliform Sampling on 12/27/2018
- 7 Days after collapse
 - No rain within last 7 days

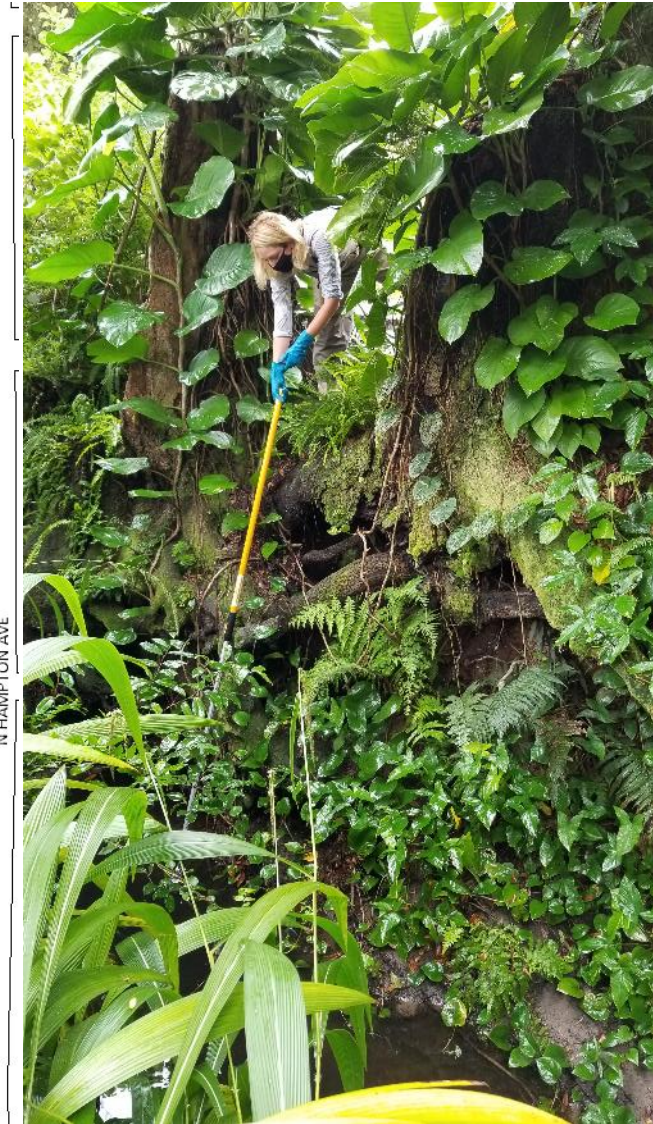
- Fecal Coliform Sampling on 1/4/2019
- 15 Days after collapse
 - No rain within last 15 days
 - Assistance requested by Water Reclamation

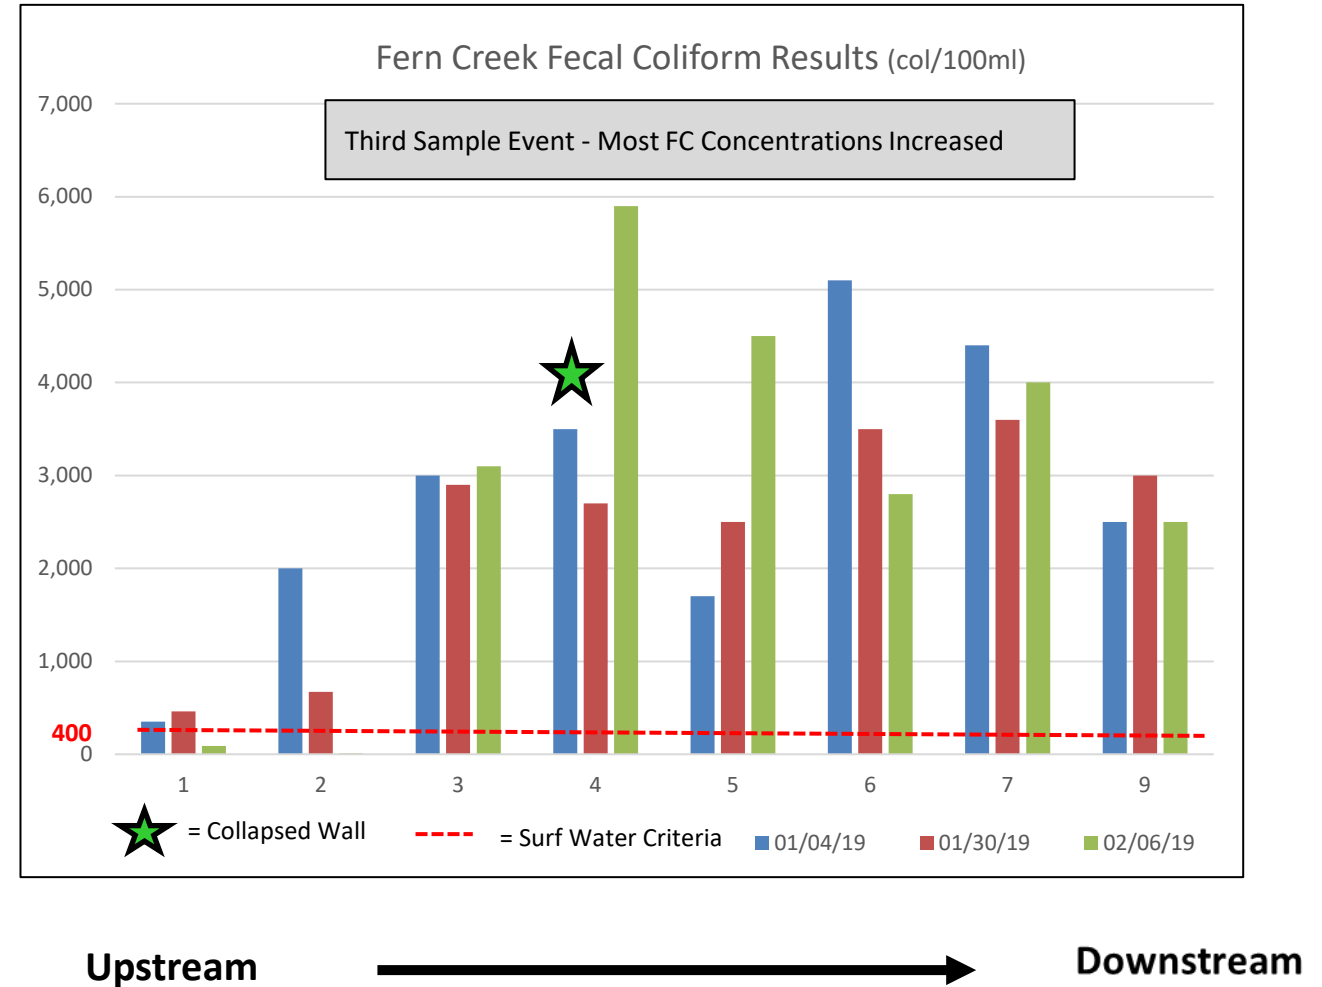
Station	01/04/19	01/30/19	02/06/19
1	350	460	90
2	2,000	670	10
3	3,000	2,900	3,100
4	3,500	2,700	5,900
5	1,700	2,500	4,500
6	5,100	3,500	2,800
7	4,400	3,600	4,000
9	2,500	3,000	2,500

* **Fecal coliform must remain less than 400 colonies/100ml** per *Surface Water Quality Standards*, Rule 62-302.530, F.A.C., for predominately fresh waters to maintain a healthy, well-balanced population of fish and wildlife

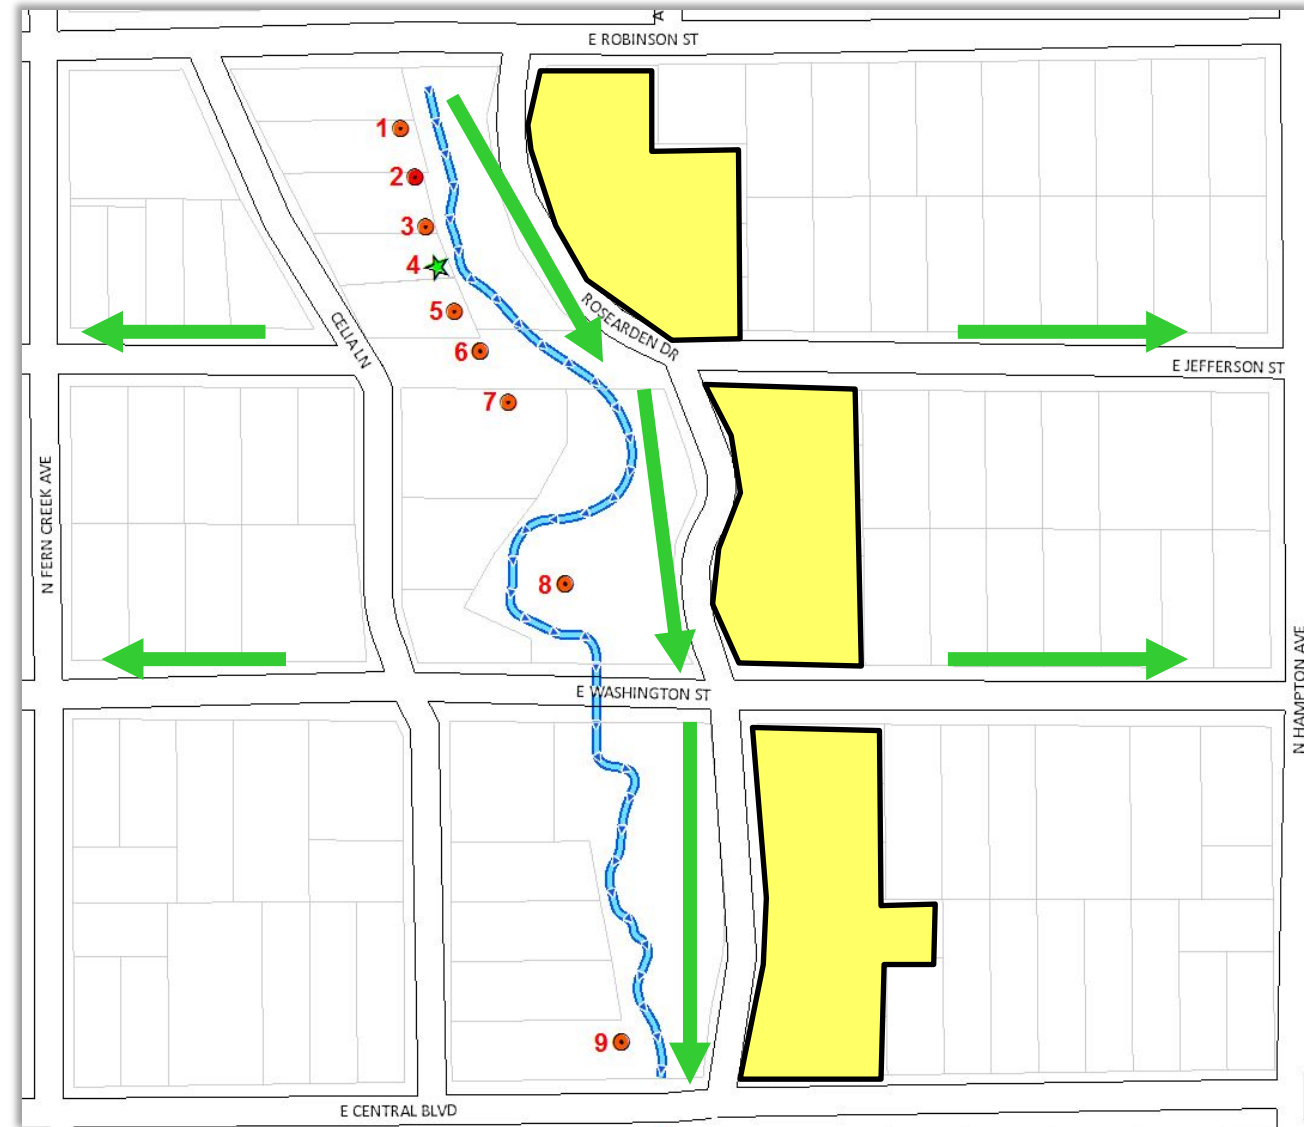
- Nearby sanitary system impacts to the creek

– Checked lateral lines along creek for integrity

= Lateral lines checked for integrity

= Direction of flow for sanitary gravity line

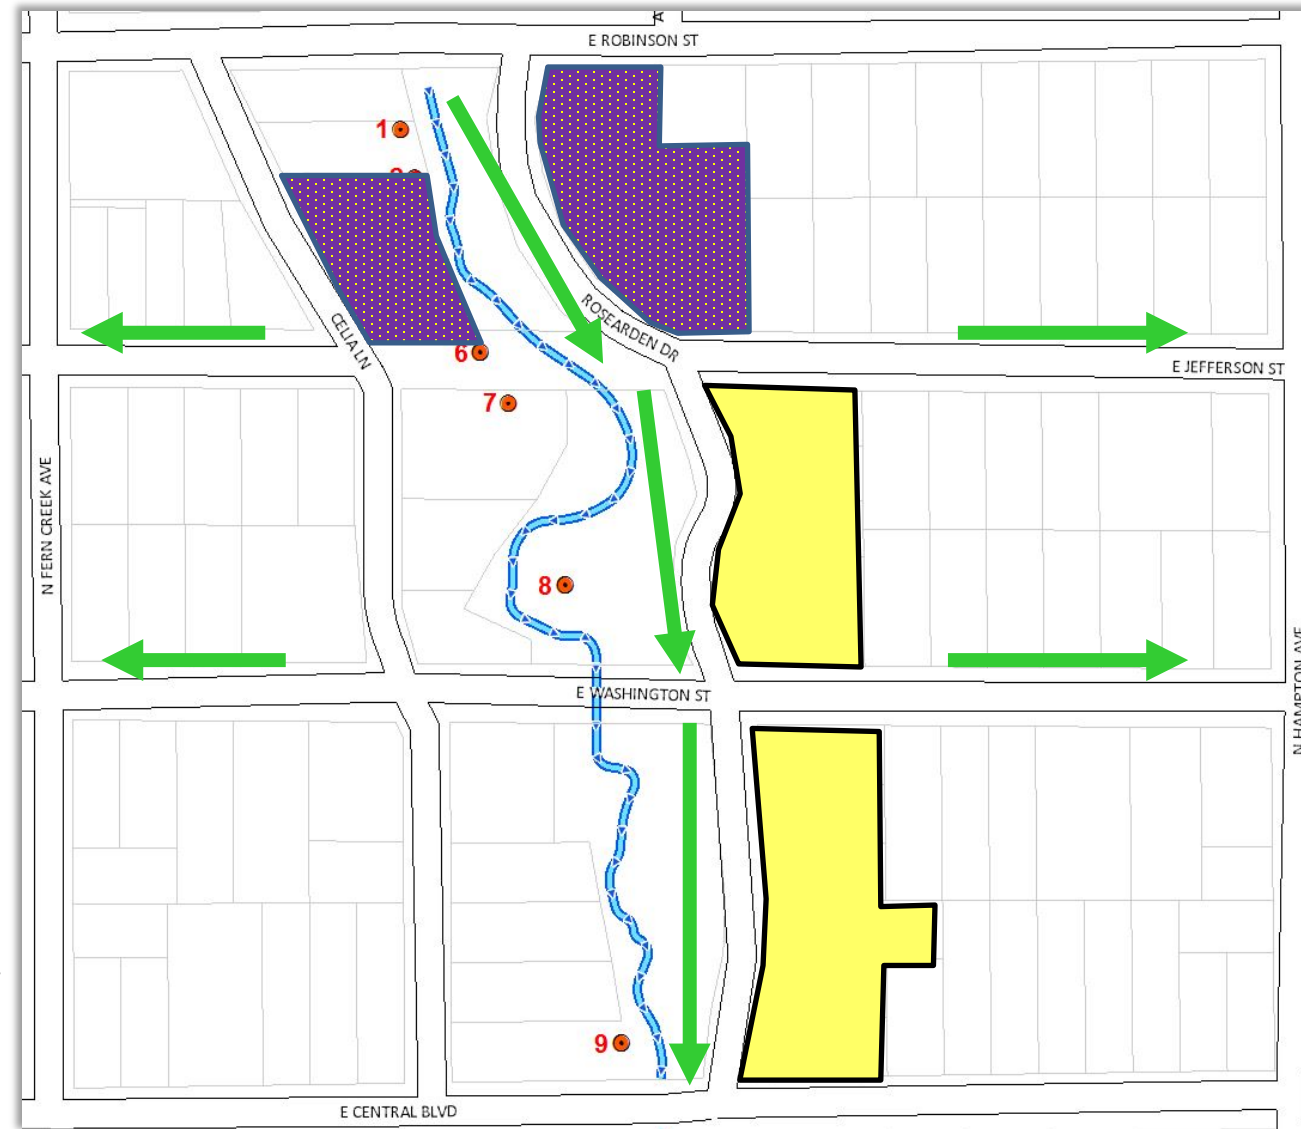
- Nearby sanitary system impacts to the creek

- Performed dye testing to identify illicit connections

- **None observed**

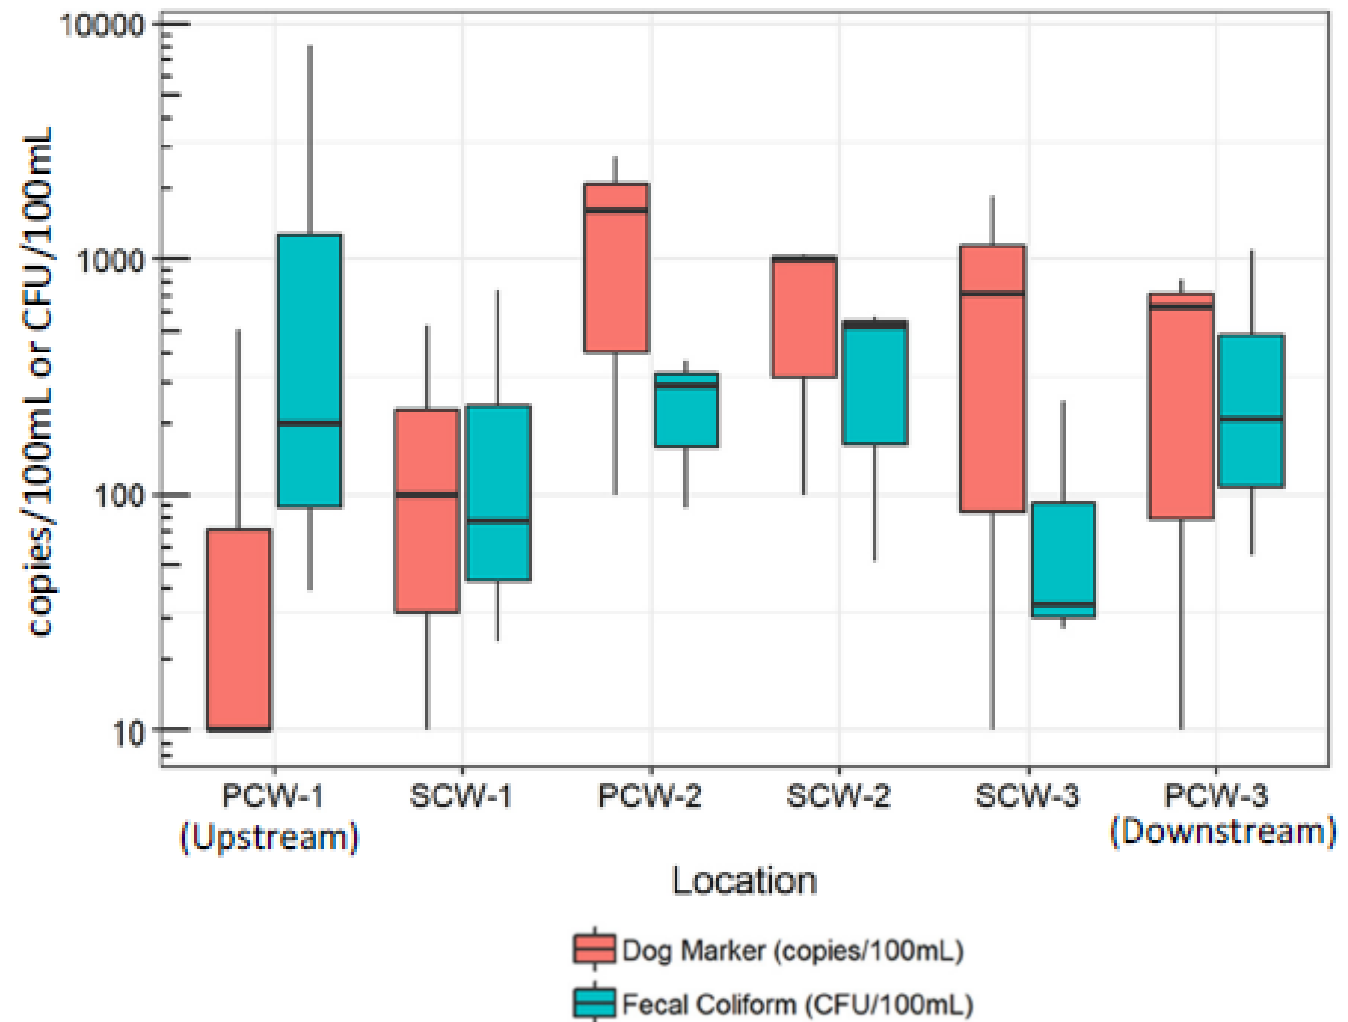
- Compared dog marker to fecal coliform concentrations
 - No significant correlation observed
 - Other non-human sources likely contributing fecal bacteria
 - Birds
 - Racoons
 - Other
