# Remote Sensing Myrtle Street Permeable Pavers

# Myrtle / Zion Street Permeable Paver Project

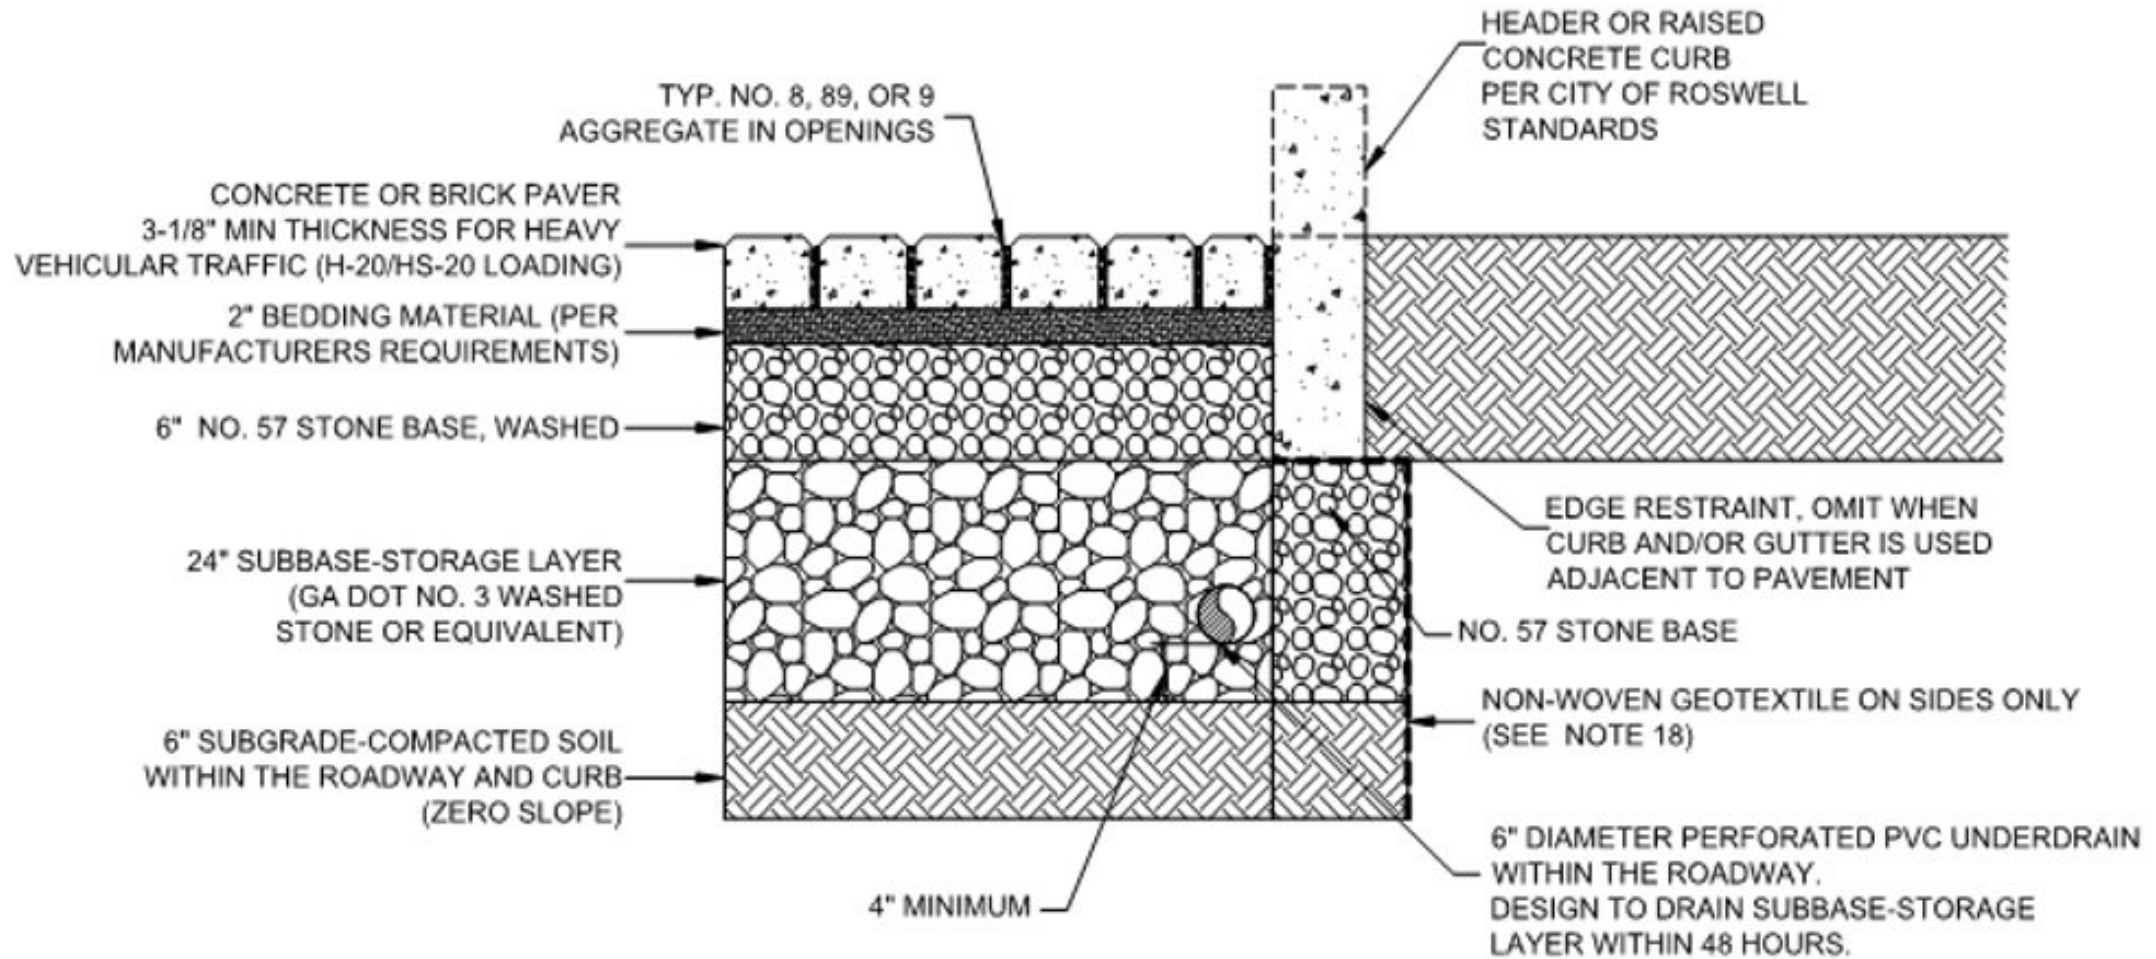
# Paver System Detail

- Received 319 grant to demonstrate GI and funding / policy tools
- Project selection criteria
  - Install project in City ROW
  - Impaired watershed
  - Area with development pressure
  - High infiltration rates
- Project design
  - Underground gravel reservoir to hold and treat stormwater

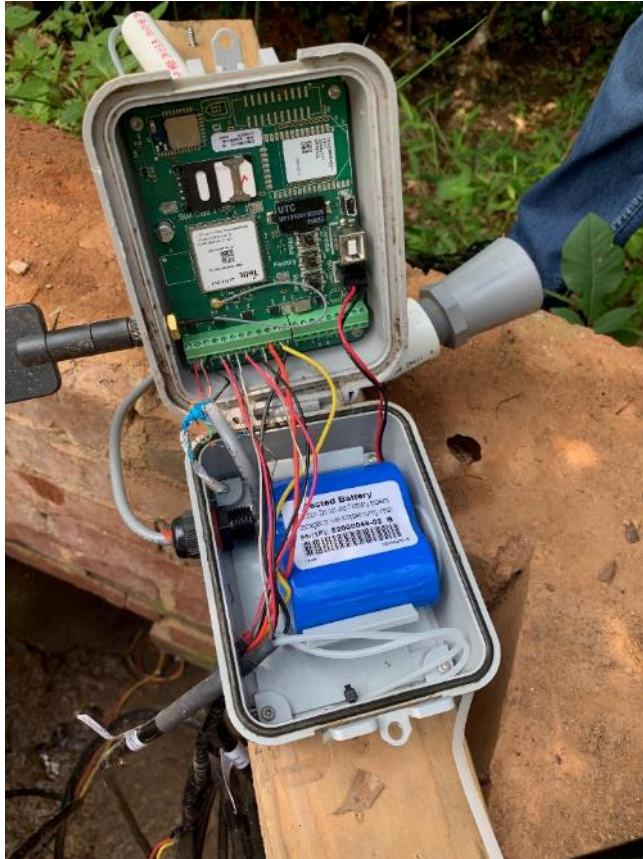
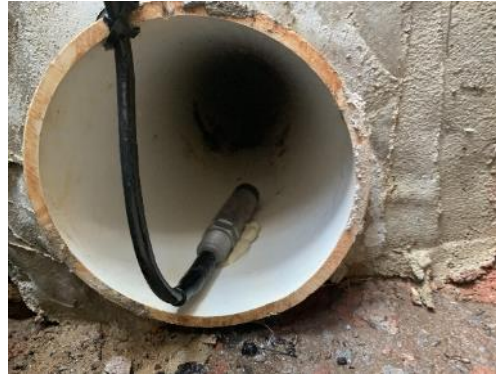
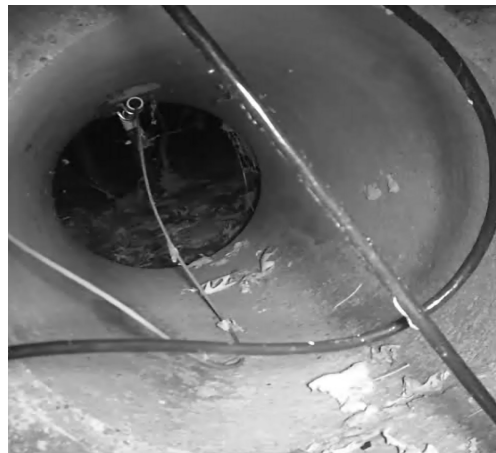
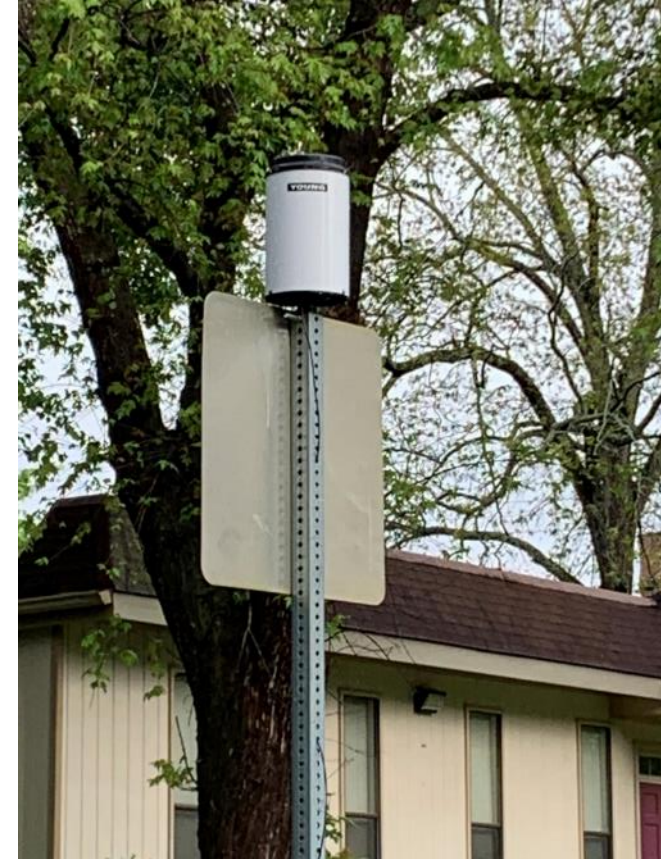
# Remote Sensing Equipment

- Install level sensor in pipe, not structure
- Small events are difficult to analyze
- Have a regular maintenance plan for sensing equipment
  - Power / battery approach
  - Cleaning of rain gauge
- Emphasize on Perc Test Data
