Cross Keys Park Naturalization Efforts

What Went Wrong

**Demetria Kimball Mehlhorn, Program Manager Sr
Division of Environmental Services, Natural Resource Protection
Lexington-Fayette Urban County Government, Kentucky**

Southeast Stormwater Association, October 6, 2022

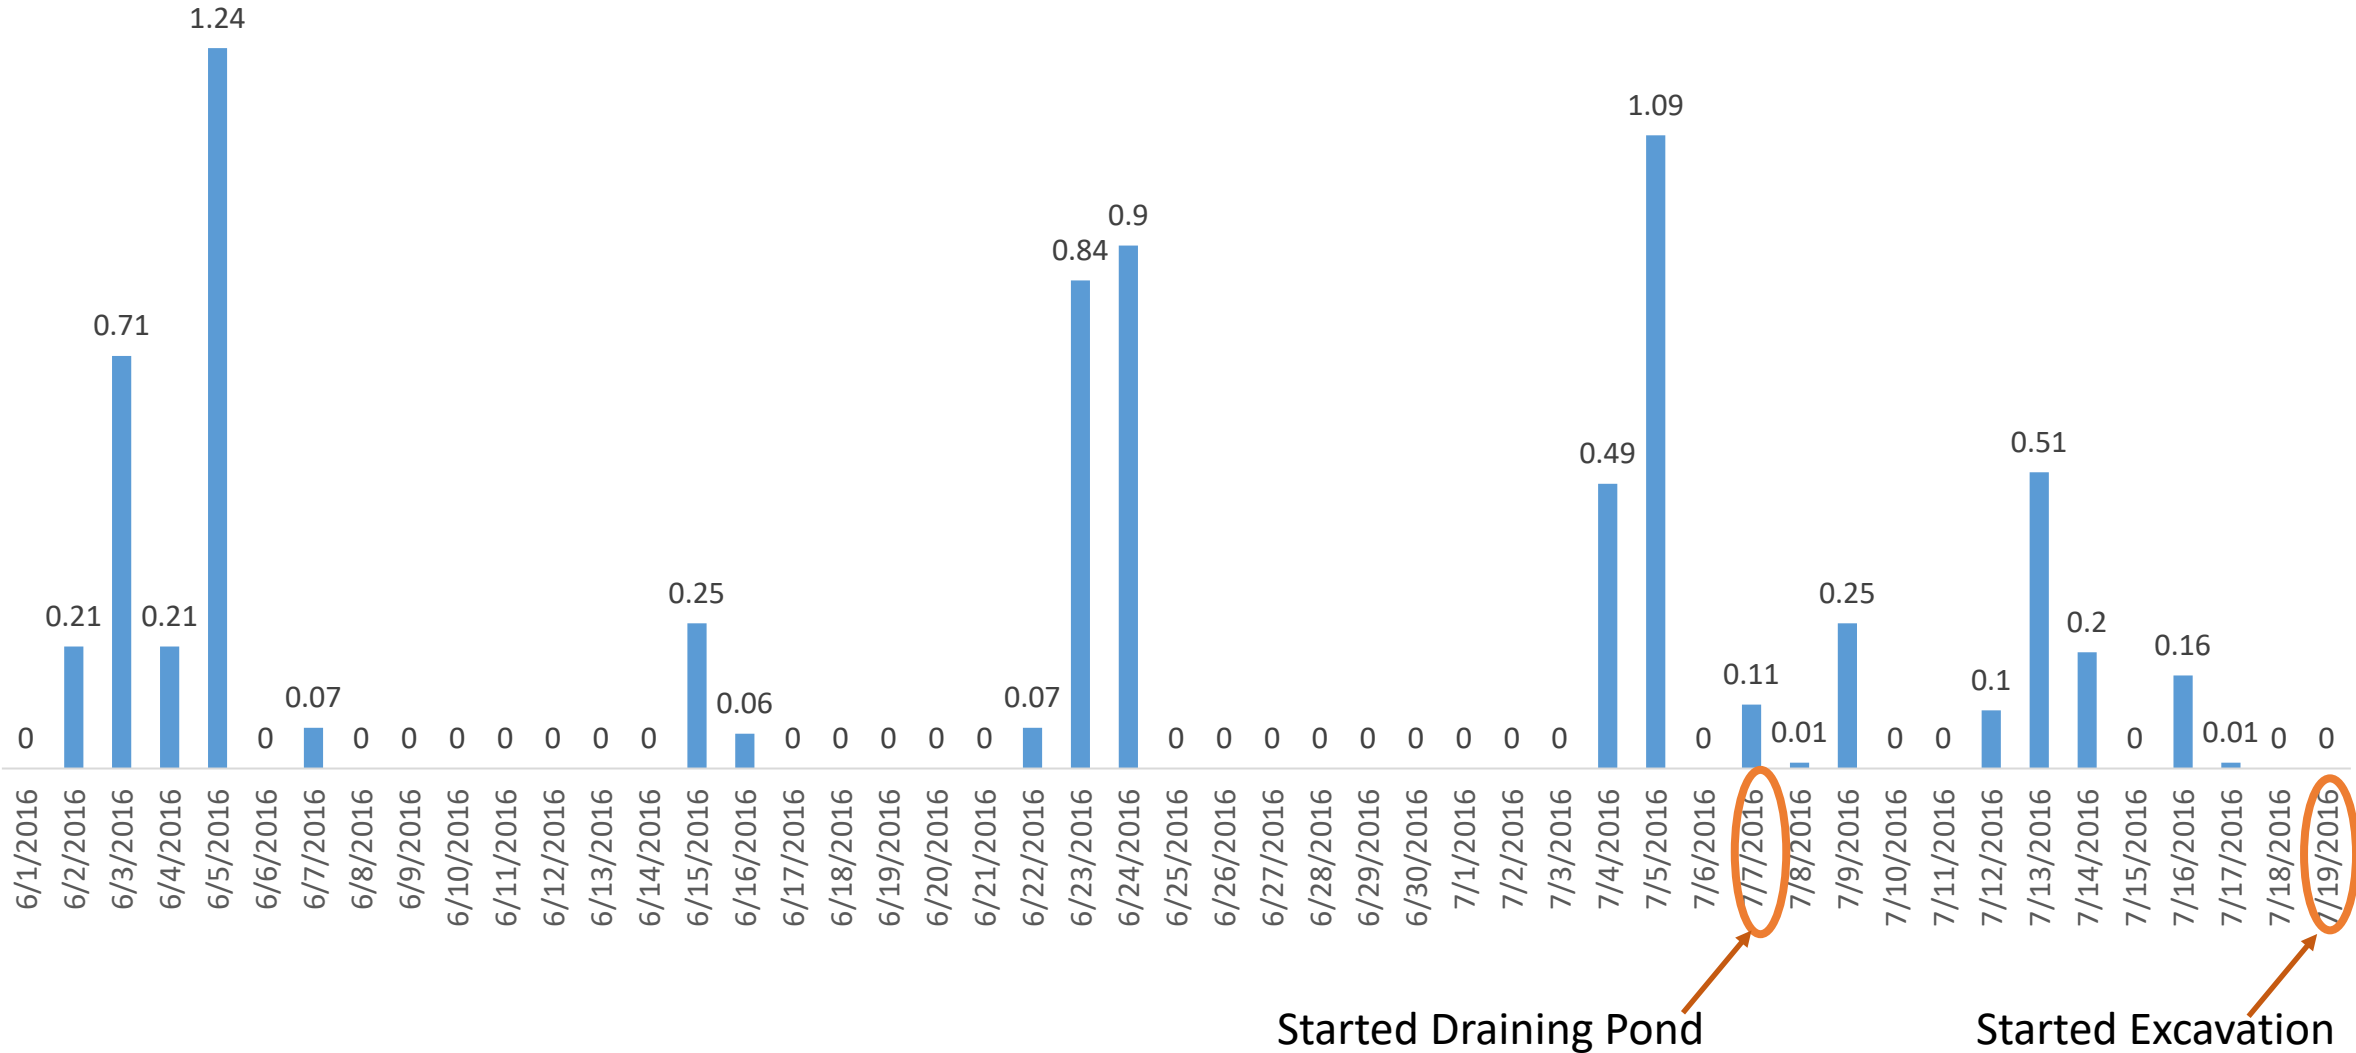
Rain Data – Weather Underground

Problem #3 – Started Late (Bid March 2016, Pre-Con May 2016)

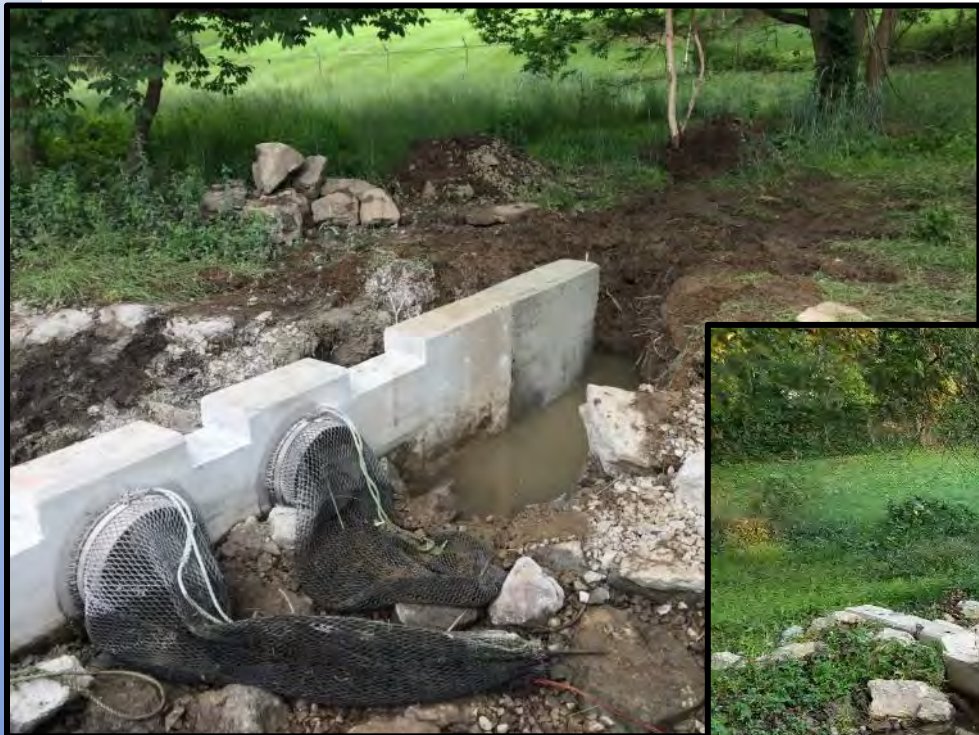
Trash Rack – Eroding Around Wing Walls

(May 2017)

Higher shear stresses present than anticipated due to constant clogging with organic debris

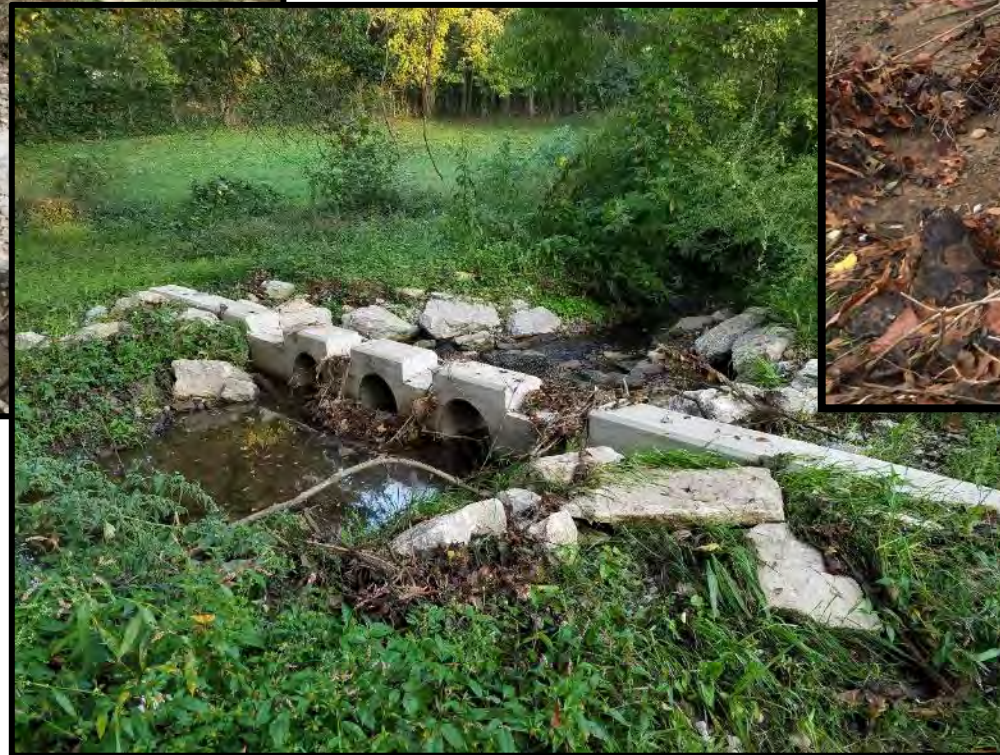
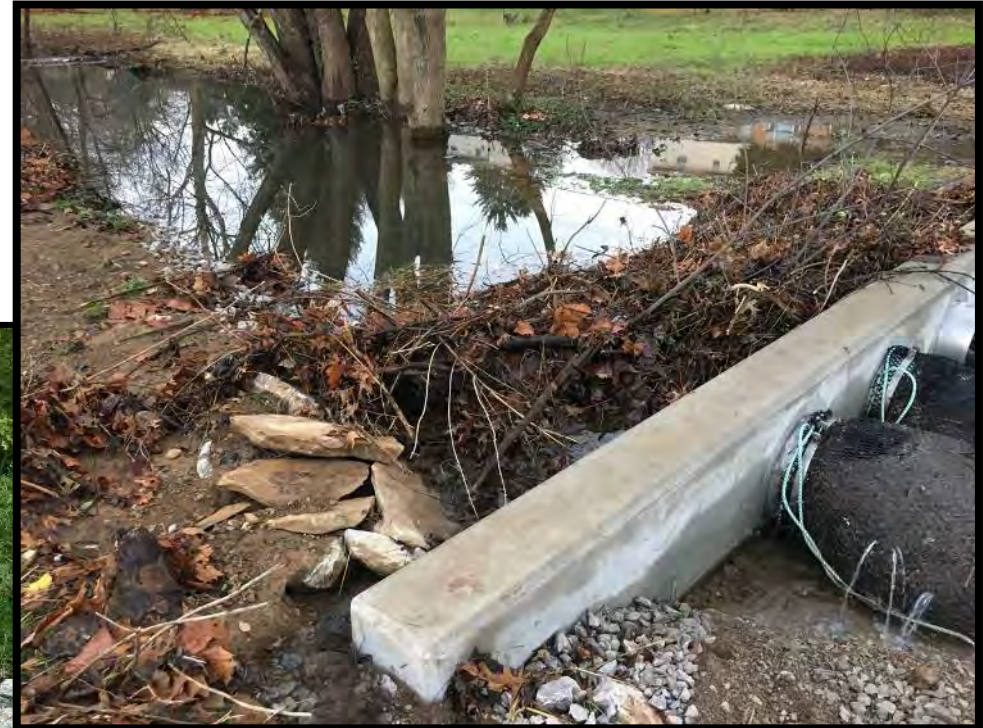
(Jan 2017)

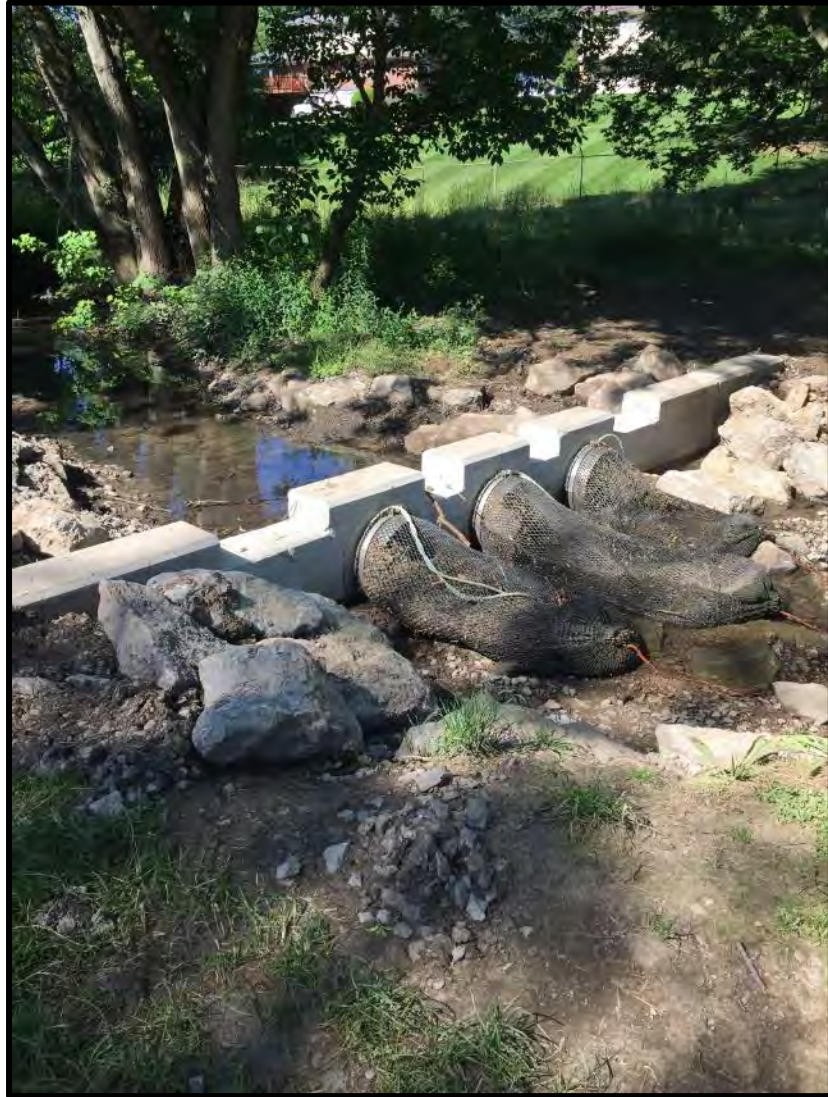
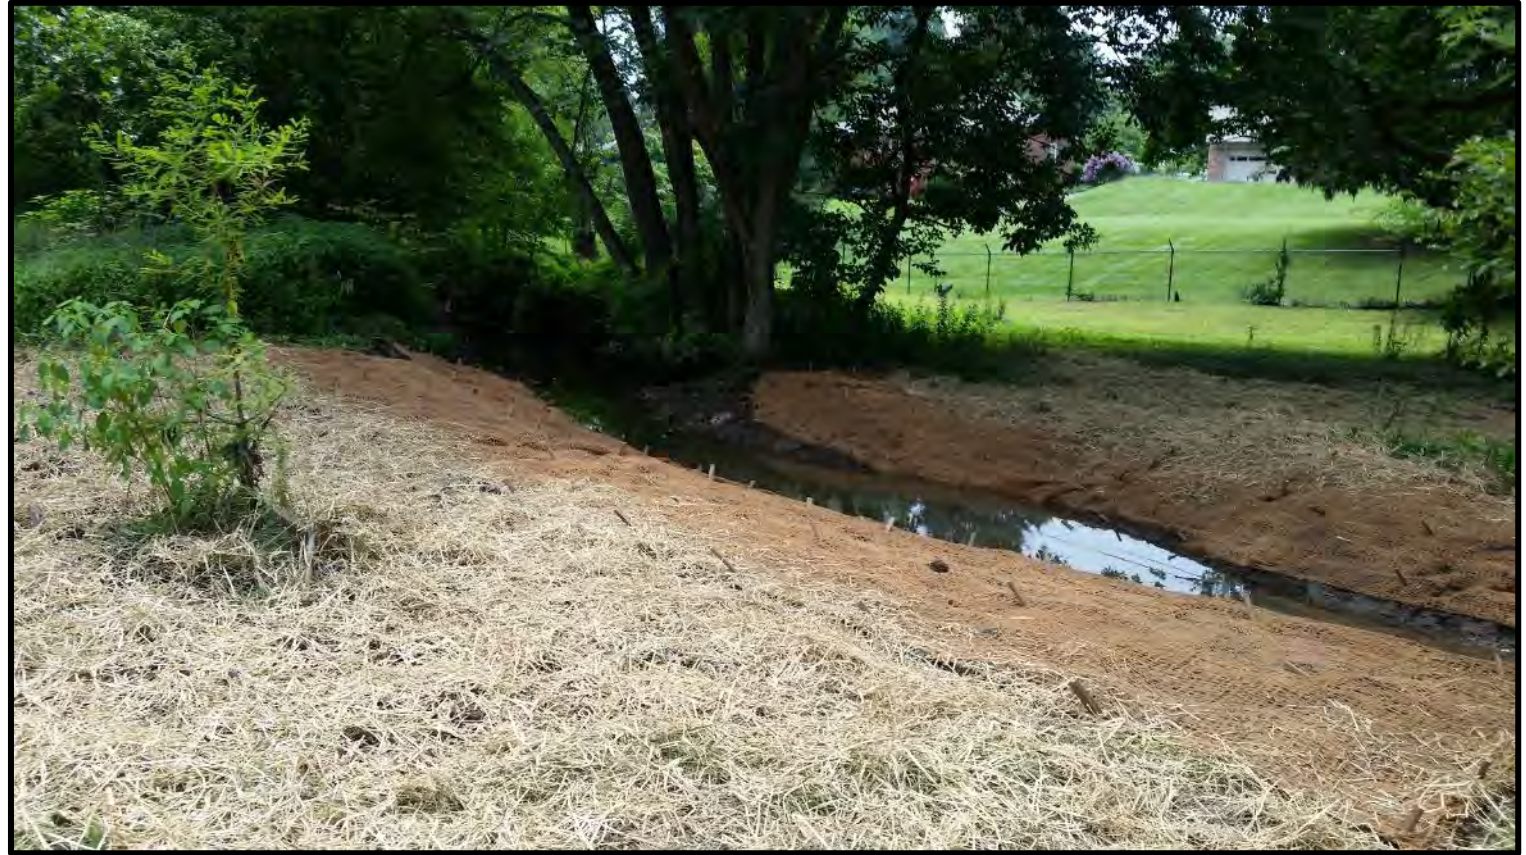
Trash Rack – Only Collect Organic Debris

June 28, 2018

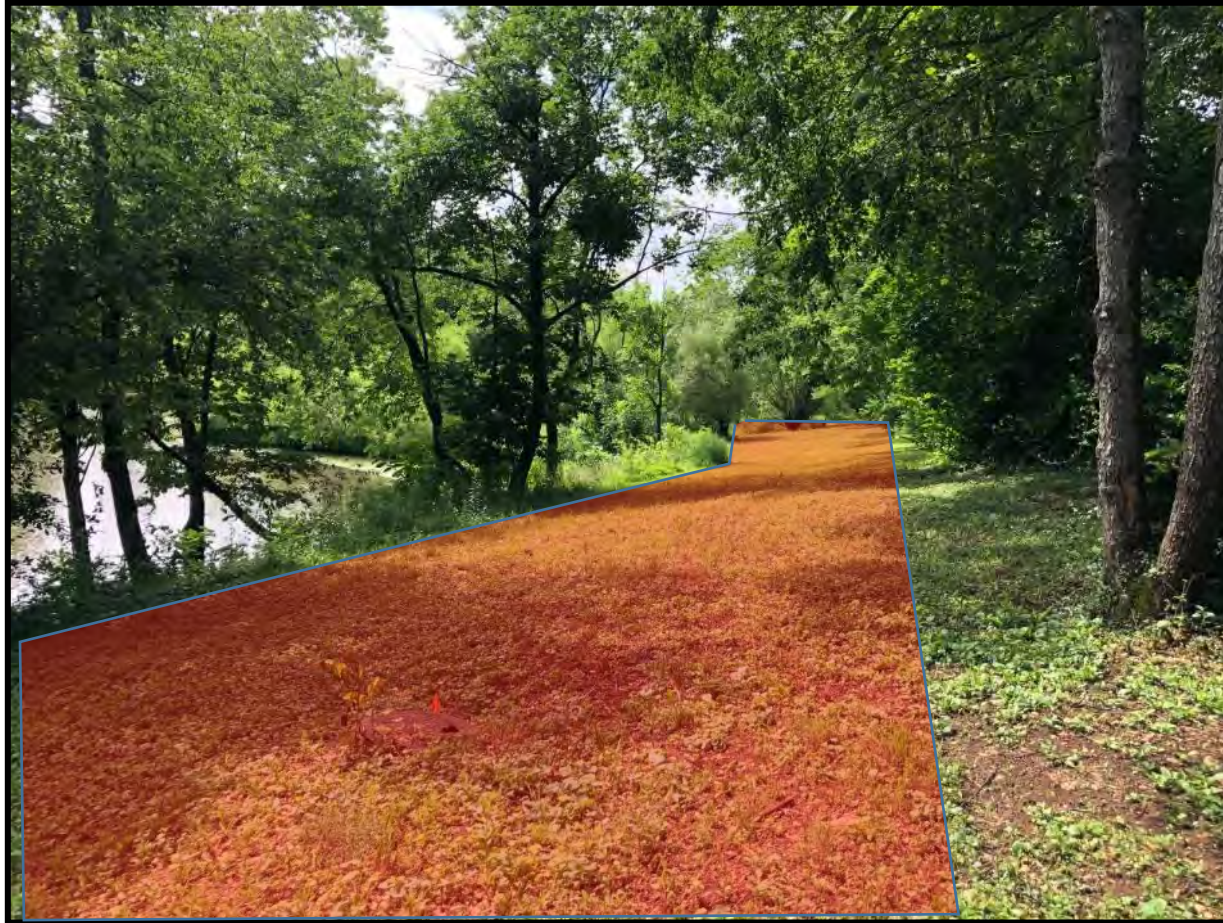
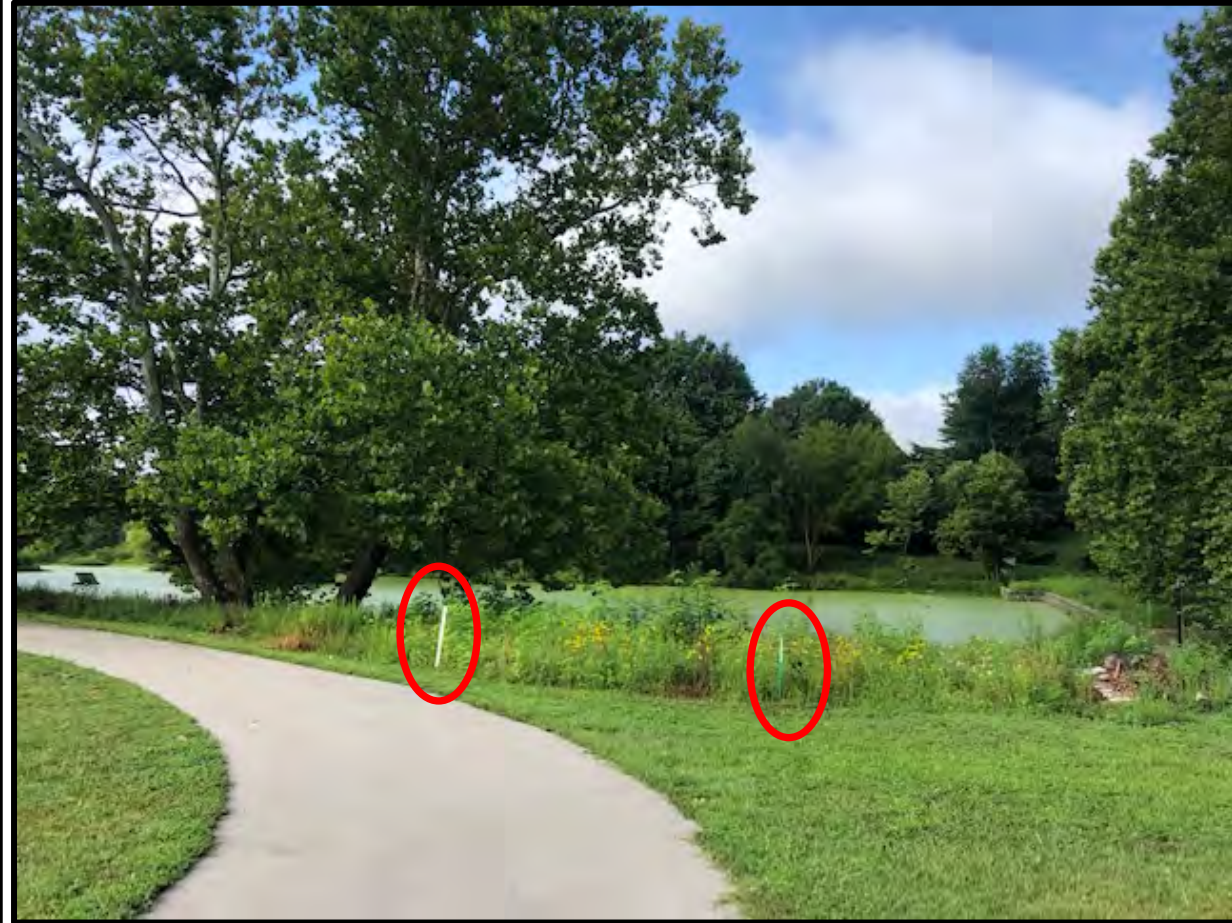
Buffer Gets Mowed Down

June 24, 2021
