WISSINOMING PARK

RESTORING HISTORY THROUGH GREEN STORMWATER INFRASTRUCTURE

SESWA'S 17TH ANNUAL REGIONAL STORMWATER CONFERENCE : OCTOBER 7, 2022

PRESENTED BY: ANDREW BIRMINGHAM, PE

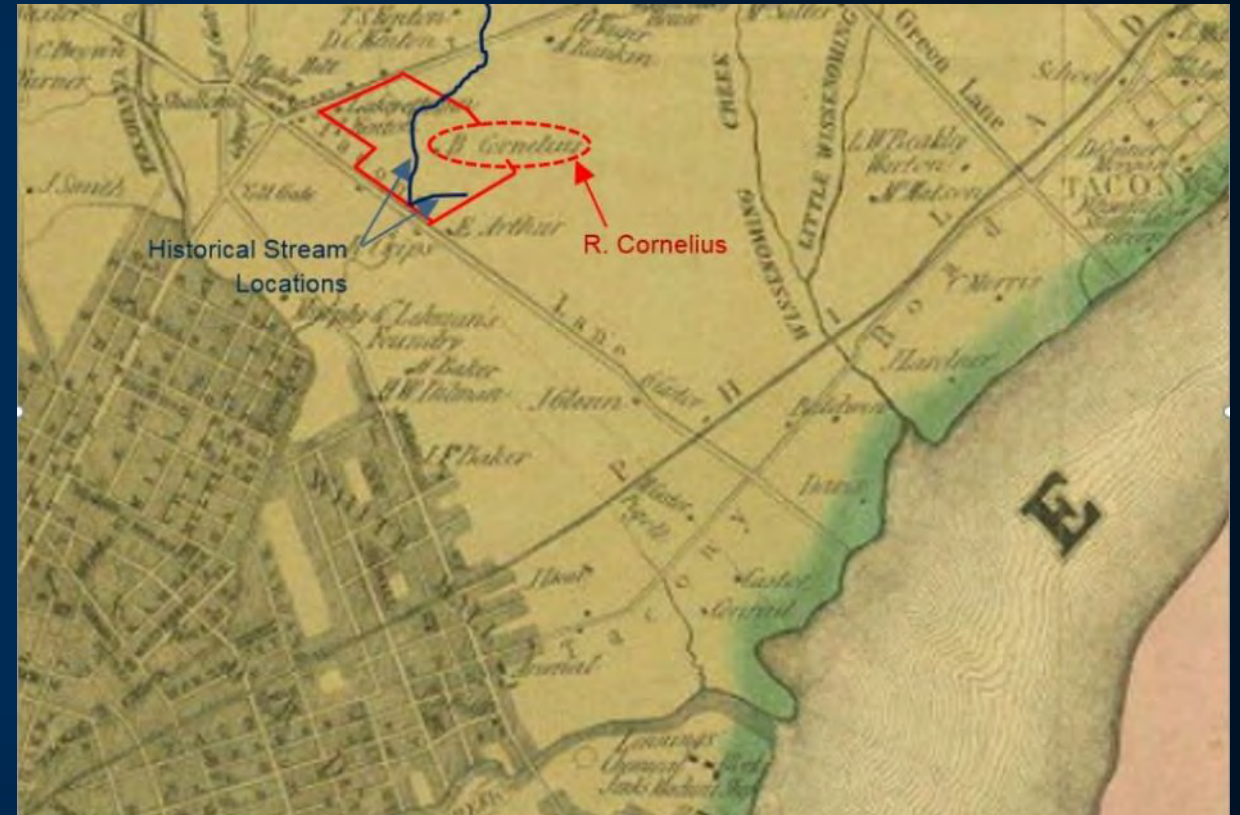
Historical stream locations and record of Robert Cornelius's estate.
(Credit: R.L. Barnes, "New Map of the Consolidated City of Philadelphia," 1855)

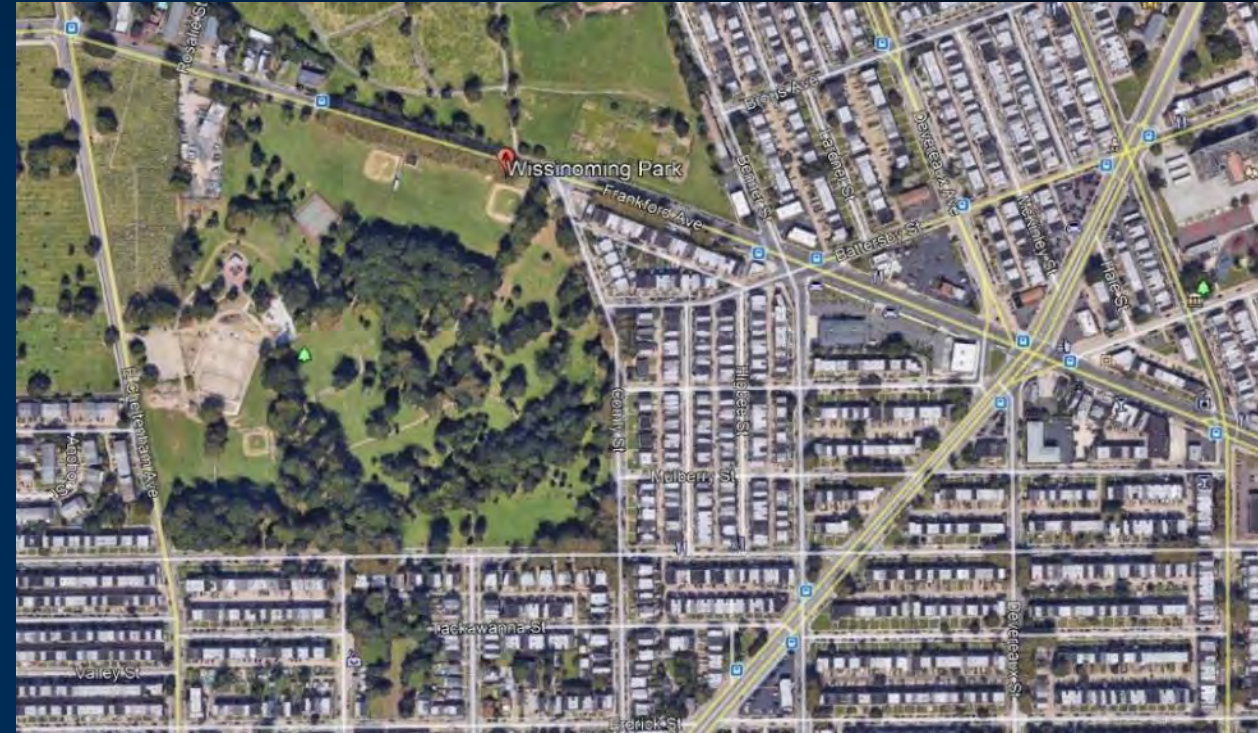
Historical layout of Wissinoming Park, showing historical stream and pond locations. (Credit: G.W. Bromley & Co., "Atlas of the City of Philadelphia, 23rd & 41st Wards," 1920) and Google Earth (2019).

- Streams buried / diverted into combined sewer system
- Late-90's: pond was filled
- Recreation fields / rinks
- Impervious areas

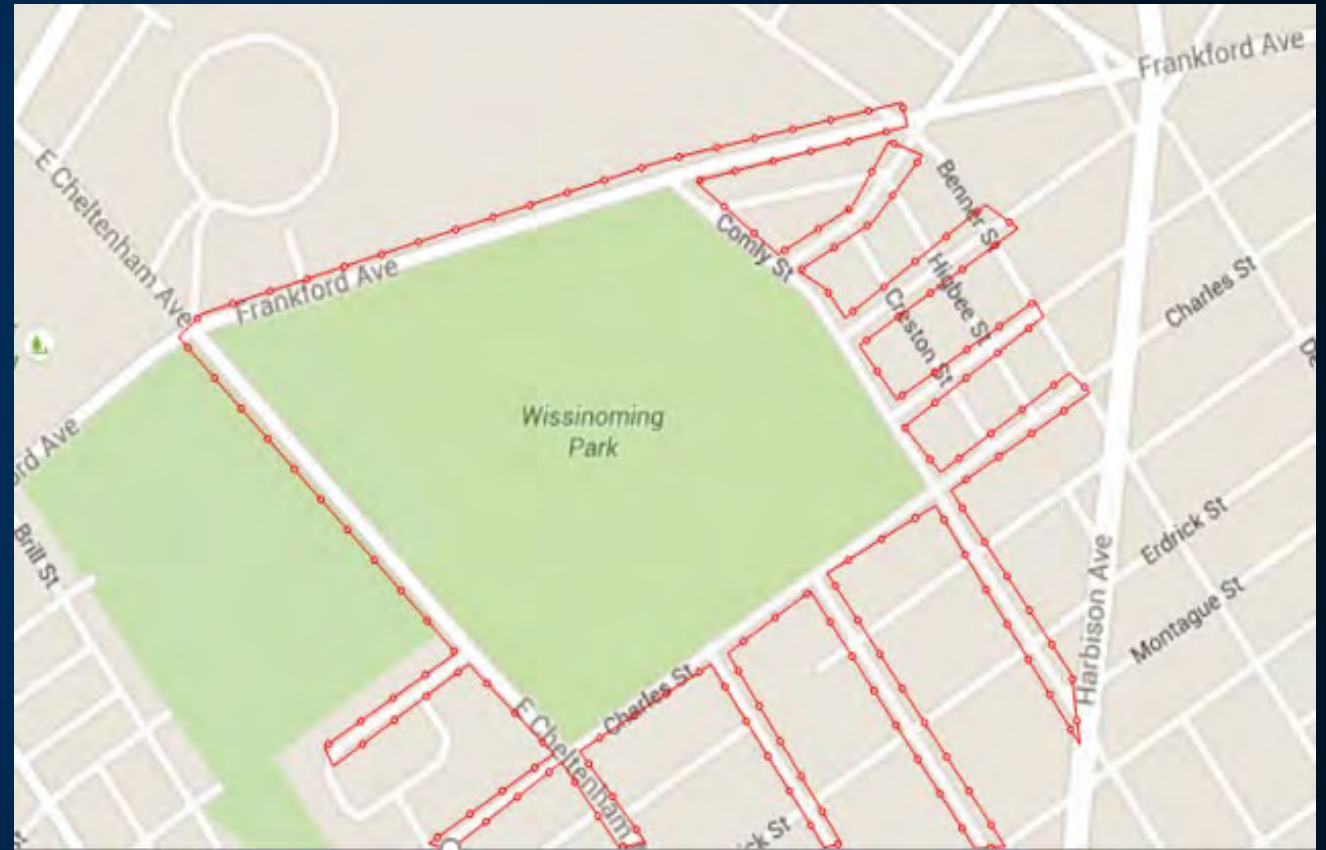
- DA = 20 acres (Impervious)
- Combined Sewers
- Public Right-of-Way
- Alleyways

- DA = 15 acres (Pervious)
- Recreation Areas/Open Space
- Historical Streams

Approximate outline of drainage area to be directed into GSI at Wissinoming Park.

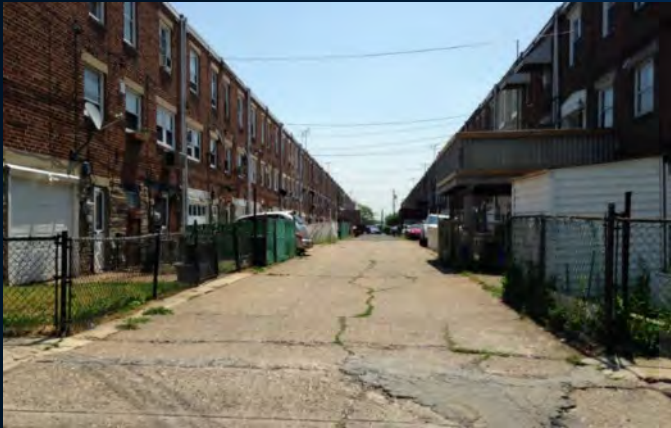
Typical alleyway configuration in surrounding neighborhood

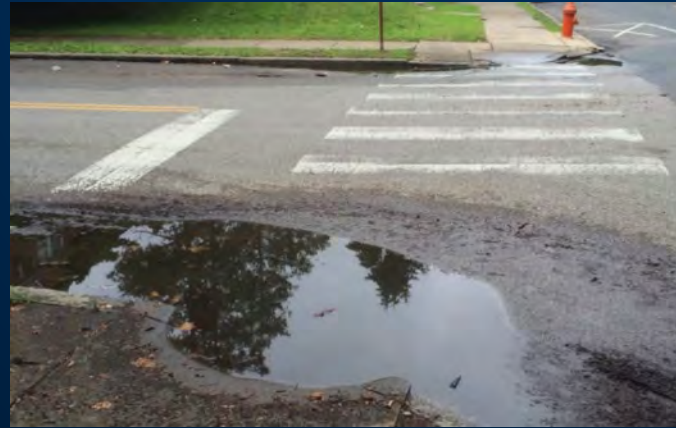
Ponding adjacent to curb ramps at the corner of Van Kirk and Charles Streets

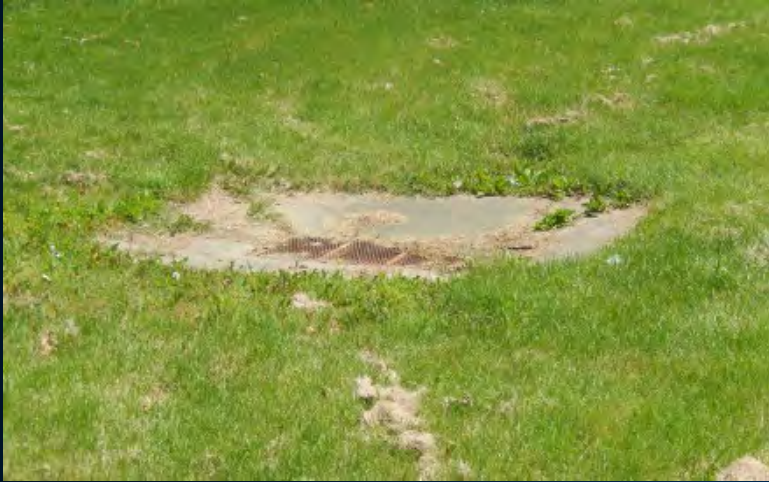
Typical yard inlet within park

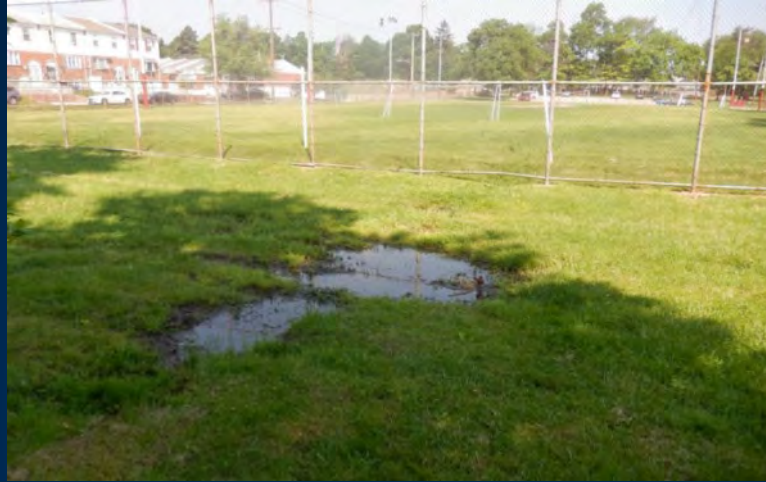
Standing water and poor drainage immediately south of the soccer field

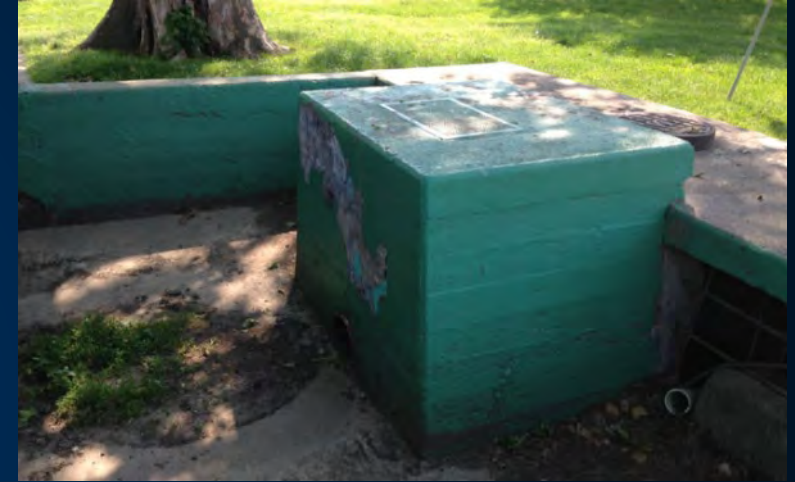
Outlet control structure located at low-point of hockey rink and basketball courts

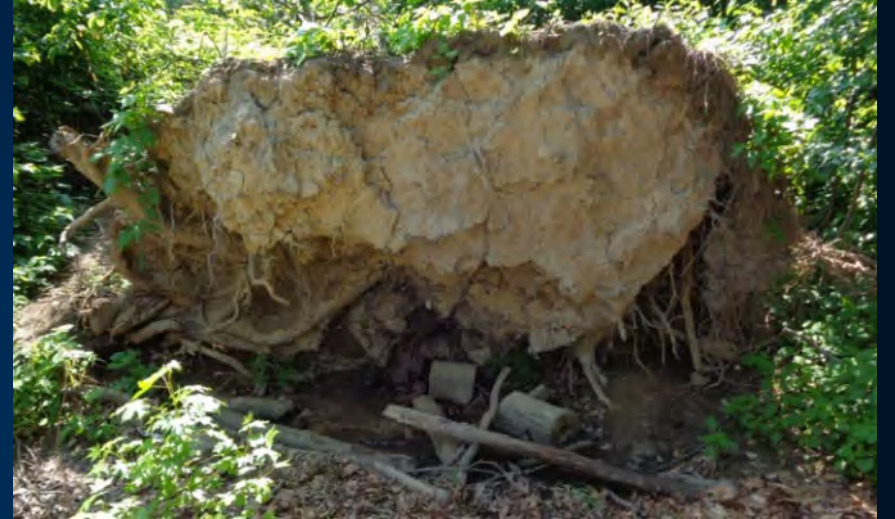
Uprooted tree in existing swale with signs of mottled soil around its roots and standing water

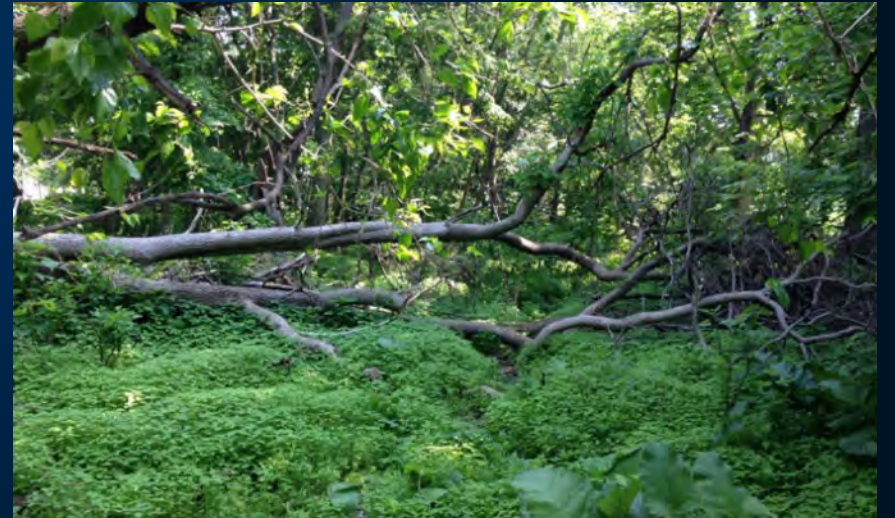
Existing swale bottom consists of an abundance of invasive vegetation

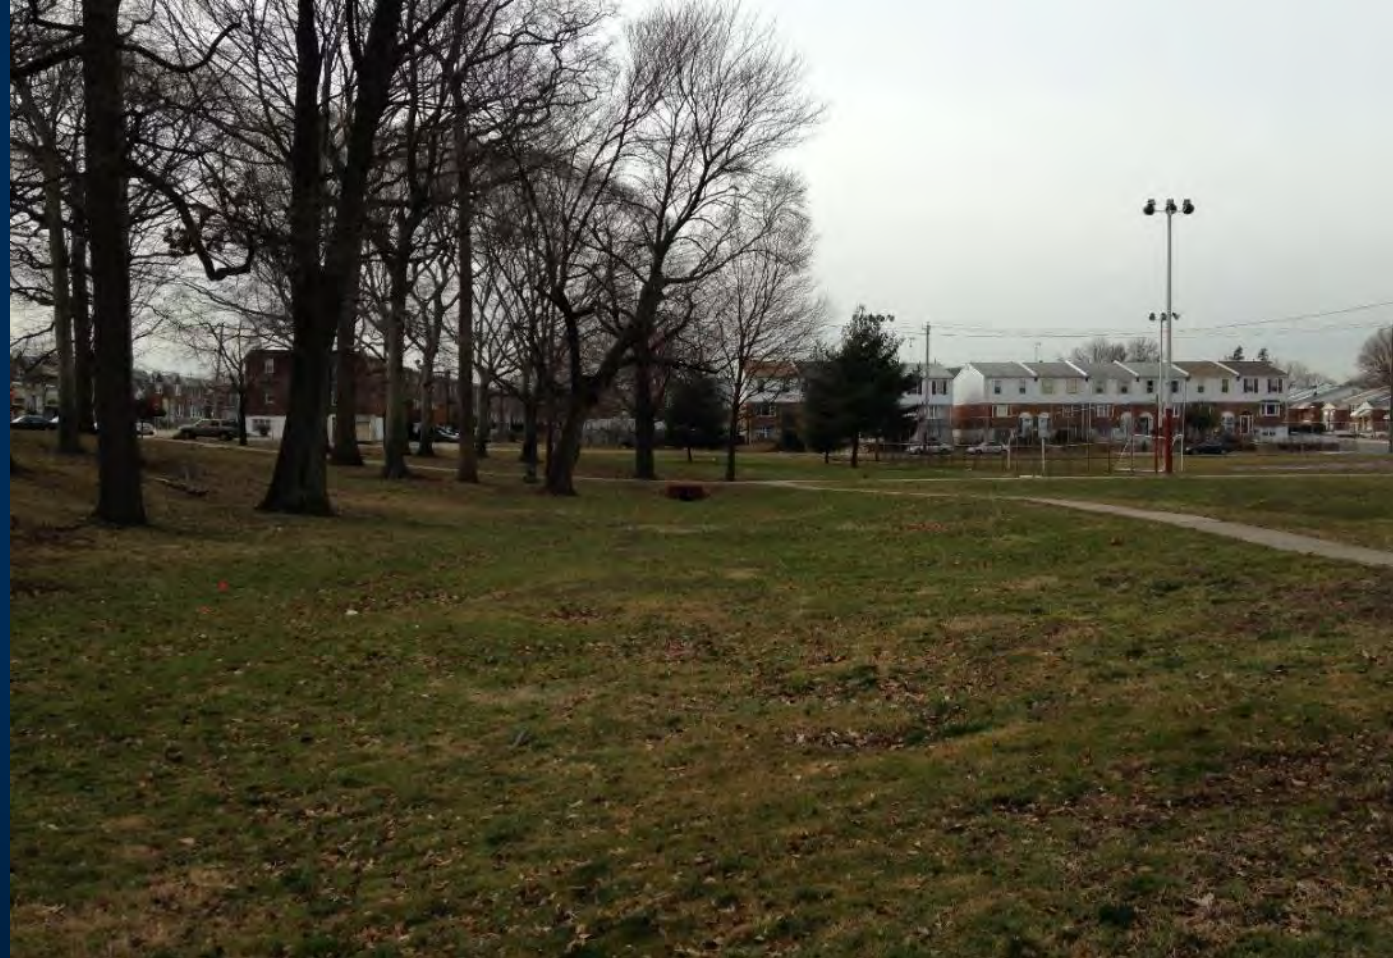
SMP 1: SLOPING WETLAND

- Existing Swale (Historical Stream)
- Sloping Wetland Complex
 - w/ upland rain garden
- Wetland Berms
- Forebays
- No-Mow Meadow “Edge Condition”
- Manages 540,000 gallons of runoff (20 GA)

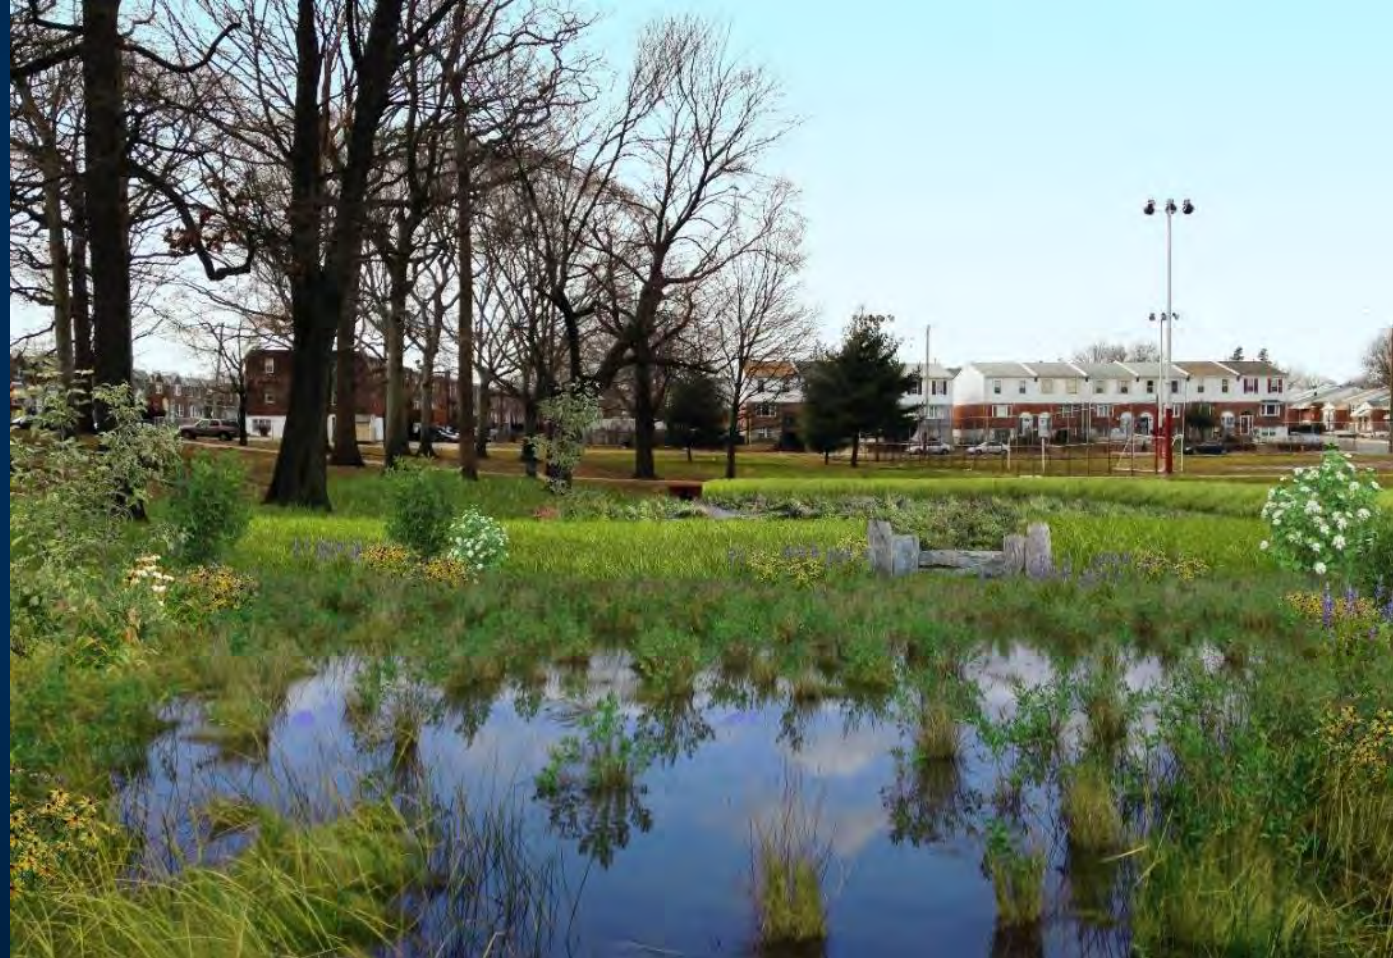
SMP 1: SLOPING WETLAND

- Existing Swale (Historical Stream)
- Sloping Wetland Complex
 - w/ upland rain garden
- Wetland Berms
- Forebays
- No-Mow Meadow “Edge Condition”
- Manages 540,000 gallons of runoff (20 GA)

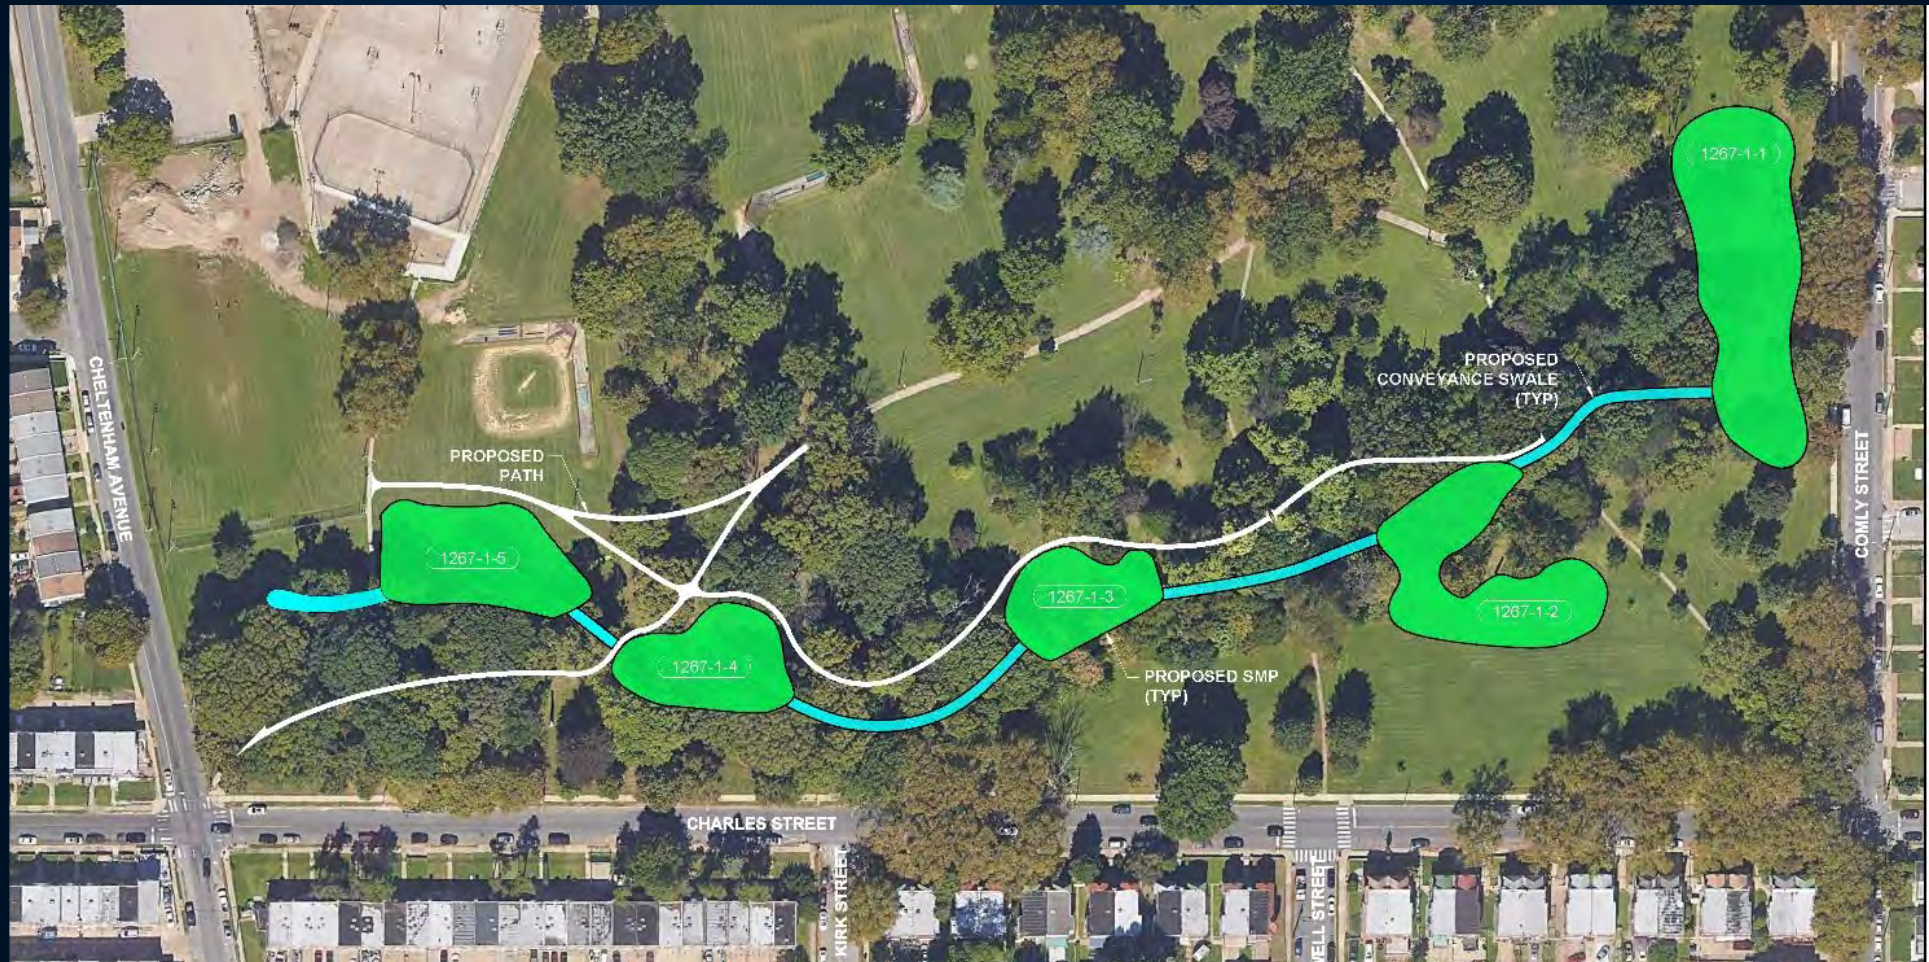
SMP 1: Sloping Wetland Complex Rendering

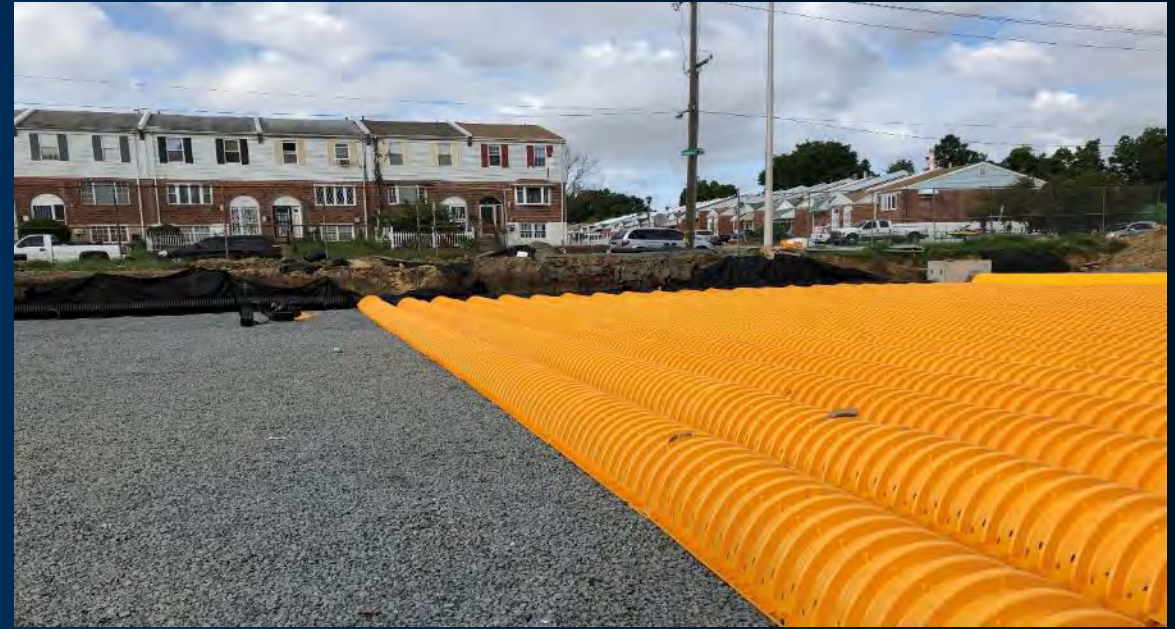
SMP 3: Construction of underground storage chambers beneath soccer field

- Existing Sports Fields (Baseball and Soccer)
- Underground Slow-Release Detention Storage Chambers
- Manages 513,000 gallons of runoff (19 GA)

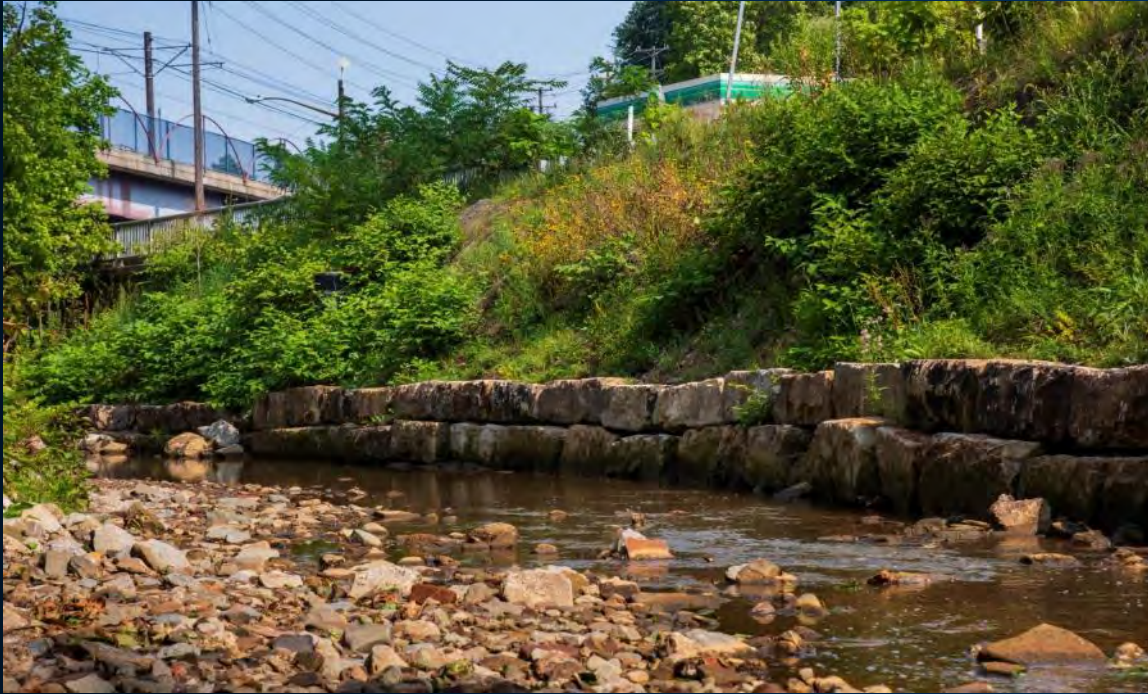
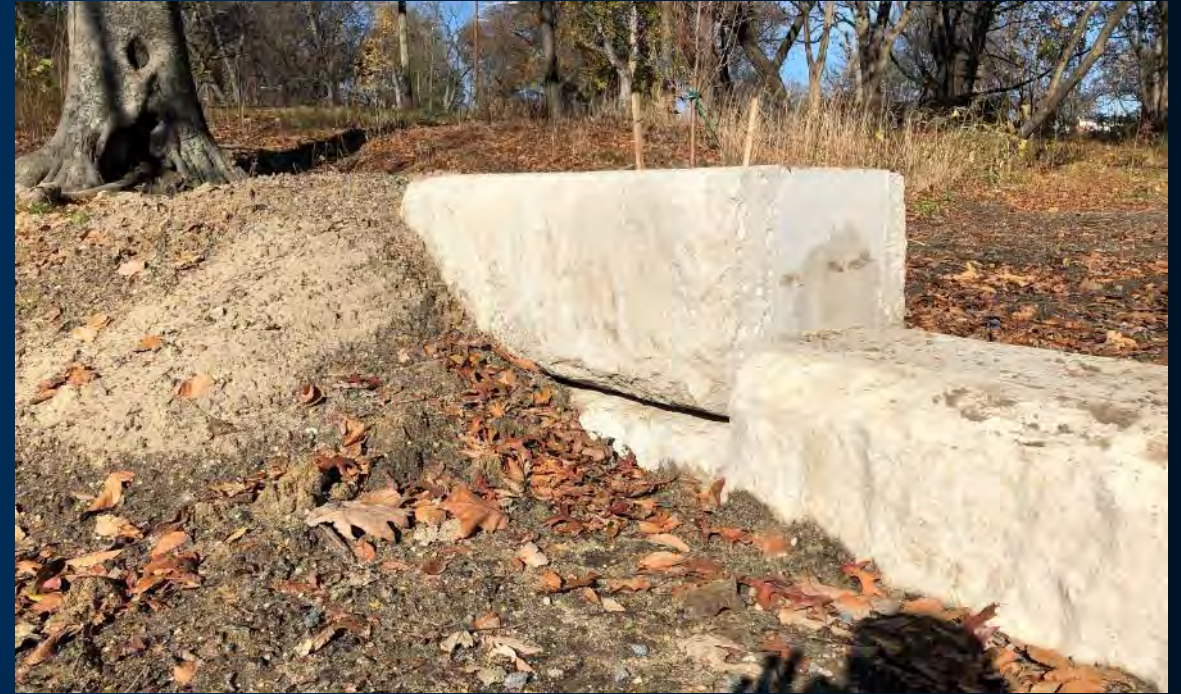
CONSTRUCTION MATERIAL AVAILABILITY

- COVID-19 Pandemic
- Schedule Considerations
- Imbricated Rock (High Demand)
- Modular Blocks (Mimics Natural Look)

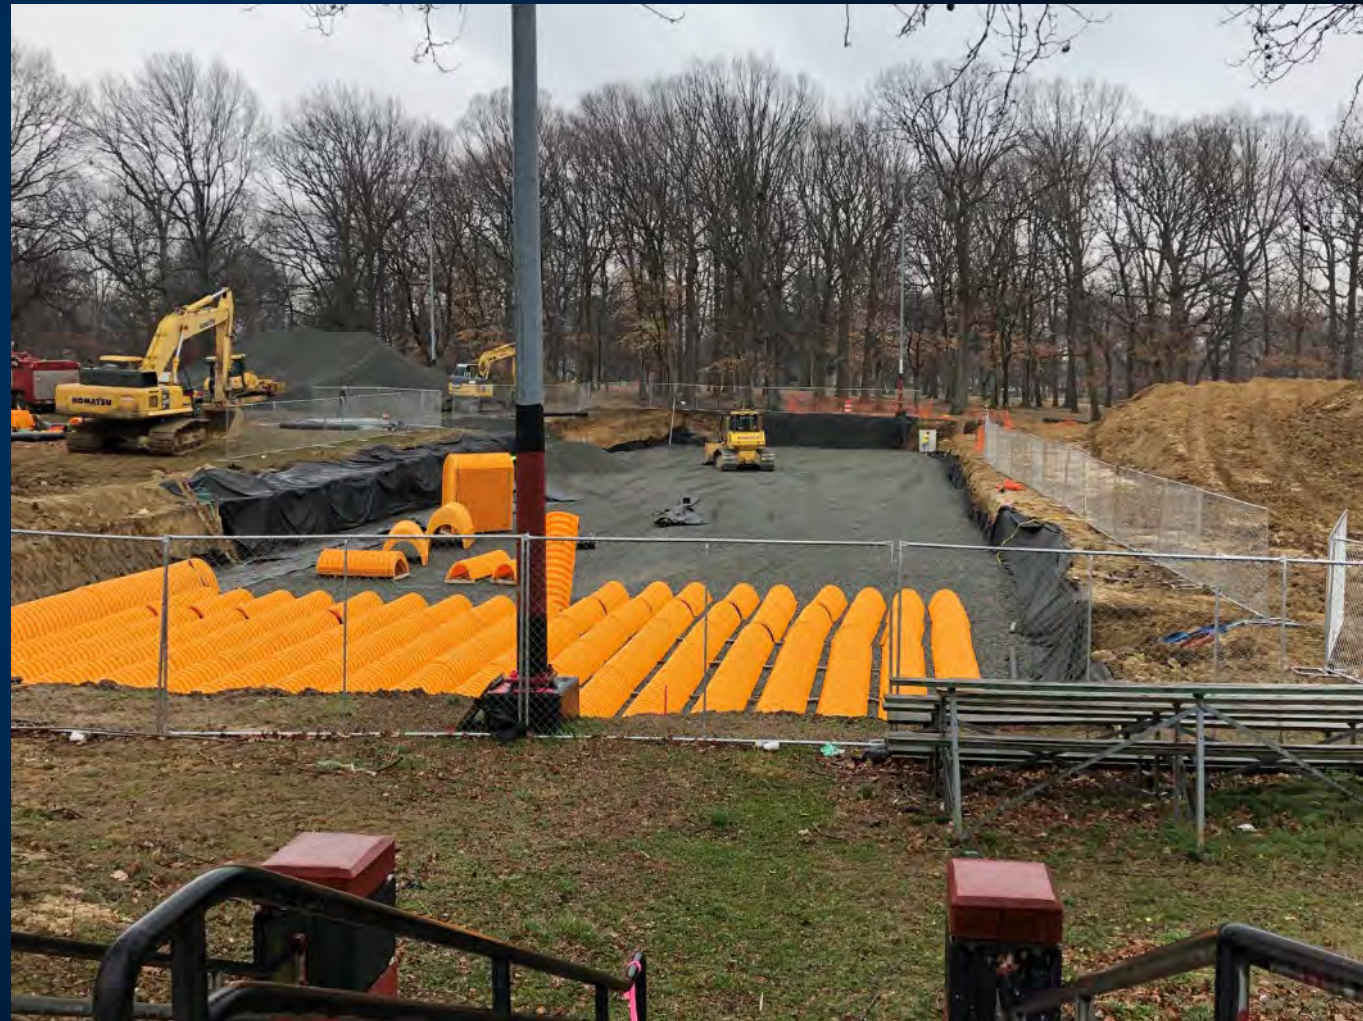
STORAGE CHAMBERS / STONE STORAGE

- Maximize Storage Volume
- Reduce Long-Term Maintenance Costs
- Prevent Clogging & Complete Failure of Stone Storage Trench
