Stormwater BMP and Stream Restoration in a City Park

Jeff Herr P.E., D.WRE Jill Stachura 770.673.3673 JHerr@BrwnCald.com

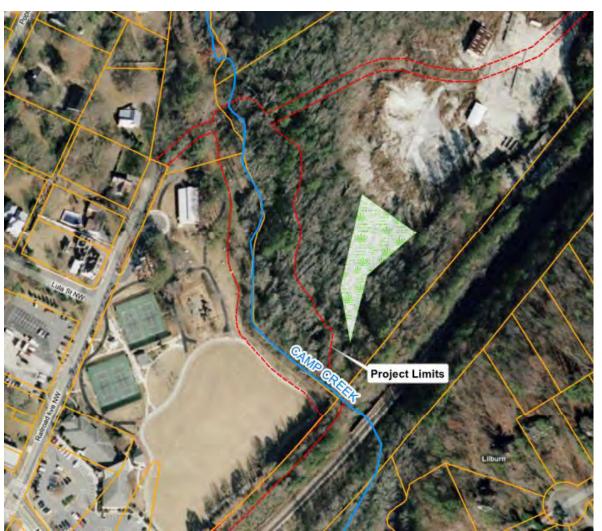
Camp Creek Existing Condition

- Incised channel, no connection to floodplain (Rosgen F-5)
- Poor habitat
- Stream eroding into left bank and encroaching on park facilities
- Steep, vertical banks safety hazard to park patrons
- Debris jams throughout

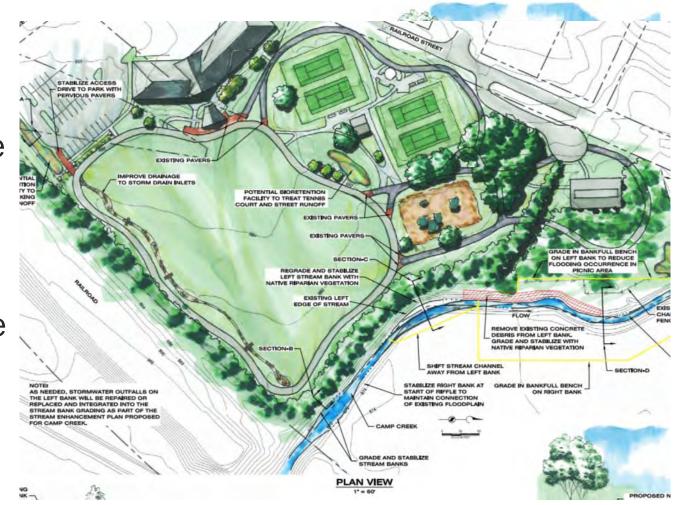
Developed 2 Alternative Conceptual Designs

- Priority 3 Stream Restoration
- Stabilize banks in place
- Create floodplain benches and reconnect to floodplain where feasible
- Remove concrete debris
- Revegetate

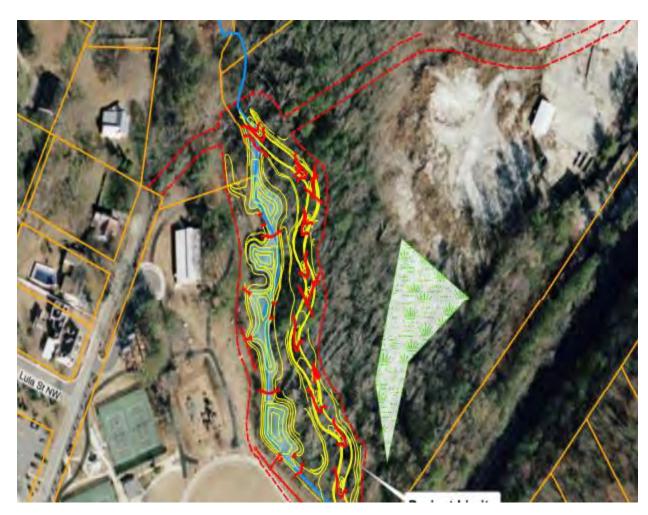
Selected Alternative 2 – Priority 1 Stream Restoration

- Relocate stream into right floodplain
- Utilize old channel for bioretention treatment of 30 acres
- Remove invasives and revegetate

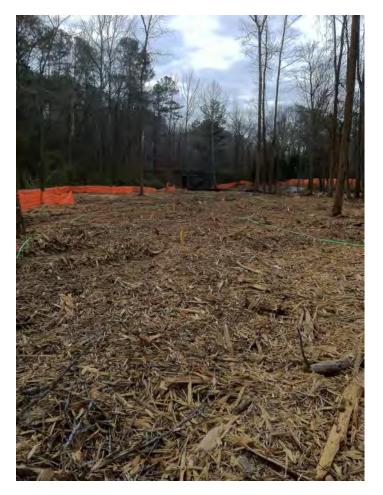
Cleared and flagged for new channel

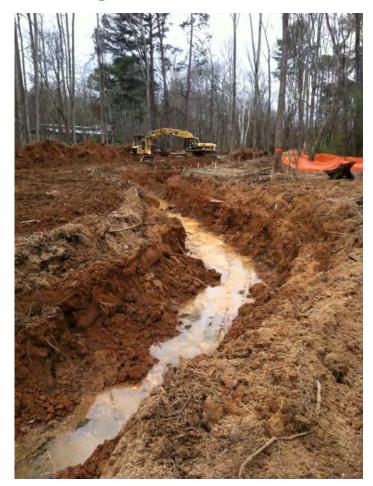
Roughed in new channel

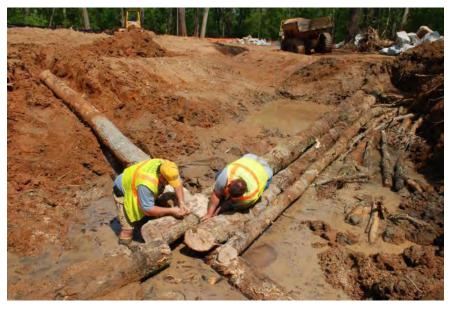
Log vane

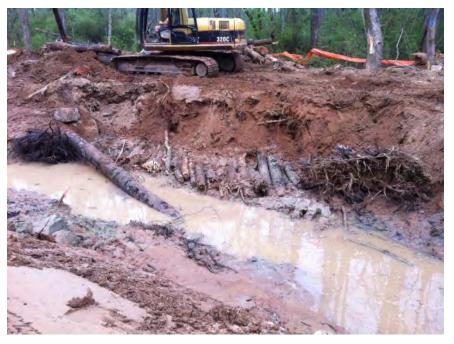
Scour log and toe wood/brush mattress

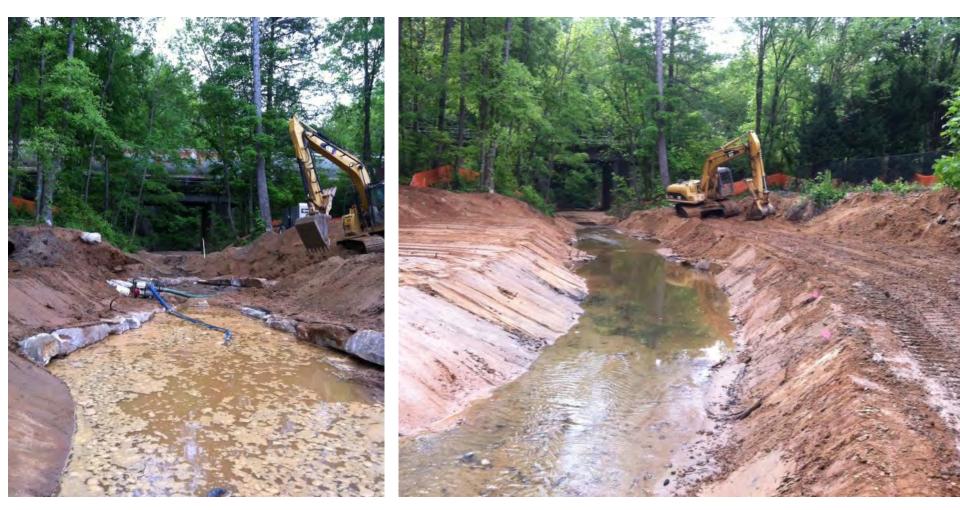
During Construction – Installing Fieldstone Cross Vanes, Structures 1 and 2

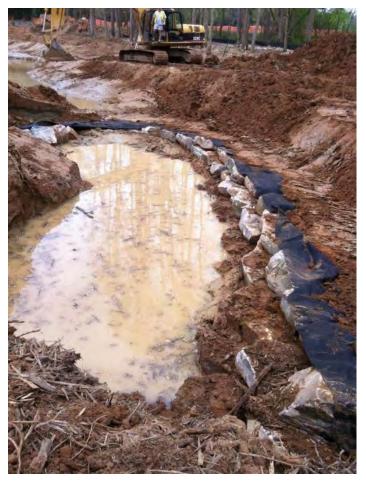
Stone J-hook

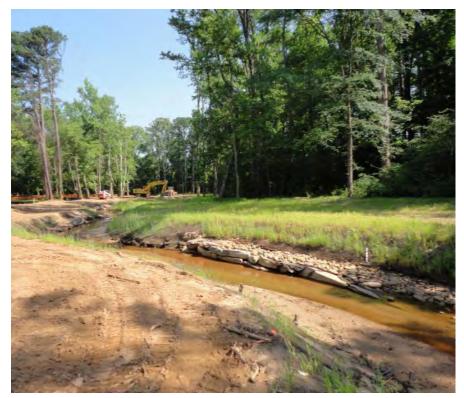
Completed Stone J-hook

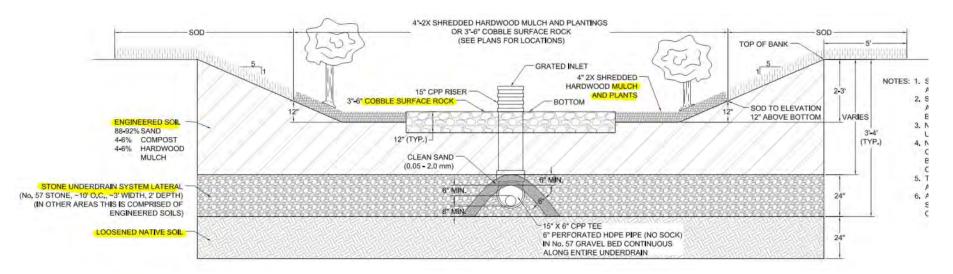
Design & Construction – Bioretention BMP

- 5 outfalls total drainage area 30 acres
- Designed system of 3 cascading bioretention cells in old channel
- Underdrain system with valve (only to be used if needed)
- Engineered soil
- Outfall connection to stream
- Plantings

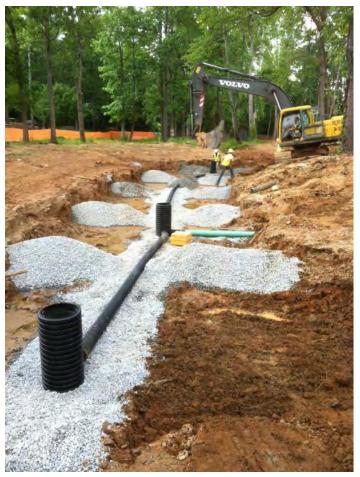
Underdrain Installation

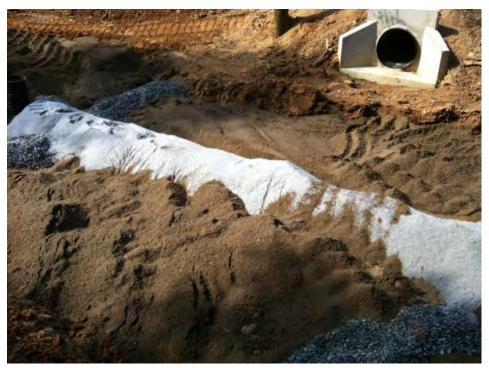
Installing Engineered Soil

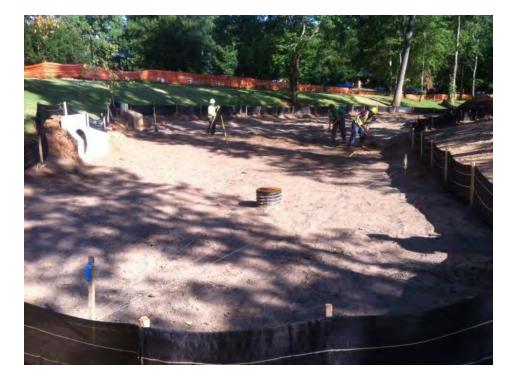
Engineered soil Installed in 1-ft lifts, water in, no compaction

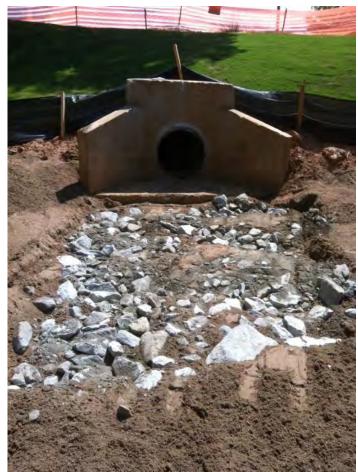
Type 3 Rip-rap at outfalls

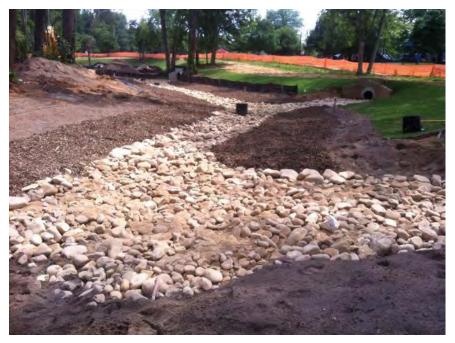
Cobble and mulch installed

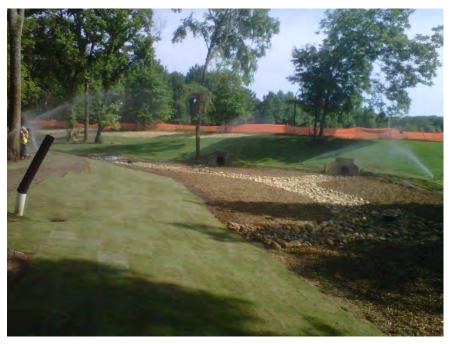
Sod and Irrigation System

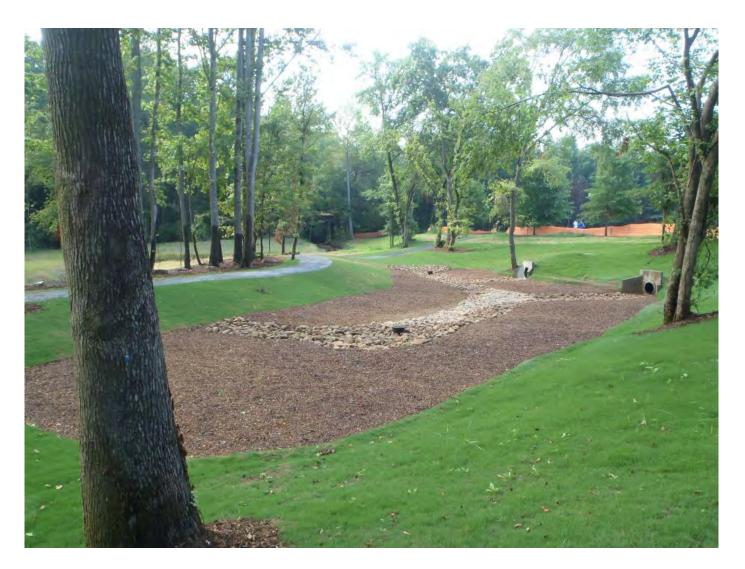
Completed Bioretention BMP
