Stormwater Condition Assessment

Case Study-City of West Palm Beach
Southeast Stormwater Association workshop
Oct 9, 2019

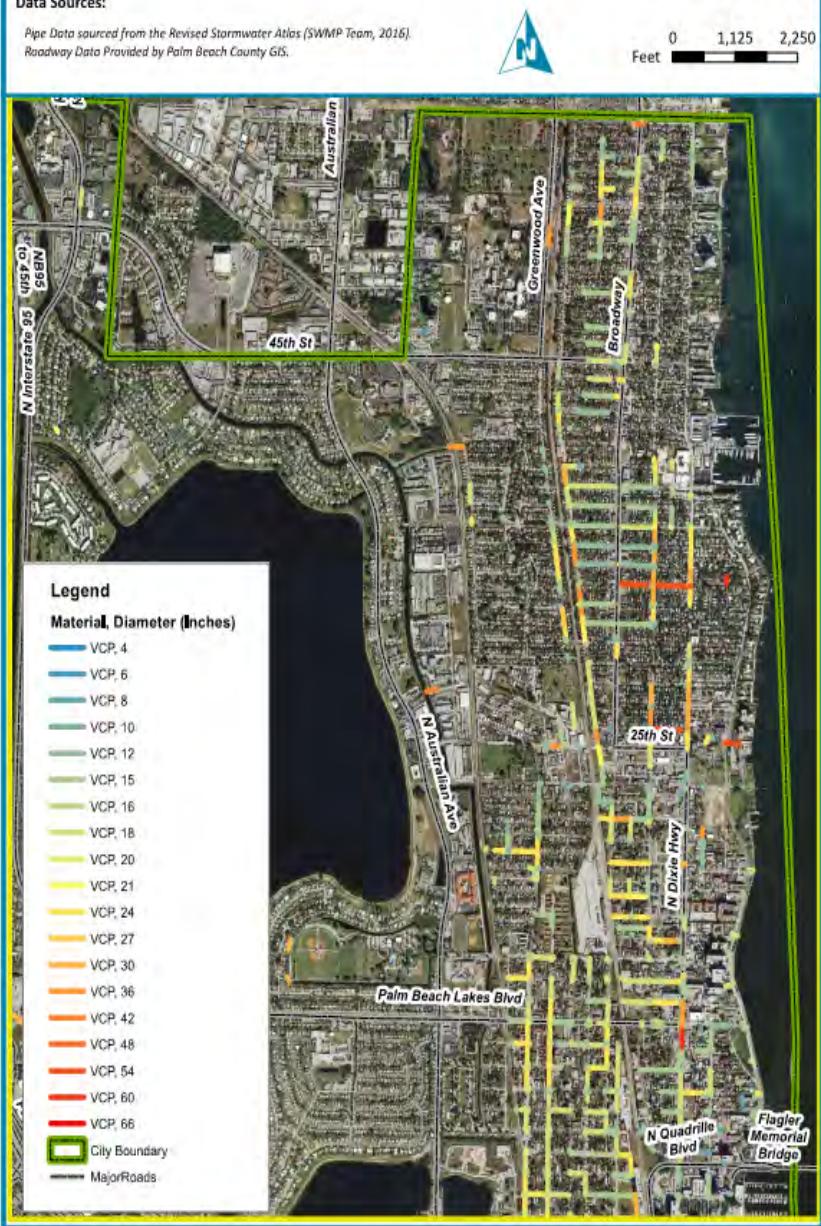
Figure 1A:
Locations of VCP by Diameter
Northeastern City

*Pipe Data sourced from the Revised Stormwater Atlas (SWMP Team, 2016).
Roadway Data Provided by Palm Beach County GIS.*

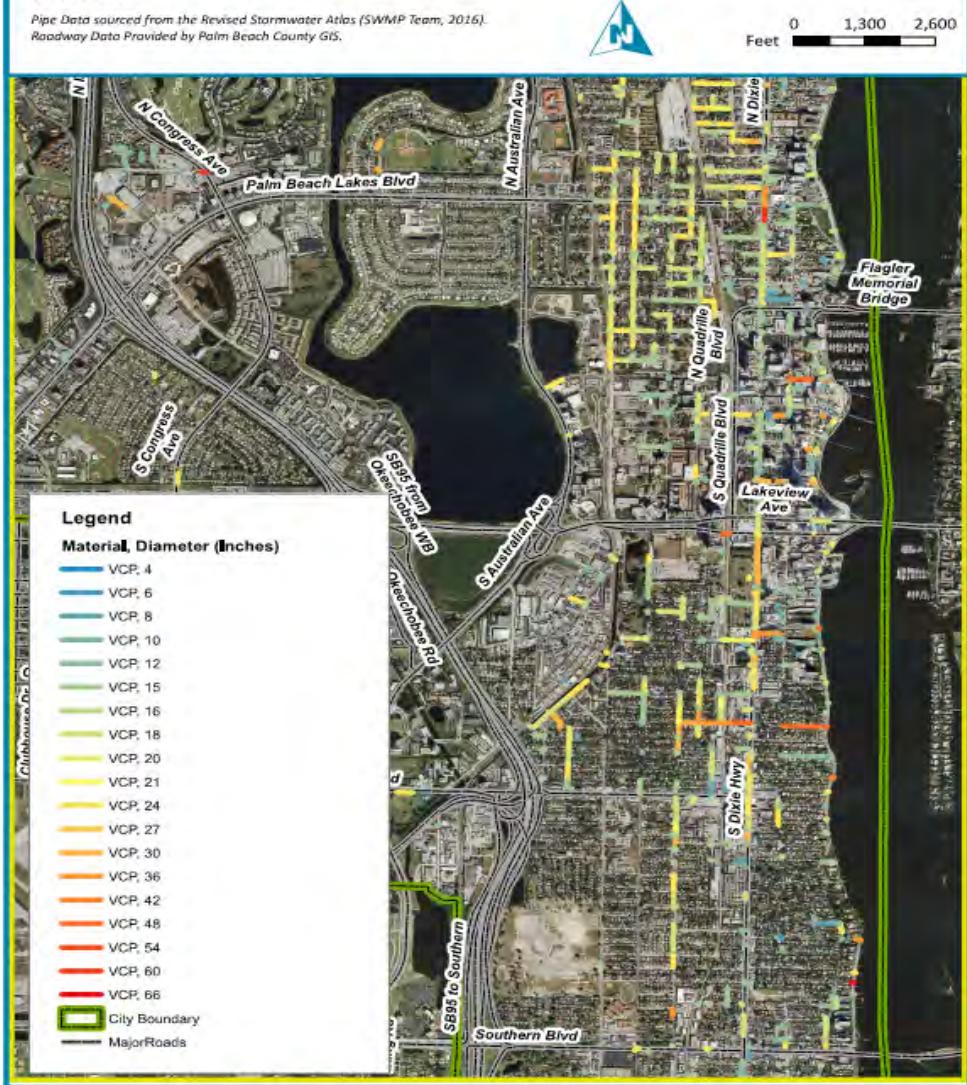
Figure 1B:
Locations of VCP by Diameter
Downtown and Surrounding Area

*Pipe Data sourced from the Revised Stormwater Atlas (SWMP Team, 2016).
Roadway Data Provided by Palm Beach County GIS.*

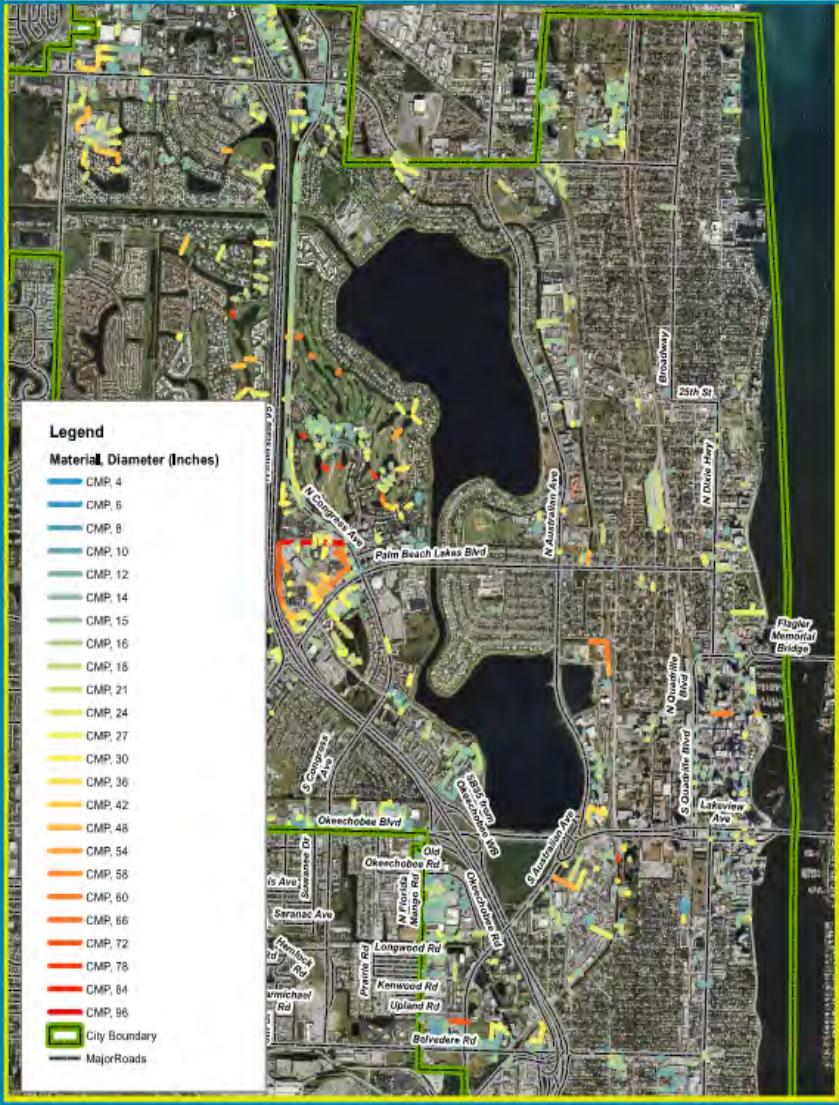
Figure 2A:
Locations of CMP by Diameter
Northeastern City

Pipe Data sourced from the Revised Stormwater Atlas (SWMP Team, 2016).
Roadway Data Provided by Palm Beach County GIS.

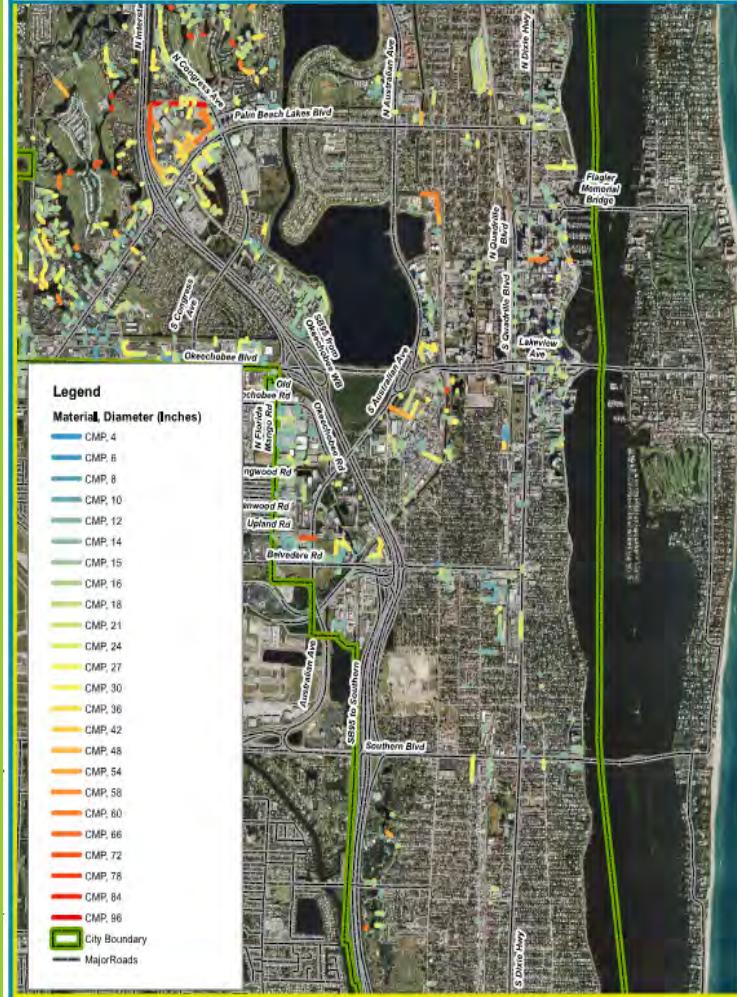
Figure 2B:
Locations of CMP by Diameter
Downtown and Surrounding Area

Pipe Data sourced from the Revised Stormwater Atlas (SWMP Team, 2016).
Roadway Data Provided by Palm Beach County GIS.

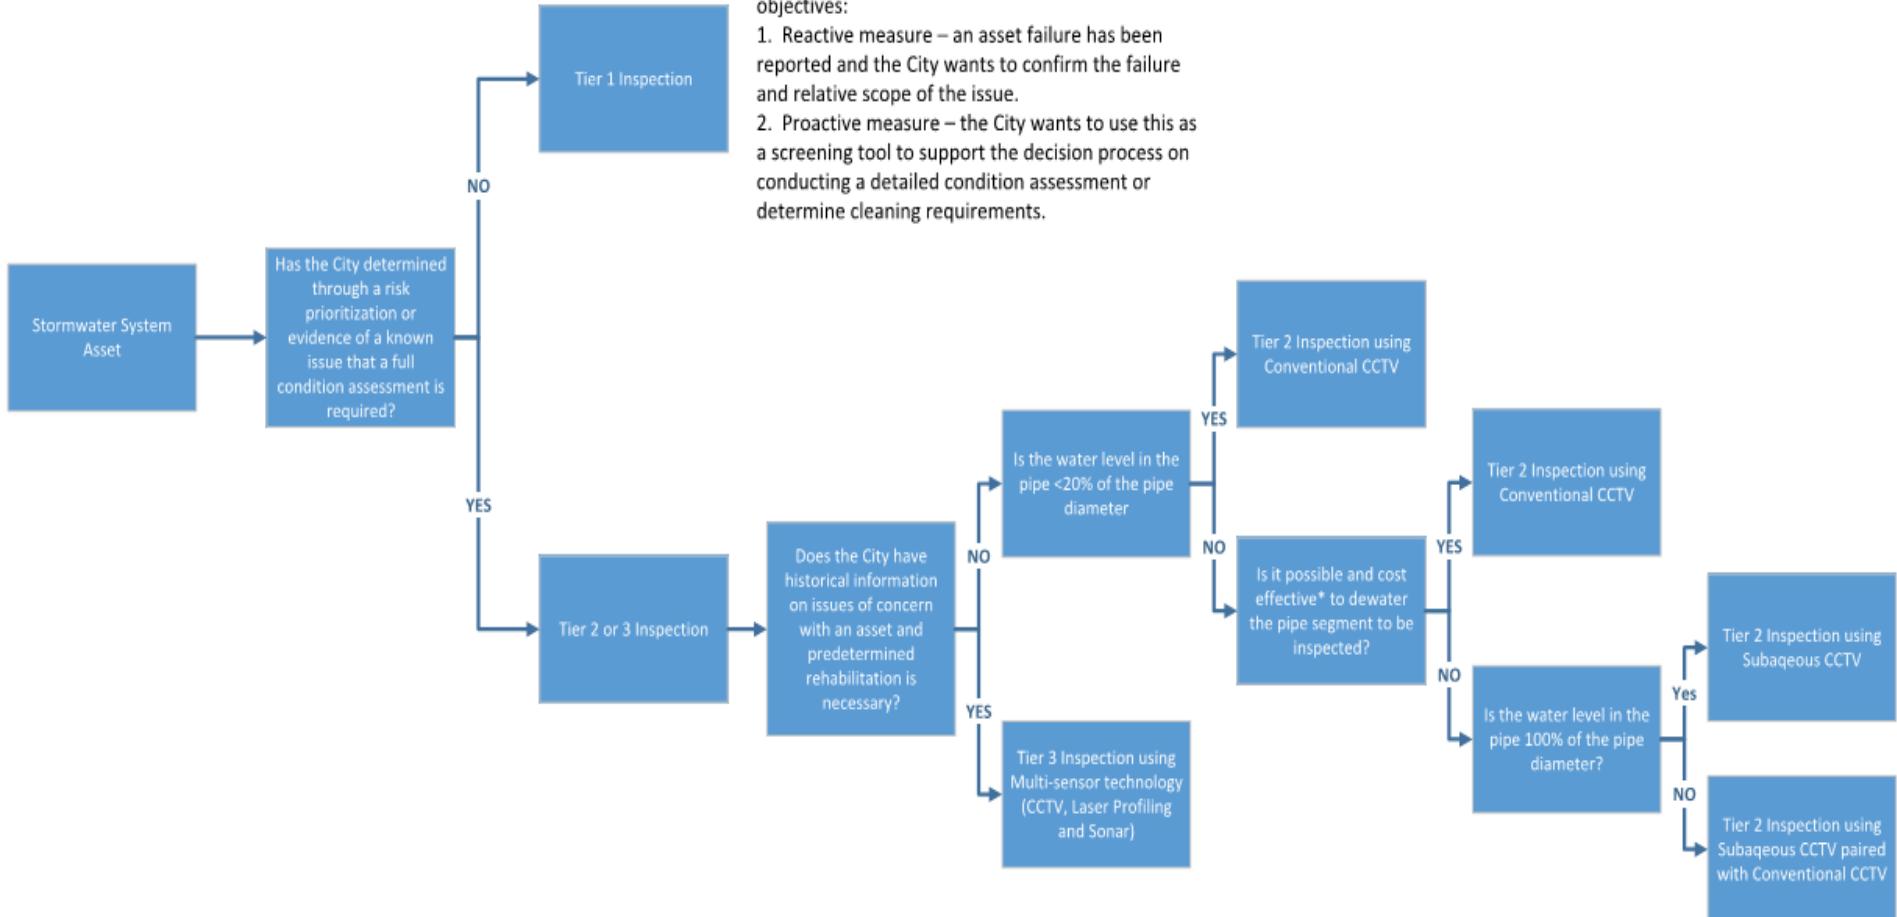
Decision Logic Diagram

Objective: to achieve an asset inspection that yields a NASSCO compliant result.

Tiered Approach for Inspection and Decision Logic

<u>Tier 1: Preliminary Inspection</u>	<u>Tier 2: Condition Assessment</u>	<u>Tier 3: Inspection to Support Engineering Design Activities</u>
<ul style="list-style-type: none">• Qualitative screening• No condition rating• Technology<ul style="list-style-type: none">◦ Subaqueous CCTV◦ Zoom camera	<ul style="list-style-type: none">• Detailed visual inspection over length of asset• Produces structural and O&M condition rating• Data can be used to define limits of more intensive Tier 3 inspections• Technology<ul style="list-style-type: none">◦ CCTV (convention or subaqueous)◦ Zoom camera (for manholes/inlets)◦ Visual inspection (for large culverts)	<ul style="list-style-type: none">• Detailed data inputs for engineering analysis to define appropriate rehab technique• Technology<ul style="list-style-type: none">◦ CCTV◦ Laser profiling

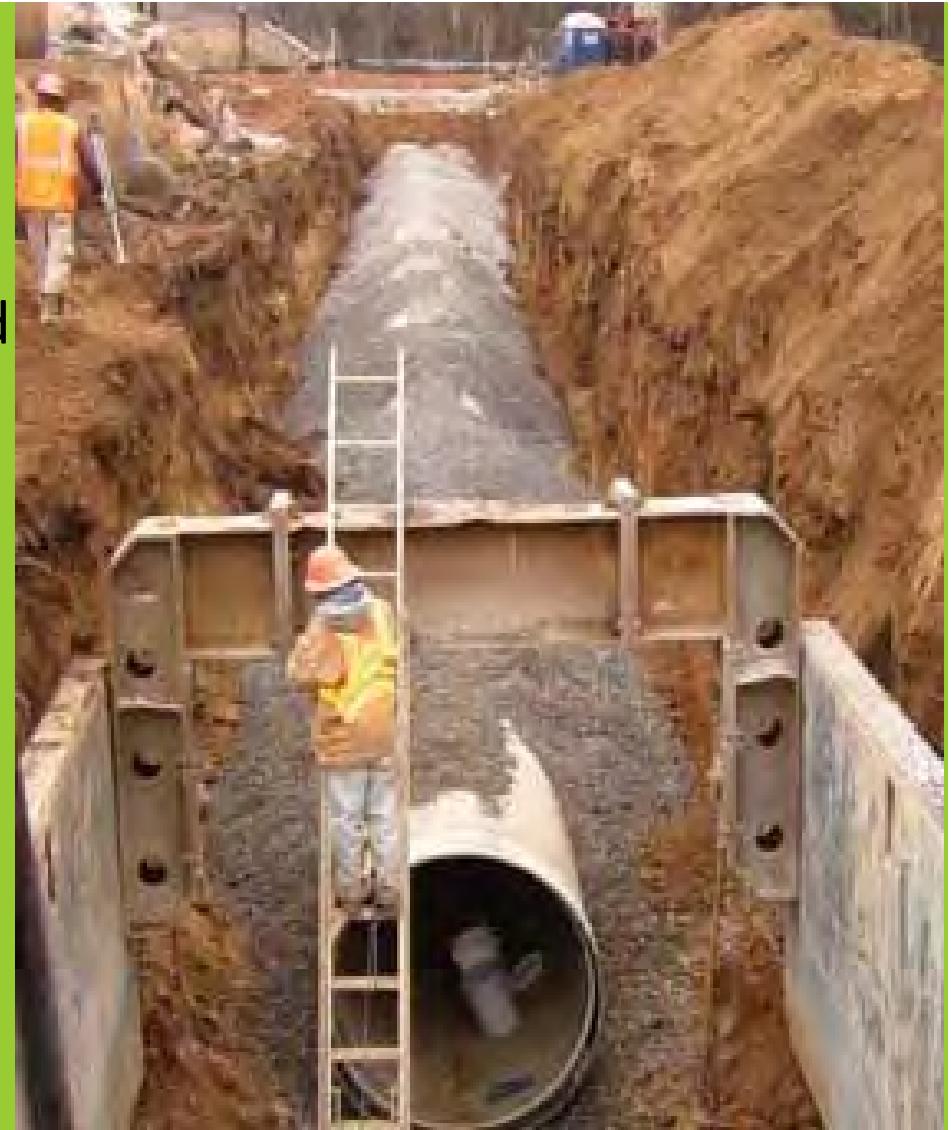
Rehabilitation Methods: Open Cut

- Key components
 - Excavation, bedding, laying and backfilling of a pipeline
- Advantages
 - Used for thousands of years
 - Numerous contractors with experience
 - Full renewal of host pipe
- Disadvantages
 - Significant surface disruption
 - Significant geotechnical requirements
 - Typically most costly
 - Construction duration

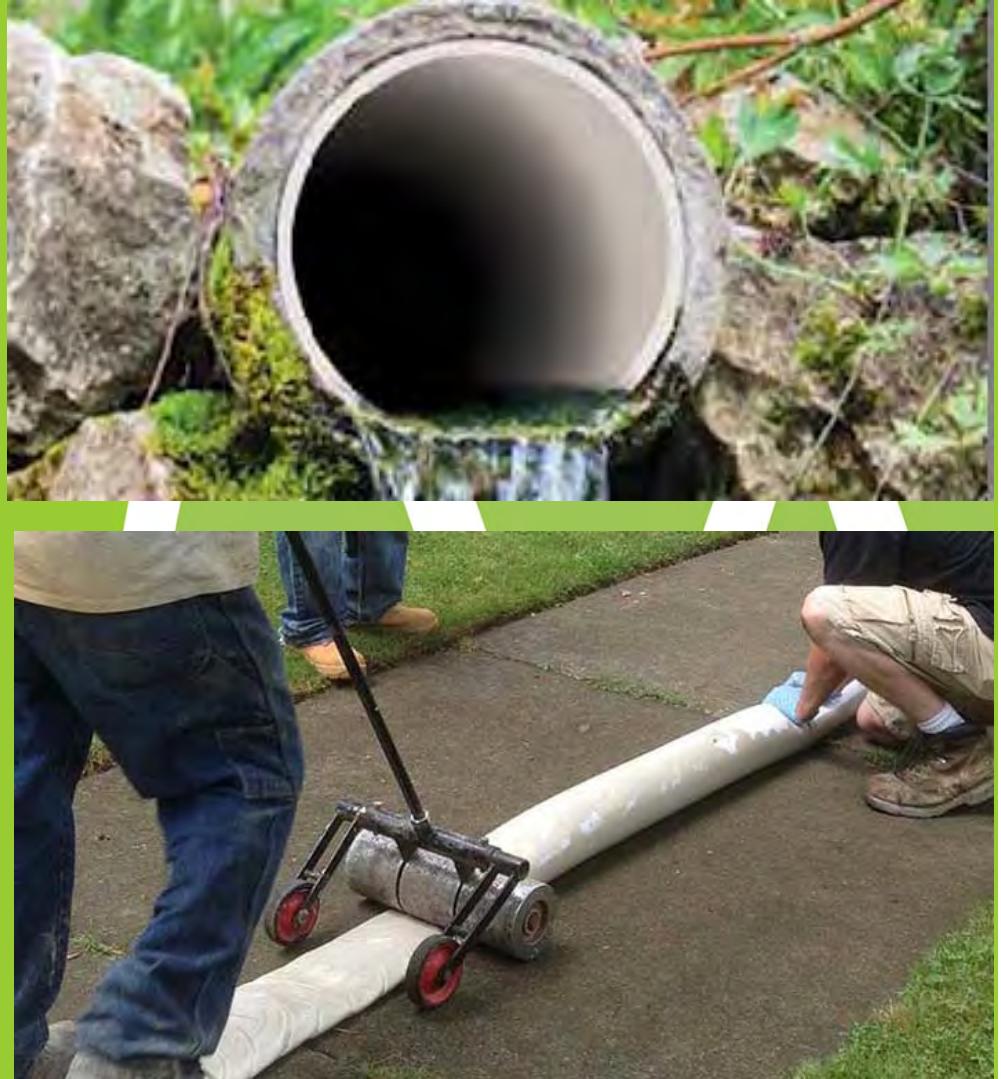
Rehabilitation Methods: Cured-in-Place-Pipe (CIPP)

- Key components
 - Insertion of a liner impregnated with thermosetting resin within an existing host pipe
- Advantages
 - Fully structural replacement
 - Small reduction in cross-sectional area – minimal impact to hydraulics
 - No entrance or exit pits required – minimal surface disruption
- Disadvantages
 - Dewatering/Bypassing required during construction
 - Sometimes more costly compared to other lining methods

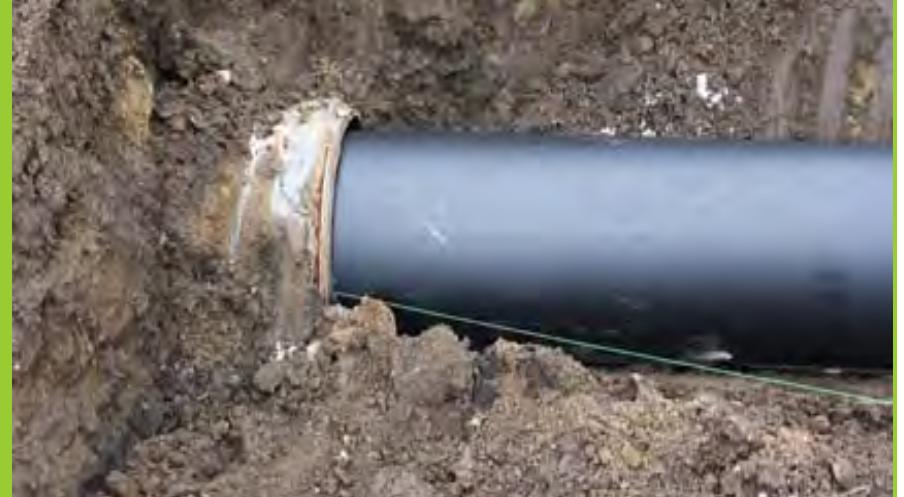
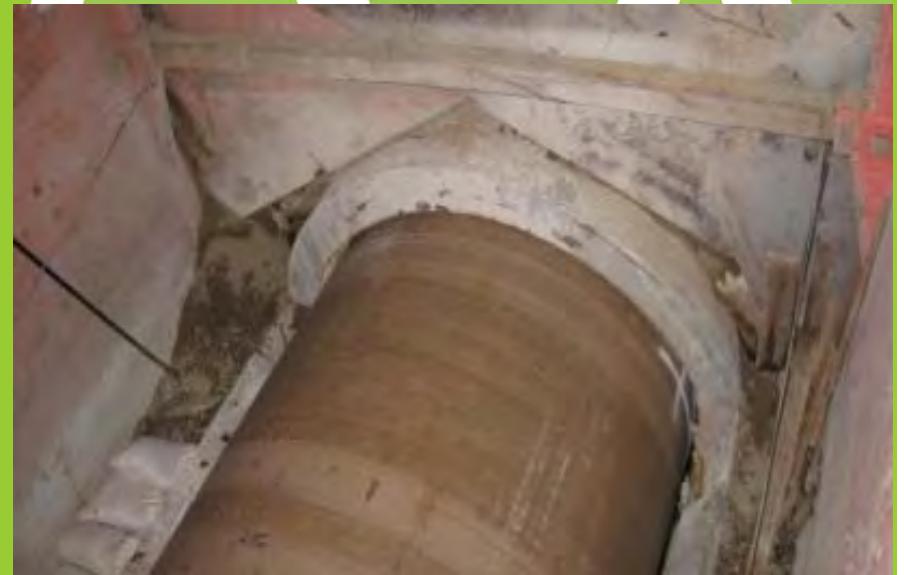
Rehabilitation Methods: Sliplining

- Key components
 - Placement of a solid or segmented pipeline inside existing pipeline
- Advantages
 - Typically only one pit required
 - Number of joints can be limited
 - Minimal/moderate surface disruption
- Disadvantages
 - Significant reduction in cross-sectional area
 - Laterals must be externally reinstated
 - Excessive pulling loads can lead to pipe failure

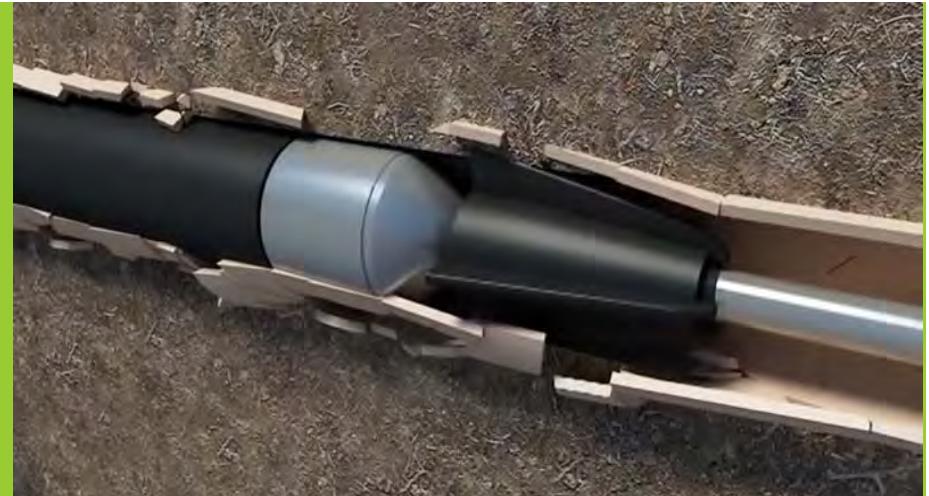
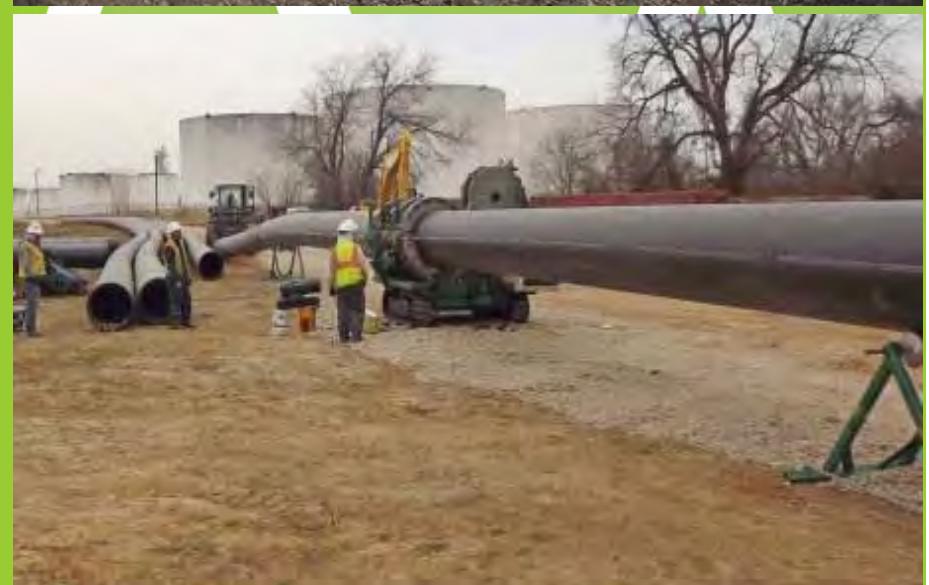
Rehabilitation Methods: Pipe Bursting

- Key components
 - Existing pipe broken and replaced with new pipe of equal or greater size
- Advantages
 - Existing pipe can be upsized (without open cut)
 - Less costly than open cut
 - Eliminates old pipe material
- Disadvantages
 - Geotechnical information required in pipe zone – minimize adjacent obstructions
 - May cause ground heave if shallow
 - Bypassing of flow necessary
 - Failures possible due to equipment breakdown, curved pipes, and rocky soils

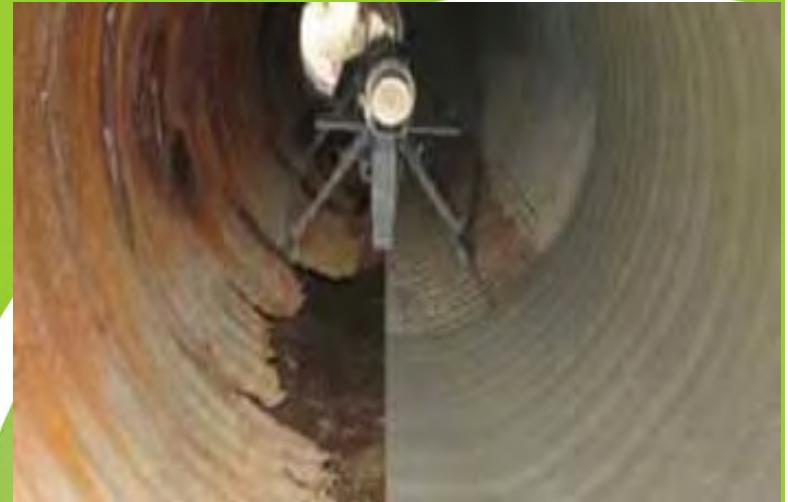
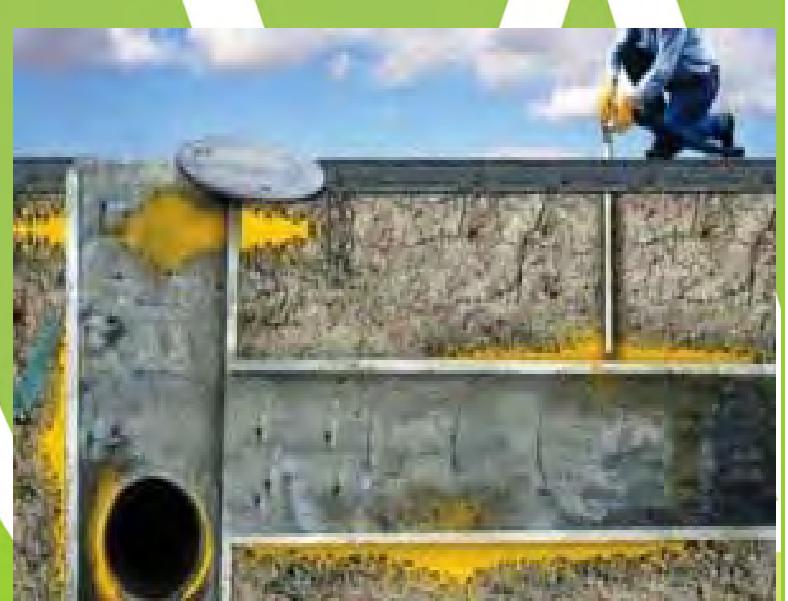
Rehabilitation Methods: Grouting

- Key components
 - Use of packer and grouter to seal individual gravity pipeline joints (inside and/or outside)
 - Alternative can be cementitious grouting
- Advantages
 - Proven technology with relatively low cost
 - Does not require bypassing for outside rehab
 - Not affected by active infiltration
 - Minimal surface disruption
- Disadvantages
 - Subject to failure in areas with fluctuating groundwater levels
 - Potential for failures associated with operator error, wet/dry cycling, and improper mixing
 - Reliant on host pipe structural integrity
