Advancing Green Infrastructure in Coastal Georgia through Monitoring and a Case Study

Robert A. Brown, Ph.D., P.E.

Goodwyn Mills Cawood (GMC)

SESWA 16th Annual Regional Stormwater Conference

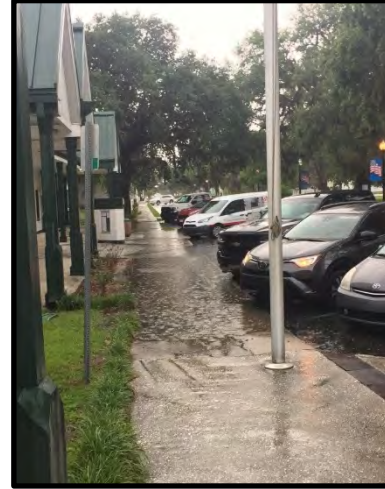
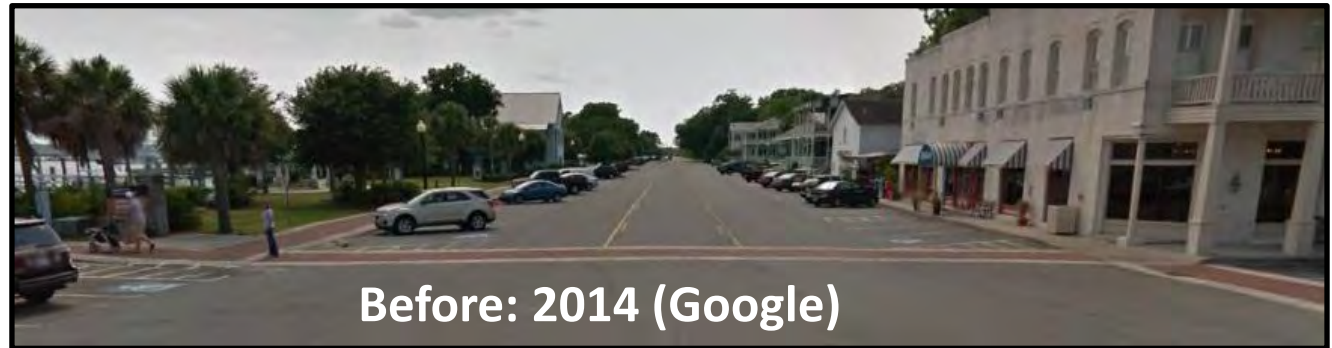
DOWNTOWN ST. MARYS, GA: PRE-GI/LID

- Site Conditions

- Flat topography
- Lack of drainage infrastructure
- Narrow sidewalks
- Limited pedestrian facilities
- Large impervious surfaces

Before: 2014 (Google)

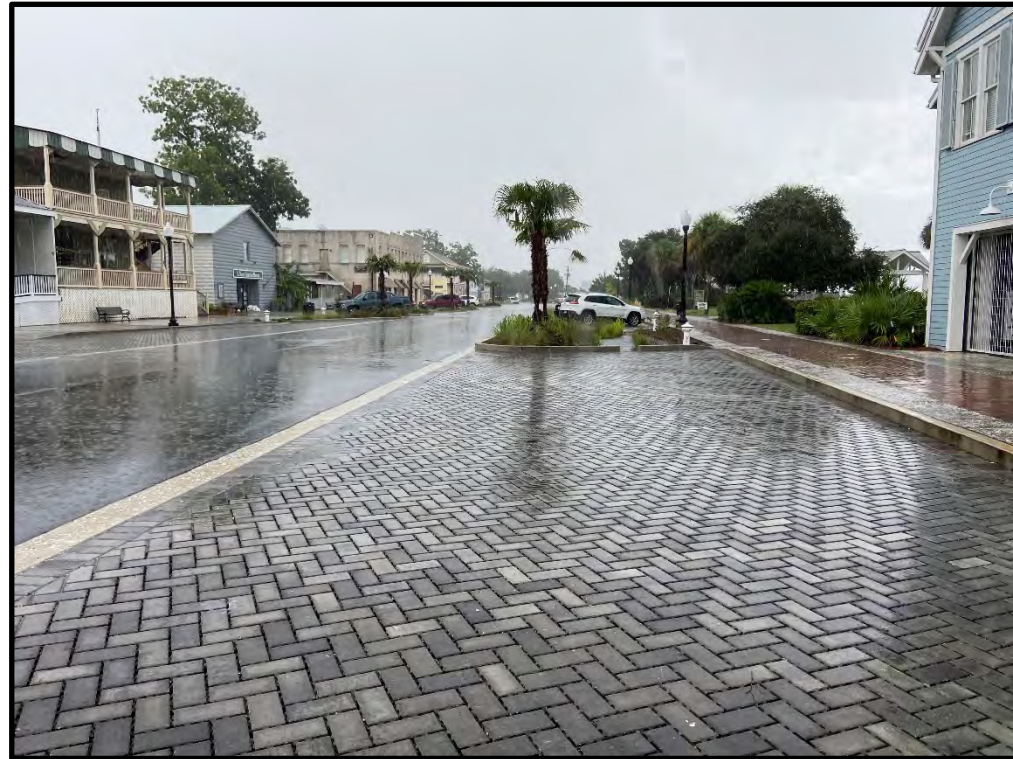
PHASE 1 – ST. MARYS STREET

Before: 6/12/2018

After: 8/19/2020

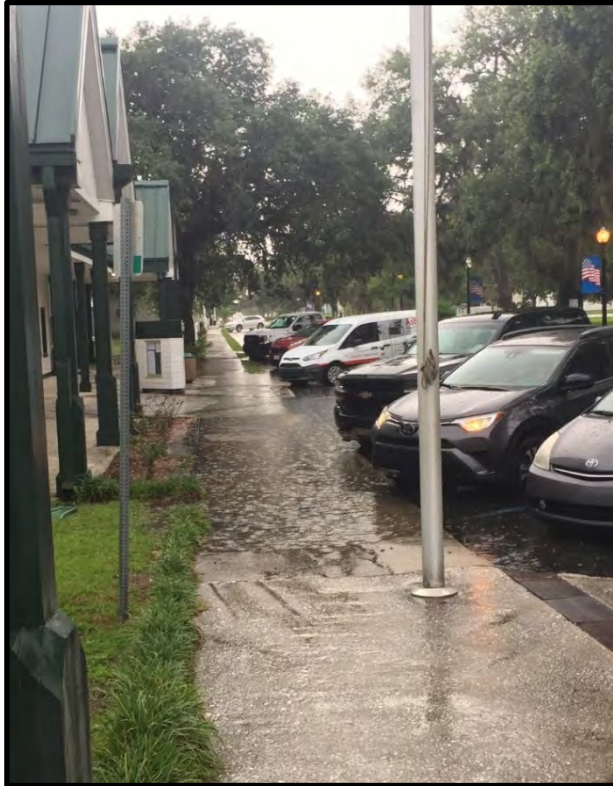
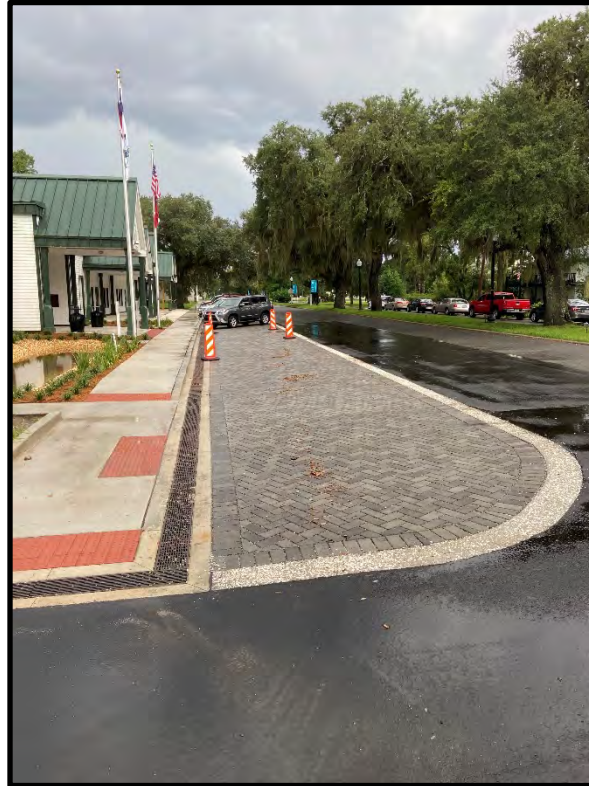
PHASE 2 – CITY HALL (OSBORNE STREET)

Before: 6/12/2018

After: 8/19/2020

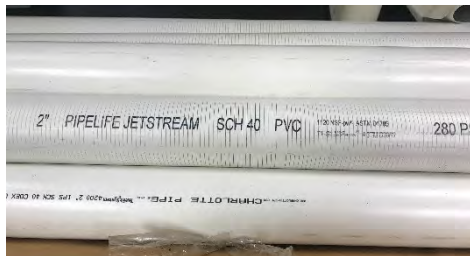
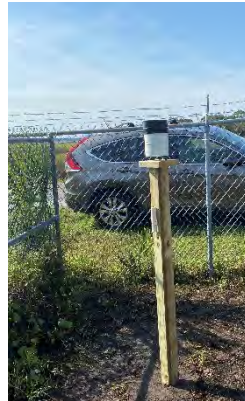
HYDROLOGIC MONITORING EQUIPMENT

- 14 Shallow Wells
 - Solinst Levelogger Edge
 - Non-vented water level datalogger
 - Extra barometric pressure logger
 - Measure infiltration & exfiltration
- Tipping Bucket Rain Gauge
 - Model runoff/inflow

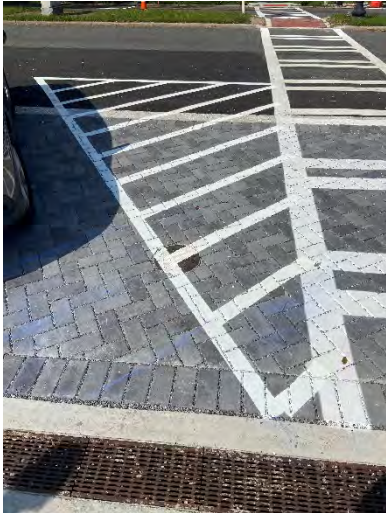
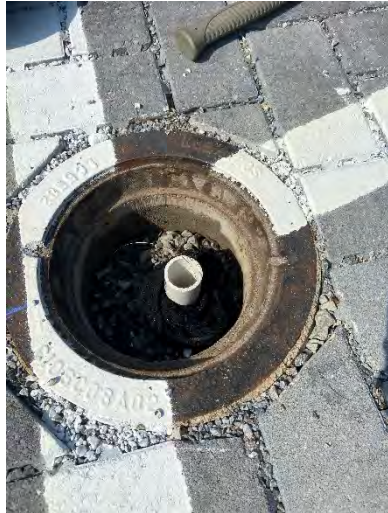
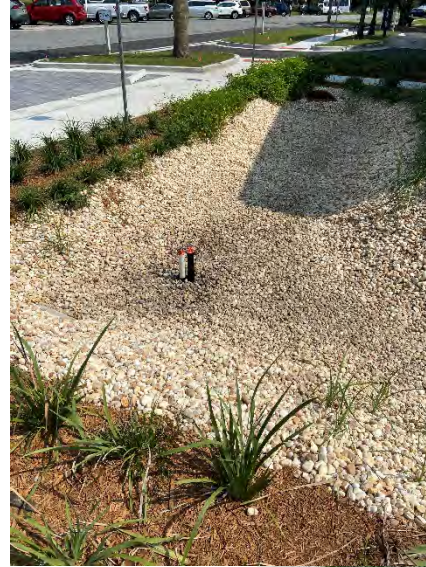
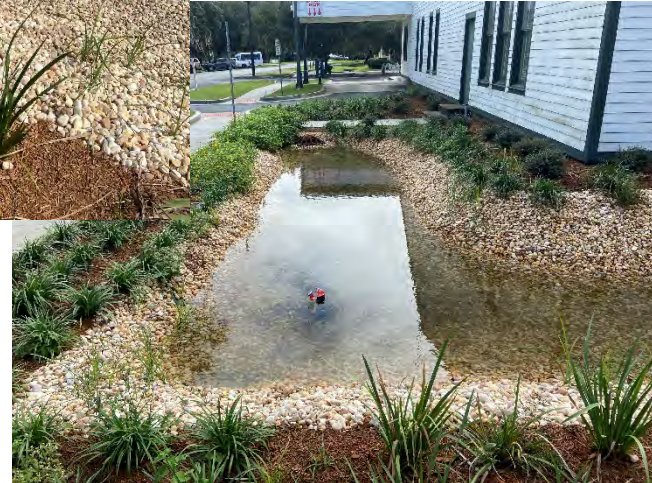
DEPLOYED AT CITY HALL (PHASE 2)

- Permeable Pavement
 - Exfiltration Rate
- Bioretention
 - Infiltration & Exfiltration Rate

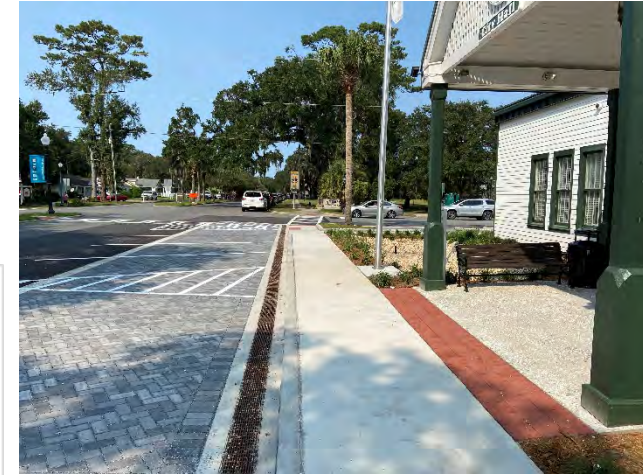
EXAMPLE EVENT – 10/6/2020; 1.71" RAINFALL

- Intra-event infiltration is substantial
- 3 segments over 8 hours
–0.19" → 2 hrs → 0.44" → 3 hrs → 1.08"

Capacity Elevations

Bottom of Pavers: 9.4' (blue)

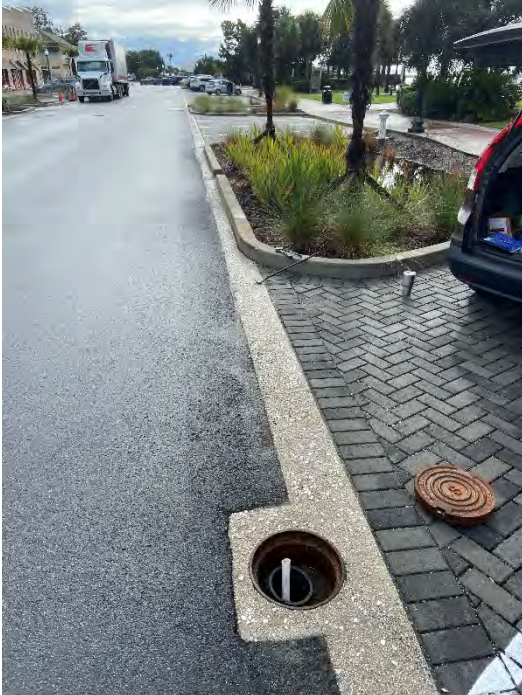
PHASE 1 – TIDAL INFLUENCE

- In-line tide flaps for underdrain installed Oct. 23, 2020

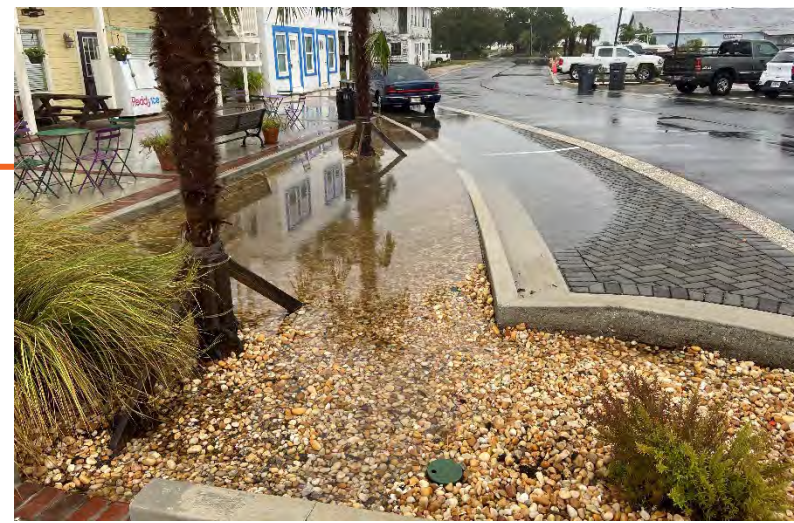
PHASE 1 MONITORING WELLS: SURFACE & SUBSURFACE

- Bypass Elevation Exceeded 9 times
 - 3 were due to tidal event only
- Ponding zone drains in ~8-18 hours

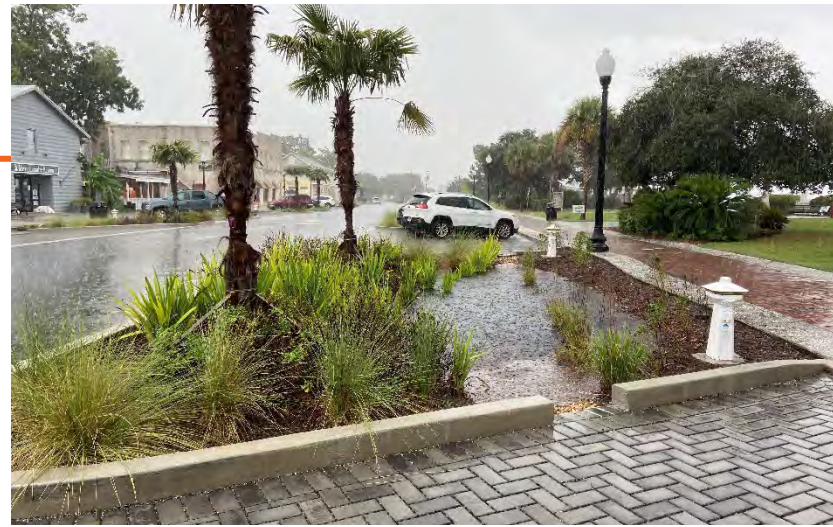
PHASE 1 MONITORING WELLS: SURFACE & SUBSURFACE

- Overflow Elevation has not been reached
- Ponding zone drains in ~2-5+ days
- Subsurface water stays present longer during wetter (and king tide) periods
