Don't Take Grants for Granted

Leveraging the Most from Congressional Funding Opportunities for the Life-Cycle Overhaul of an Inventory of Municipally Operated Dams

James Grimes, PE Brandon Harris, PE

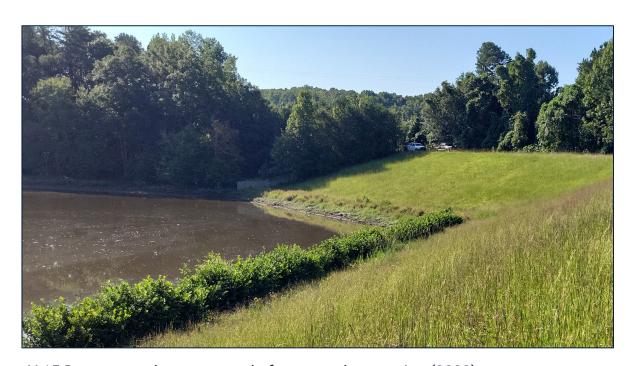
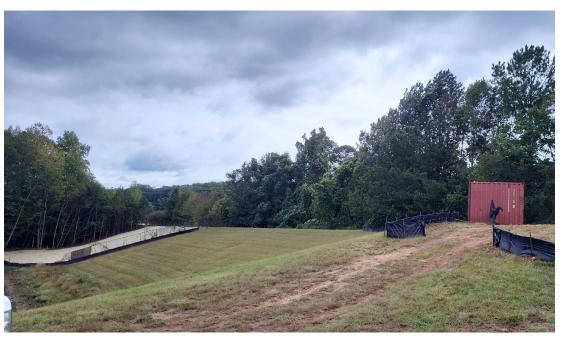
Y-15 Dam, pre and post removal of unwanted vegetation (2023)

Remove unwanted vegetation from dam limits

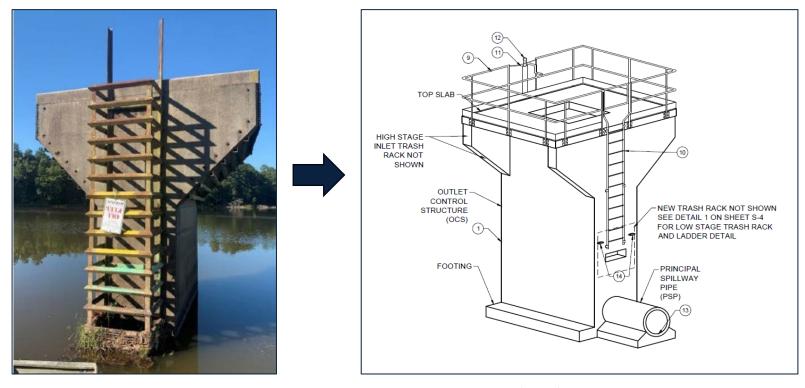
Replace or repair outlet control structures

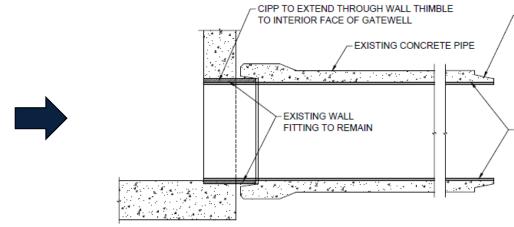
S3 PIPE LINER DETAIL
S3 SCALE: 3/4"=1'-0"

- CLEAN RUST FROM STEEL BAND AT OUTLET END OF PSP AND RE-COAT WITH A RUST PROTECTIVE COATING AS SPECIFIED IN THE GENERAL STRUCTURAL NOTES.

SEAL CRACKS IN CONCRETE AT OUTLET END OF PSP PER DETAIL 5 ON THIS SHEET. PATCH SPALLS IN CONCRETE PER DETAIL 4 ON THIS SHEET. CLEAN AND APPLY AN ABRASION RESISTANT COATING, AS SPECIFIED IN THE GENERAL STRUCTURAL NOTES, TO THE EXPOSED EXTERIOR CONCRETE AT OUTLET OF PSP.

INSTALL NEW 16.5mm CURED IN PLACE PIPE (CIPP) LINER PER SPECIFICATIONS

Line principal spillway pipes (Cast in Place Pipe lining)
